Vulnerability of Norwegian Bridges across Channels

Per TAMBS-LYCHE
Director Bridge Division
Public Roads Administration
Oslo, Norway

The paper describes the procedures for protective actions taken for securing bridge foundations against ship collisions. Relevant loads used in the design are given. No major catastrophe has occurred. Some minor collisions causing relatively serious damage are described. A survey undertaken in 1982 to spot and evaluate the bridges that could be in danger of ship collision are presented.

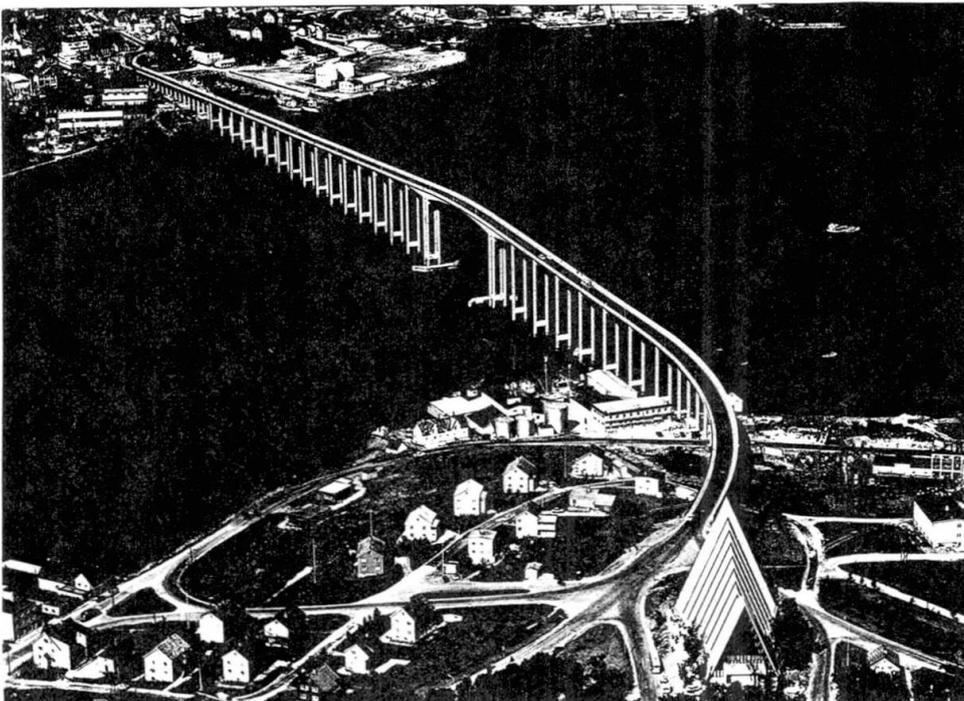
Fig. 2 Tromsø Bridge

To day, having learned by experience from several serious accidents around the world, and also a great number of smaller accidents in Tromsø Sound, we must state that the risk of collision between passing ships and the columns of Tromsø Bridge, was not satisfactorily judged when the bridge was planned.

The center to center distance between the two pairs of columns on each side of the main span is only 80 metres, and between fenders protecting these columns, the channel is only 60 metres wide. Between the main span and the abutments on the Tromsø side and the Tromsdal side respectively, the distance between the pairs of columns varies from 24 to 10 metres.

- I Installation of radar echo equipment along the main channel (on buoys of skerries).
- II Installation of navigation lamps and/or improving existing lighting systems on the bridge.
- III Installation of special warning devices to stop all the traffic across the bridge in case of serious damage to the structure.

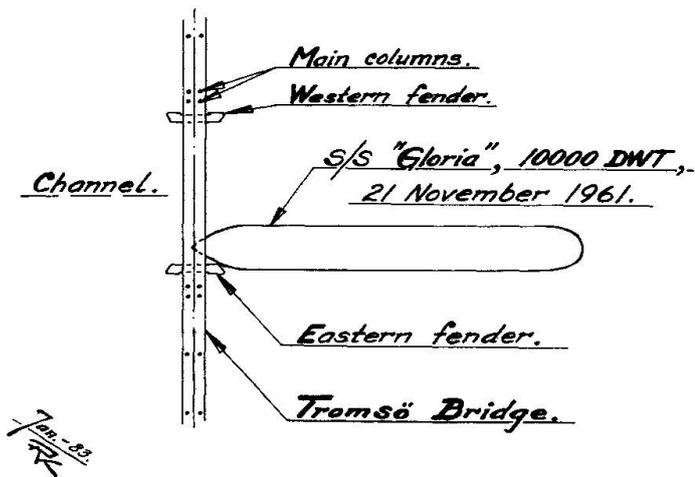
On the 21 November 1961, the 10 000 dwt. S/S "Gloria" ran into the eastern fender. The fender slab above the water as well as most of the concrete piles carrying the slab were completely destroyed and ended on the bottom of the sea. Fig. 3 shows the dimensions of the ship, the channel and the fenders.

Fig. 3 Tromsø Bridge: Collision, November 1961. Dimensions of ship, channel and fenders.

When the two fenders were rebuilt in 1962-63, hollow steel piles KP 35, filled with concrete, were used. The clearance between the fender slab and the nearest columns was 5 metres. Fracture of the piles were expected at a horizontal deformation of the fender of 4.3 metres. This would, approximately, be sufficient to stop a 10 000 dwt ship drifting into the fender at a speed of 0.5 m/sec.

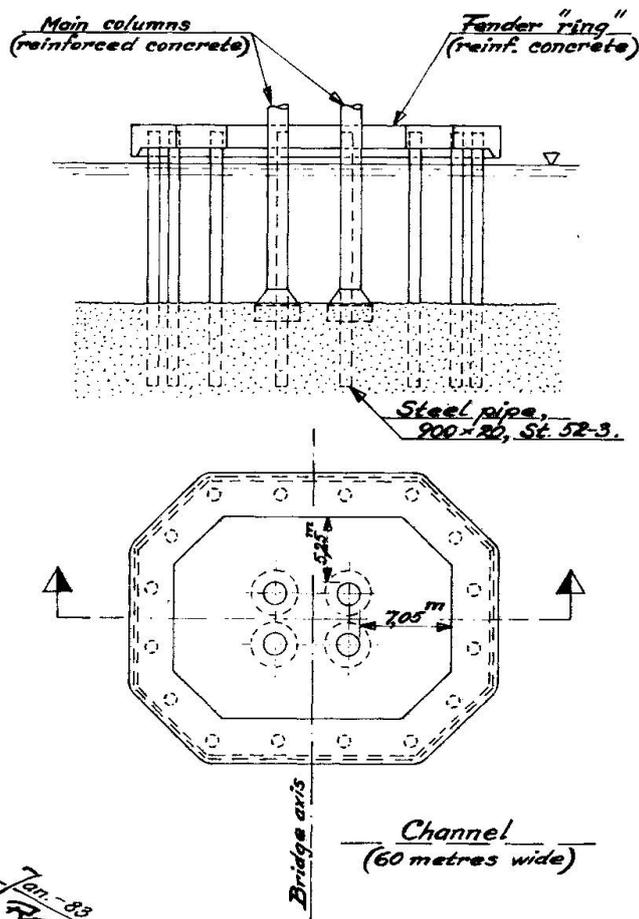
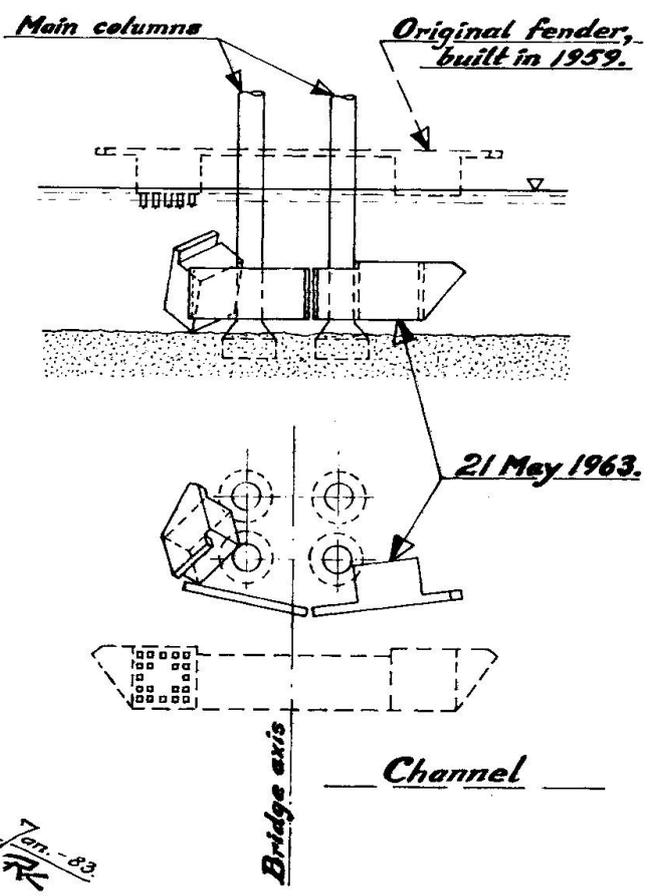
On the 21 May 1963 the western fender suffered the same fate as its easterly twin. M/S "Rotesand", a 1560 dwt ore-ship, then ran foul of the fender which collapsed and had to be removed. Fig. 4 shows the fender structure after the breakdown.

Fig. 4 Tromsø Bridge: Western fender before and after having been destroyed. (The destroyed fender was partly resting on heaps of broken piles, which are not shown on the figure).

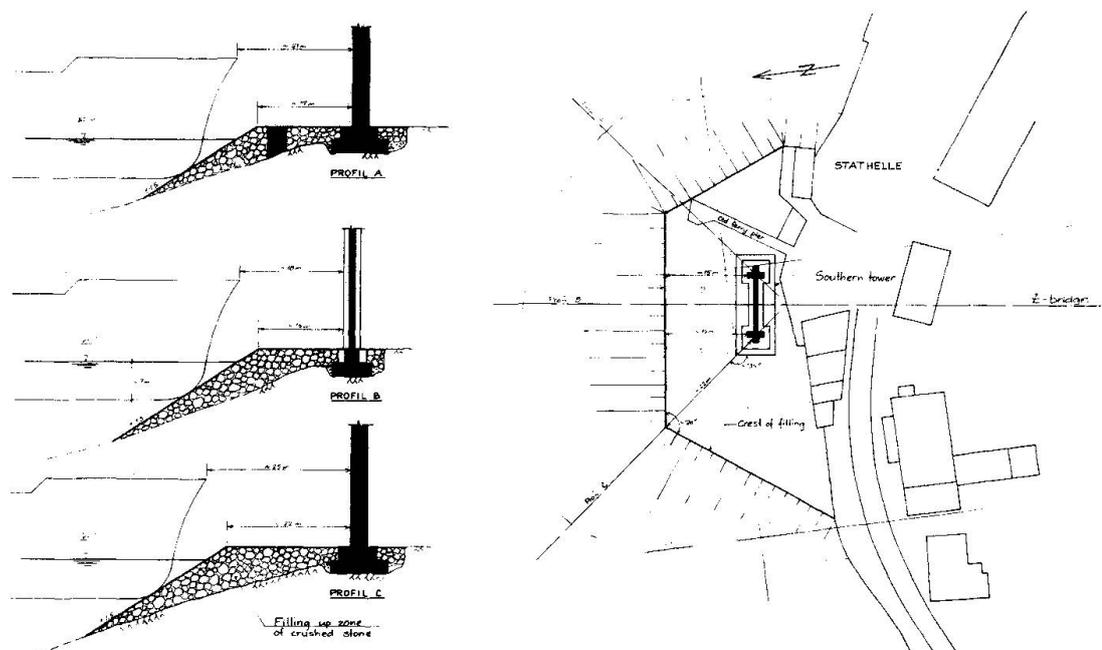
The southern tower of the main span has been regarded as vulnerable to the ship-traffic taking place through the channel. The navigational conditions are not the best ones through the shallow, narrow and tidal waters of the inlet, though certain equipment with regard to surveillance of the ships concerned has been in operation for some time.

Even though, incidents are now and then taking place in the channel including two cases of running aground close by the tower. One of the towerpiers was left with spalled concrete after one of these episodes. In addition three other close by incidents (agrounds within 20m from the tower) have been registered. All the run-agrounds in the bridge area have taken place while ships were leaving the harbour. According to attached figure 7 the tower is obviously most exposed to collision from ships moving in that direction. It should be emphasized that part of the tonnage passing the sound carries dangerous cargo, e.g. gastankers.

Fig. 7 Brevik Bridge; Filling up zone, southern tower

- I A proposed filling up zone as indicated in figure 7, will reduce sailing depths at the southern tower and will also provide an energy absorbing cushion for ships running aground.
- II Installation of warning devices to stop road traffic in case of serious damage to the structure.
