Artikel: Vulnerability of Norwegian bridges across channels

Autor: Tambs-Lyche, Per

Vulnérabilité des ponts enjambant des canaux de navigation, en Norvège Verwundbarkeit von Wasserstraßen überquerender Brücken in Norwegen

Per TAMBS-LYCHE Director Bridge Division Public Roads Administration Oslo, Norway

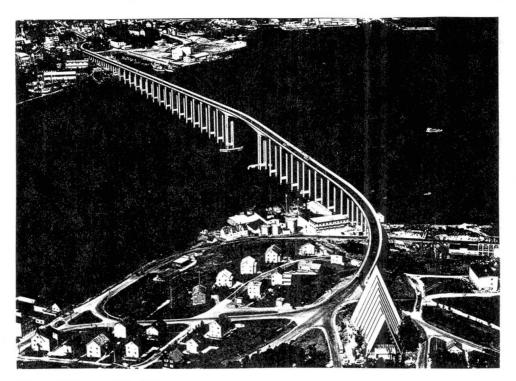
Fig. 2 Tromsø Bridge

To day, having learned by experience from several serious accidents around the world, and also a great number of smaller accidents in Tromsø Sound, we must state that the risk of collision between passing ships and the columns of Tromsø Bridge, was not satisfactorily judged when the bridge was planned.

The center to center distance between the two pairs of columns on each side of the main span is only 80 metres, and between fenders protecting these columns, the channel is only 60 metres wide. Between the main span and the abutments on the Tromsø side and the Tromsdal side respectively, the distance between the pairs of columns varies from 24 to 10 metres.

- I Installation of radar echo equipment along the main channel (on buoys of skerries).
- II Installation of navigation lamps and/or improving existing lighting systems on the bridge.
- III Installation of special warming devices to stop all the traffic across the bridge in case of serious damage to the structure.

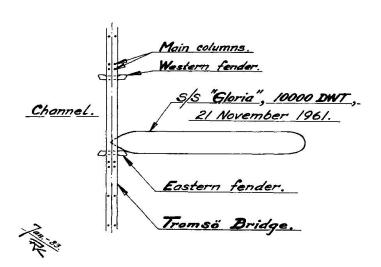
On the 21 November 1961, the 10 000 dwt. S/S "Gloria" ran into the eastern fender. The fender slab above the water as well as most of the concrete piles carrying the slab were completely destroyed and ended on the bottom of the sea. Fig. 3 shows the dimensions of the ship, the channel and the fenders.

Fig. 3 Tromsø Bridge: Collision, November 1961. Dimensions of ship, channel and fenders.

When the two fenders were rebuilt in 1962-63, hollow steel piles KP 35, filled with concrete, were used. The clearance between the fender slab and the nearest columns was 5 metres. Fracture of the piles were expected at a horizontal deformation of the fender of 4.3 metres. This would, approximately, be sufficient to stop a 10 000 dwt ship drifting into the fender at a speed of 0.5 m/sec.

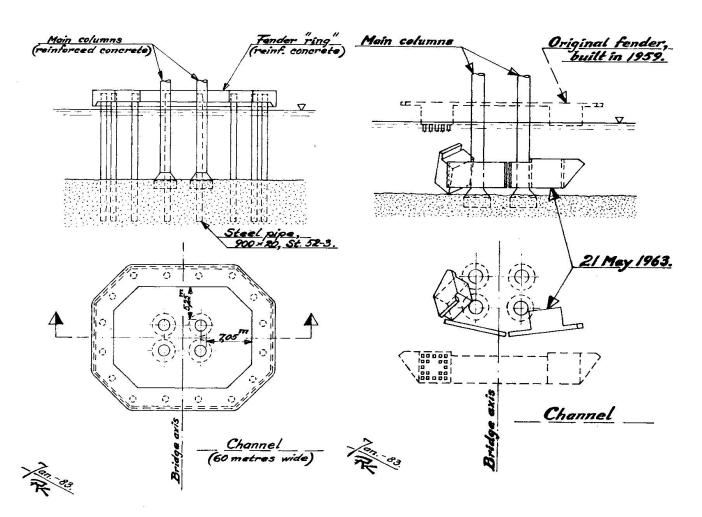
On the 21 May 1963 the western fender suffered the same fate as its easterly twin. M/S "Rotesand", a 1560 dwt ore-ship, then ran foul of the fender which collapsed and had to be removed. Fig. 4 shows the fender structure after the breakdown.

Fig. 4 Tromsø Bridge: Western fender before and after having been destroyed. (The destroyed fender was partly resting on heaps of broken piles, which are not shown on the figure).

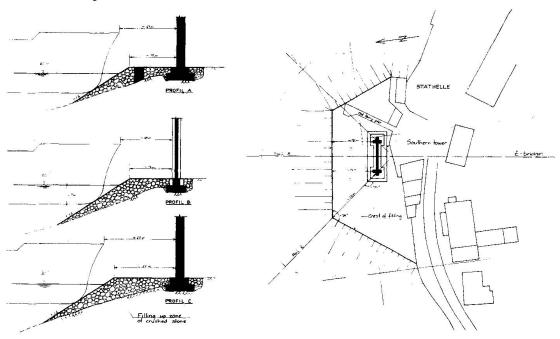
The southern tower of the main span has been regarded as vulnerable to the shiptraffic taking place through the channel. The navigational conditions are not the best ones through the shallow, narrow and tidal waters of the inlet, though certain equipment with regard to surveillance of the ships concerned has been in operation for some time.

Even though, incidents are now and then taking place in the channel including two cases of running aground close by the tower. One of the towerpiers was left with spalled concrete after one of these episodes. In addition three other close by incidents (agrounds within 20m from the tower) have been registered. All the run-agrounds in the bridge area have taken place while ships were leaving the harbour. According to attached figure 7 the tower is obviously most exposed to collision from ships moving in that direction. It should be emphasized that part of the tonnage passing the sound carries dangerous cargo, e.g. gastankers.

Fig. 7 Brevik Bridge; Filling up zone, southern tower

- I A proposed filling up zone as indicated in figure 7, will reduce sailing depths at the southern tower and will also provide an energy absorbing cushion for ships running aground.
- II Installation of warning devices to stop road traffic in case of serious damage to the structure.

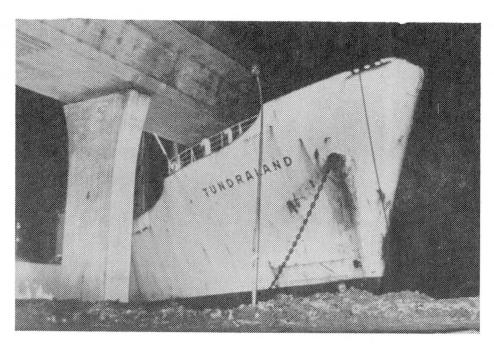
This motorway bridge was finished in 1975. It is a concrete box-section construction with spans around 50m. Close to the bridge is a quay in use for larger ships. In 1978 a ship of 4572 dwt was not able to reverse the engine. However, by very good seamanship the ship was grounded after manouvering between two columns. The superstructure of the ship only caused minor damages to the edges of the box-section. Fig. 8.

Fig. 8 Drammen Bridge; Nearly catastrophe
