Artikel: Vulnerability of Norwegian bridges across channels
Autor: Tambs-Lyche, Per
DOI: <https://doi.org/10.5169/seals-32402>

Vulnerability of Norwegian Bridges across Channels

Per TAMBS-LYCHE
Director Bridge Division
Public Roads Administration
Oslo, Norway

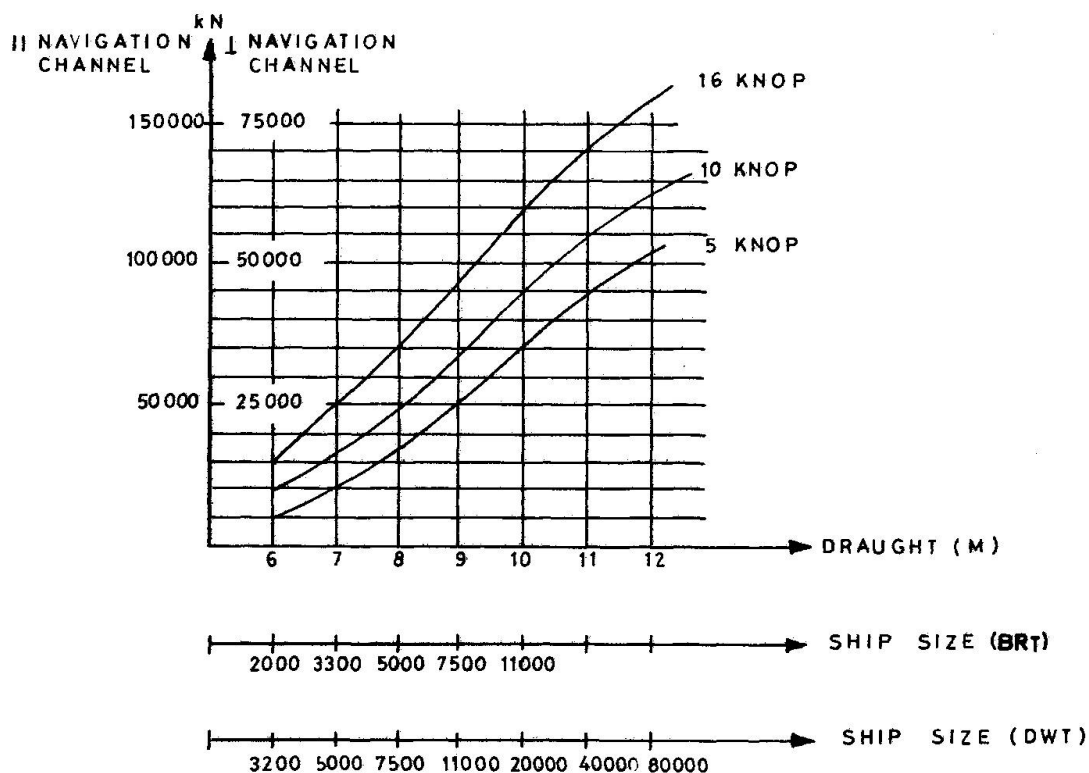
Fig. 1 Magnitude of ship collision force as a function of ship size and speed

Norwegian bridge foundations adjoining a ship channel are as a rule designed for a static force of 3000 MP perpendicular to the bridge's axis (parallel to the channel) and 1500 MP parallel to the bridge. The foundations are usually supposed to be rigid. The size of this force is approximately supposed to represent a ship of 8000 dwt at a speed of 5 knot.

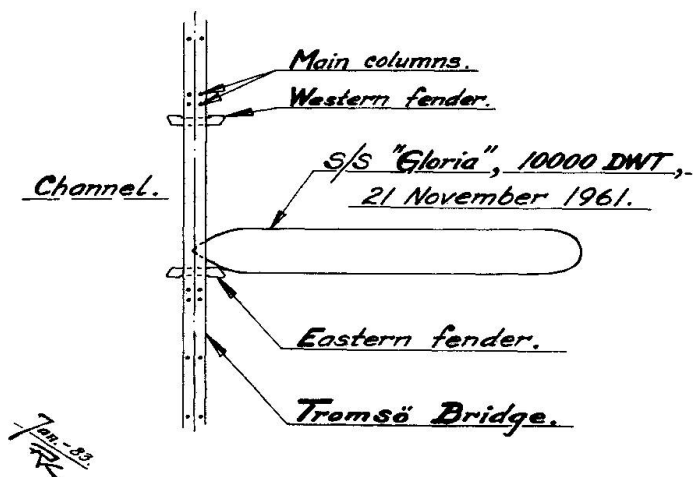
On the 21 November 1961, the 10 000 dwt. S/S "Gloria" ran into the eastern fender. The fender slab above the water as well as most of the concrete piles carrying the slab were completely destroyed and ended on the bottom of the sea. Fig. 3 shows the dimensions of the ship, the channel and the fenders.

Fig. 3 Tromsø Bridge:
Collision, November 1961.
Dimensions of ship,
channel and fenders.

When the two fenders were rebuilt in 1962-63, hollow steel piles KP 35, filled with concrete, were used. The clearance between the fender slab and the nearest columns was 5 metres. Fracture of the piles were expected at a horizontal deformation of the fender of 4.3 metres. This would, approximately, be sufficient to stop a 10 000 dwt ship drifting into the fender at a speed of 0.5 m/sec.

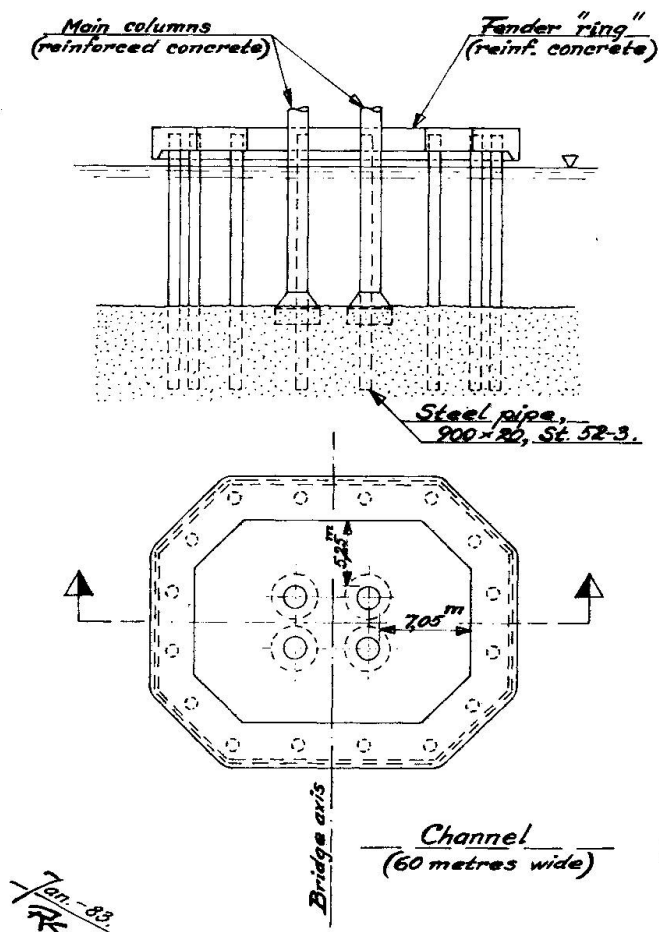
On the 21 May 1963 the western fender suffered the same fate as its easterly twin. M/S "Rotesand", a 1560 dwt ore-ship, then ran foul of the fender which collapsed and had to be removed. Fig. 4 shows the fender structure after the breakdown.

Fig. 4 Tromsø Bridge:
Western fender before and
after having been destroyed.
(The destroyed fender was
partly resting on heaps of
broken piles, which are not
shown on the figure).

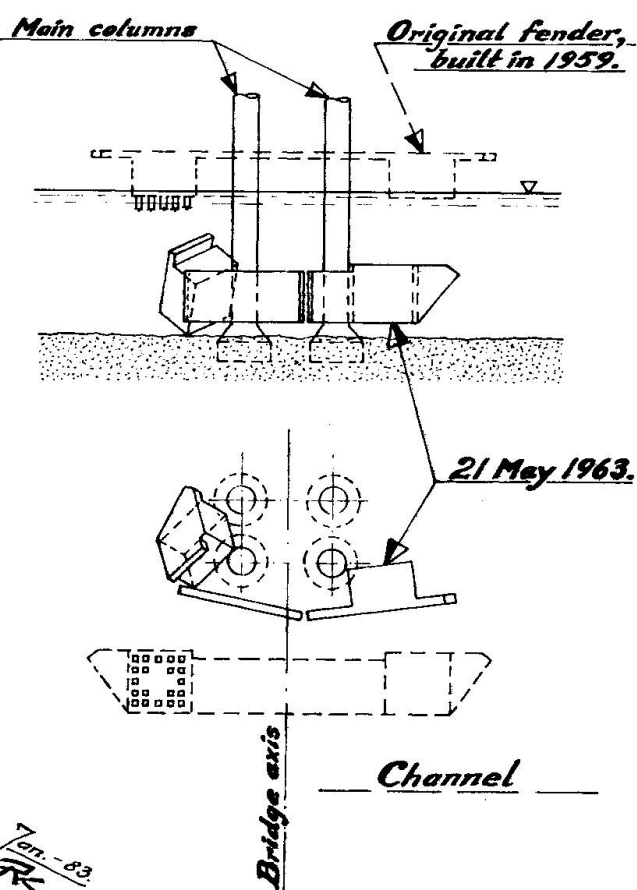
Ring-shaped reinforced concrete structures resting on steel piles, now encircles the groups of four columns on each side of the main span. The clearance between concrete ring and the nearest pair of columns, is 5.25 metres measured at right angle to the channel, and 7.05 metres measured parallel to the channel. Fig. 5.

Fig. 5 Tromsø Bridge:
New fender.
Ring-shaped reinforced concrete
structure resting on steel piles.

alistic manner on the 5 July 1975. Then the passenger ship "Ragnvald Jarl" ran into one of the fenders resulting in a big crack in the side of the ship and four damaged cabins.

The wooden planks along the concrete fender were more or less crushed and torn off, but the concrete and the steel parts of the structure were not damaged.

If the new fenders had not been built, the whole mid-section of the bridge would probably have fallen down.

The existing fender structure which were built in 1974-75, were therefore designed to withstand the impact of a 7000 tons body (ship plus hydraulic mass) with a speed of 4 m/sec. The design was based on assumptions so chosen that the resulting forces should be on the safe side as far as the bridge structure is considered. (2), (3).

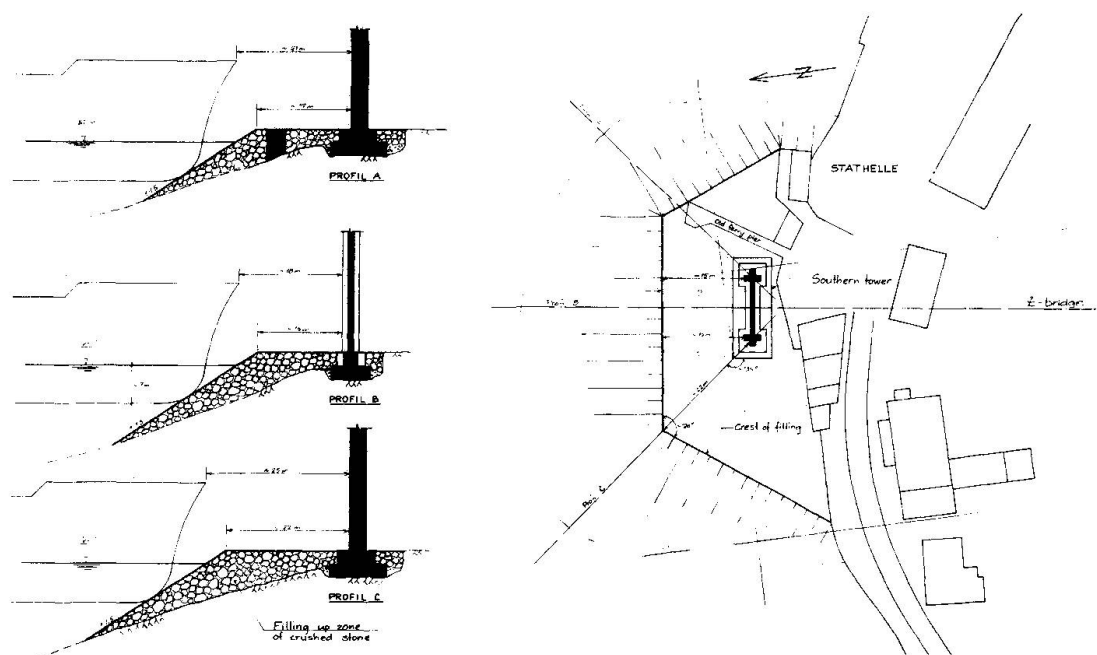
The southern tower of the main span has been regarded as vulnerable to the ship-traffic taking place through the channel. The navigational conditions are not the best ones through the shallow, narrow and tidal waters of the inlet, though certain equipment with regard to surveillance of the ships concerned has been in operation for some time.

Even though, incidents are now and then taking place in the channel including two cases of running aground close by the tower. One of the towerpiers was left with spalled concrete after one of these episodes. In addition three other close by incidents (agrounds within 20m from the tower) have been registered. All the run-agrounds in the bridge area have taken place while ships were leaving the harbour. According to attached figure 7 the tower is obviously most exposed to collision from ships moving in that direction. It should be emphasized that part of the tonnage passing the sound carries dangerous cargo, e.g. gastankers.

Fig. 7 Brevik Bridge; Filling up zone, southern tower

- I A proposed filling up zone as indicated in figure 7, will reduce sailing depths at the southern tower and will also provide an energy absorbing cushion for ships running aground.
- II Installation of warning devices to stop road traffic in case of serious damage to the structure.

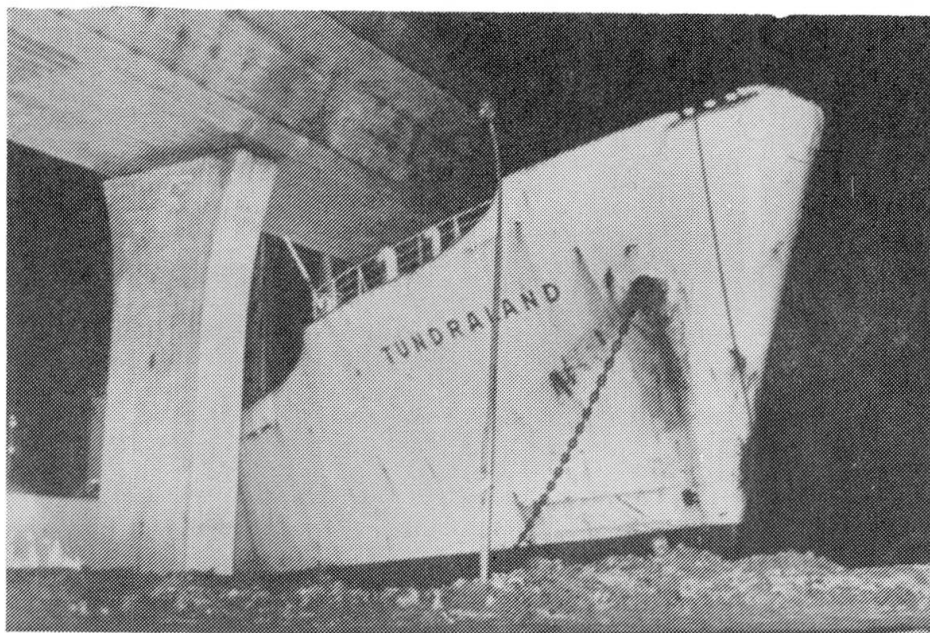
This motorway bridge was finished in 1975. It is a concrete box-section construction with spans around 50m. Close to the bridge is a quay in use for larger ships. In 1978 a ship of 4572 dwt was not able to reverse the engine. However, by very good seamanship the ship was grounded after manouvering between two columns. The superstructure of the ship only caused minor damages to the edges of the box-section. Fig. 8.

Fig. 8 Drammen Bridge; Nearly catastrophe
