Zeitschrift: IABSE reports = Rapports AIPC = IVBH Berichte

Band: 42 (1983)

Rubrik: Theme A: Case stories of recent ship collision accidents

Case Stories of Recent Ship Collision Accidents
Rapports d'accidents de collisions de bateaux
Fälle von neueren Schiffskollisionen

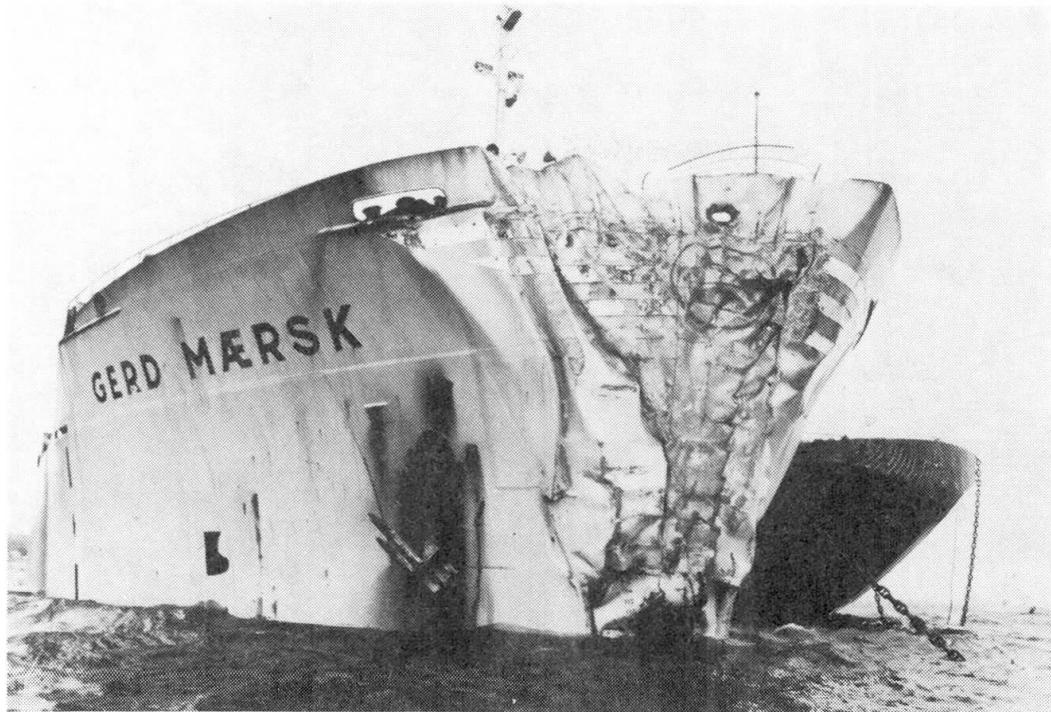
Fig. 2. Collision damage to tanker.

The bow of the ship was crushed in to the extent that the ship was shortened 3.5 m (Fig. 2). The ship came to a complete stop and then drifted off. Although it took on some water through sprung plates, no oil was spilled, and the ship was never in danger of sinking.

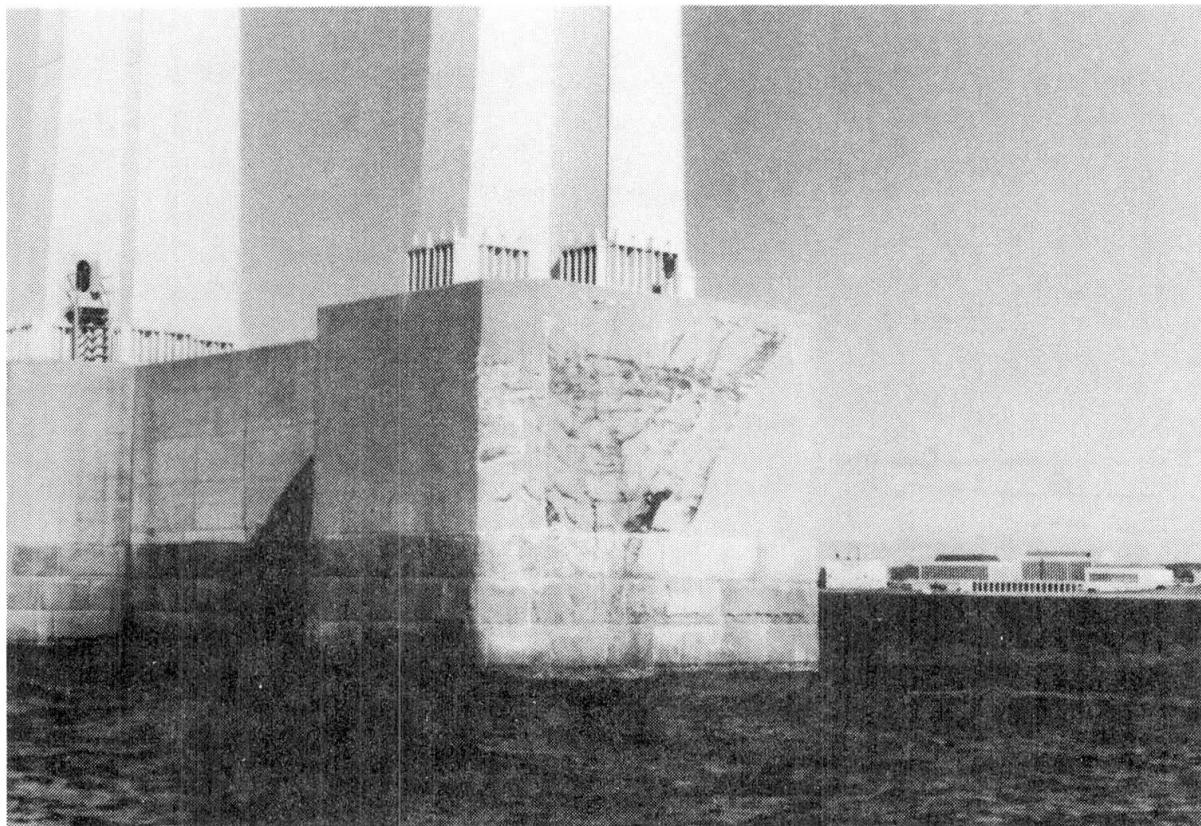
Fig. 3. Bridge pier damage.

Damage to the bridge was negligible. The pier suffered no displacement or rotation, and there was no misalignment of the roadway deck joints or any other superstructure elements. The side of the pier suffered extensive surface scrapes, gouges, and spalls of the concrete (Fig. 3) to a depth of 2 to 5 cm over an area roughly 7 m wide by 20 m high, approximately equally above and below the water line (Fig. 4).

There were a number of superficial tears in steel plating of the underwater caisson structure, but no damage to the concrete behind the plating. A spectacular blotch of gray paint decorated the side of the pier for several days before falling off.

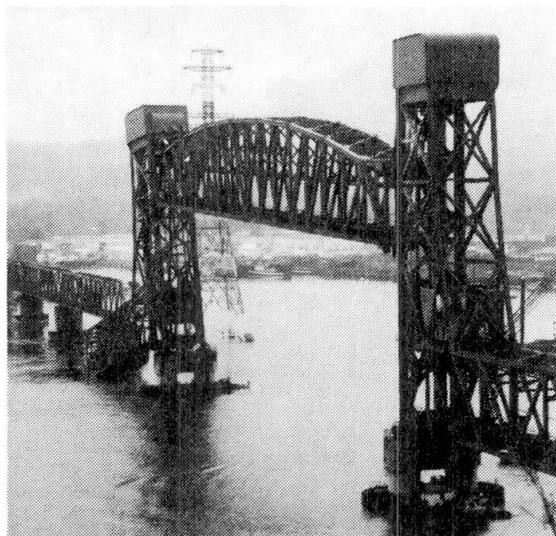
Figure 1

The initial appraisal of damage indicated a dramatic series of instantaneous failure mechanisms. The severe damage was limited to the bottom chord and web system between panel points (p.p.) L2 and L4 (see Fig. 2 for p.p. numbering). This damage permitted the remaining portion of the span to rotate against a plastic hinge which formed in the top chord at U2. An examination of the point of impact of the vessel at L3 failed to show any vertical striations in the paintwork indicating the explosive suddenness of the lateral displacement. Except for one member in the immediate area of impact, the top lateral system was undamaged, as was the portal bracing system.

All the bottom laterals which were visible from L0 to L6 displayed compression failure, although the floor beams and stringers in the undamaged panels did not exhibit any distress.

The top chord members from U7 to U2 were virtually undamaged except for two significant areas. The first was the plastic hinge in the chords and the second was the compression failure of the diagonal brace from U3E to U2W. The latter was of great importance during truss separation.

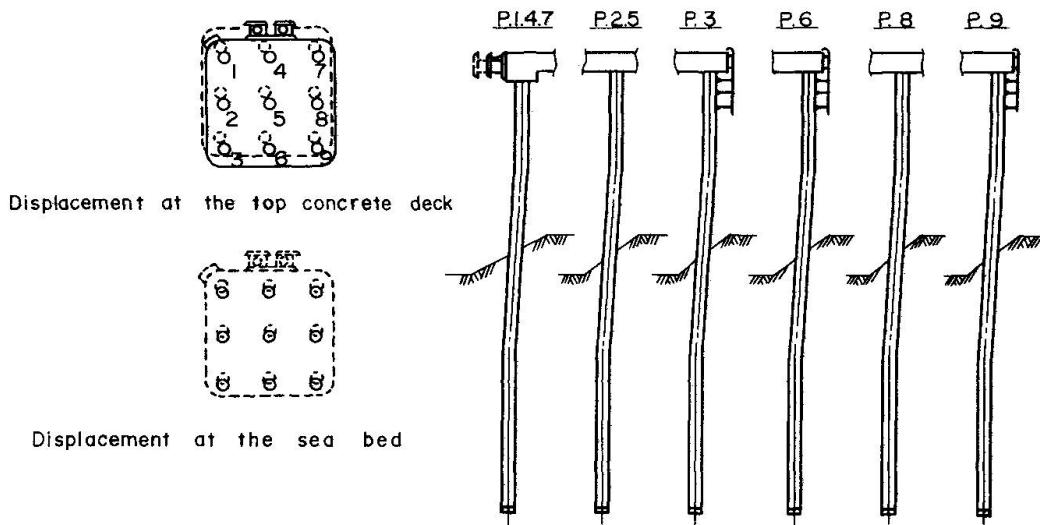
Fig.5 Deformation of Dolphin B-3

The results of our inspection carried out immediately after the accidents are briefly as follows: (See Fig.5)

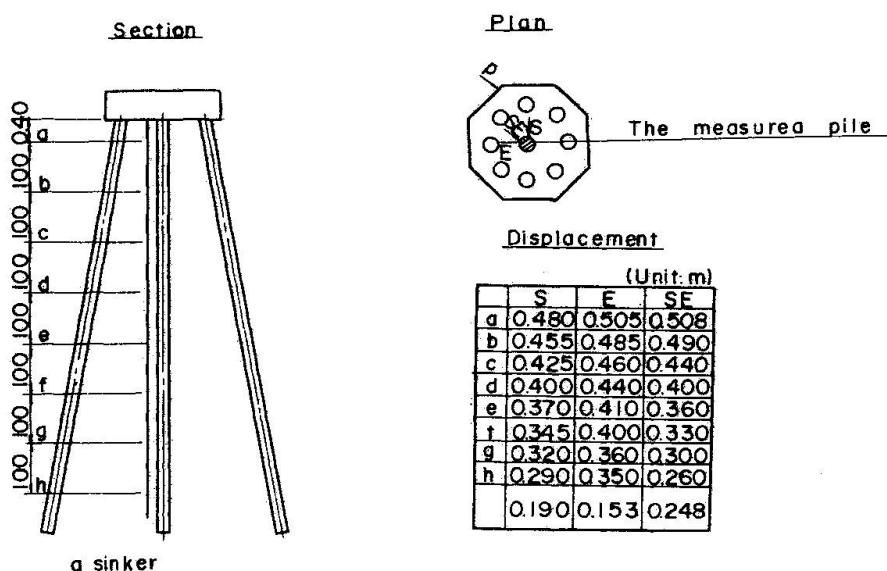
Fig.6 Deformation of Dolphin M-1

The sea bed was covered with mud so that deformation of the ground could not be inspected there.

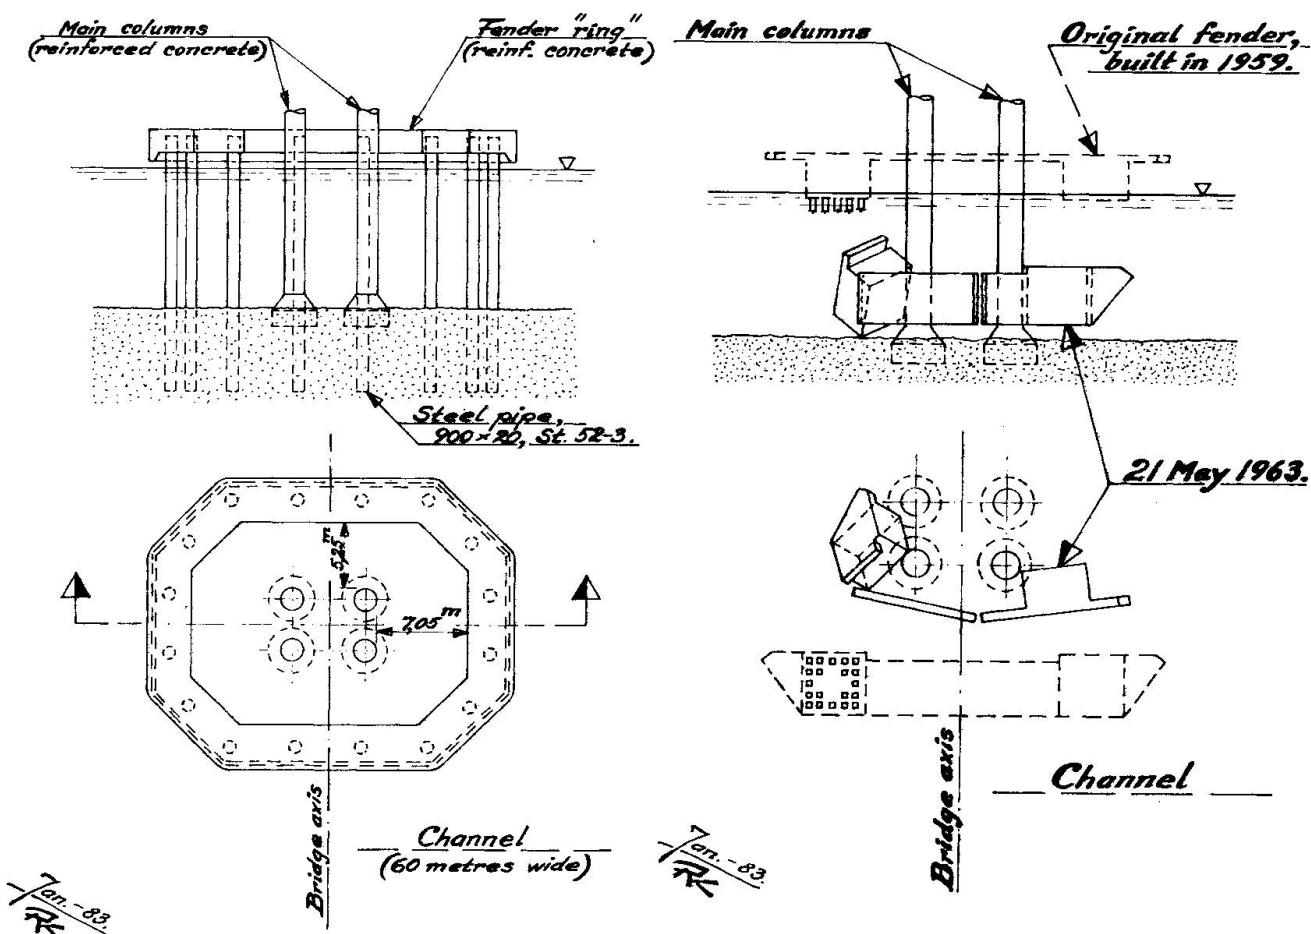
Fig. 4 Tromsø Bridge:
Western fender before and
after having been destroyed.
(The destroyed fender was
partly resting on heaps of
broken piles, which are not
shown on the figure).

Fig. 5 Tromsø Bridge:
New fender.
Ring-shaped reinforced concrete
structure resting on steel piles.

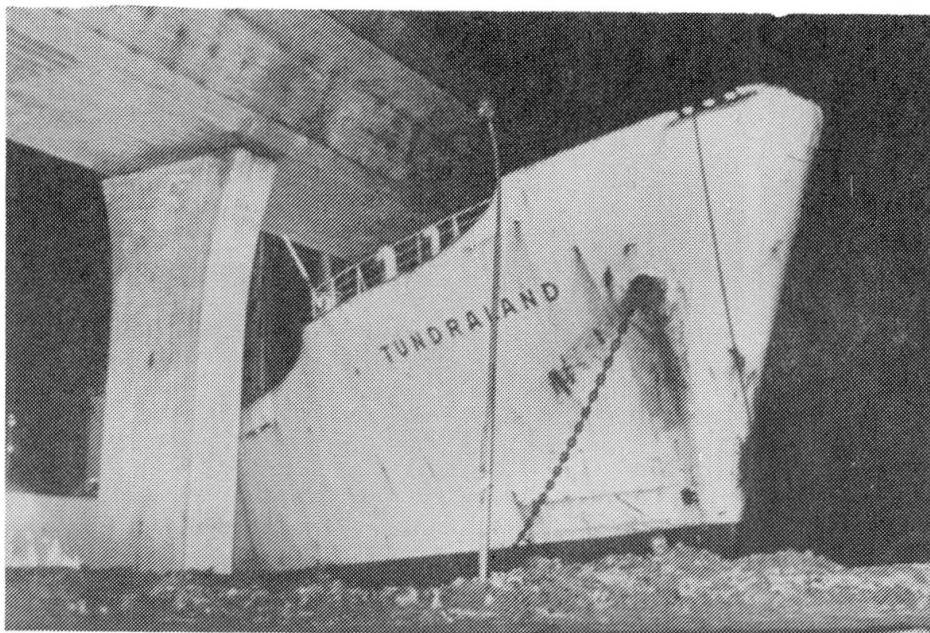
This motorway bridge was finished in 1975. It is a concrete box-section construction with spans around 50m. Close to the bridge is a quay in use for larger ships. In 1978 a ship of 4572 dwt was not able to reverse the engine. However, by very good seamanship the ship was grounded after manouevring between two columns. The superstructure of the ship only caused minor damages to the edges of the box-section. Fig. 8.

Fig. 8 Drammen Bridge; Nearly catastrophe
