**Zeitschrift:** IABSE reports = Rapports AIPC = IVBH Berichte  
**Band:** 42 (1983)

**Rubrik:** Theme A: Case stories of recent ship collision accidents

### **Case Stories of Recent Ship Collision Accidents**

## Ship Collisions with Danish Lighthouses

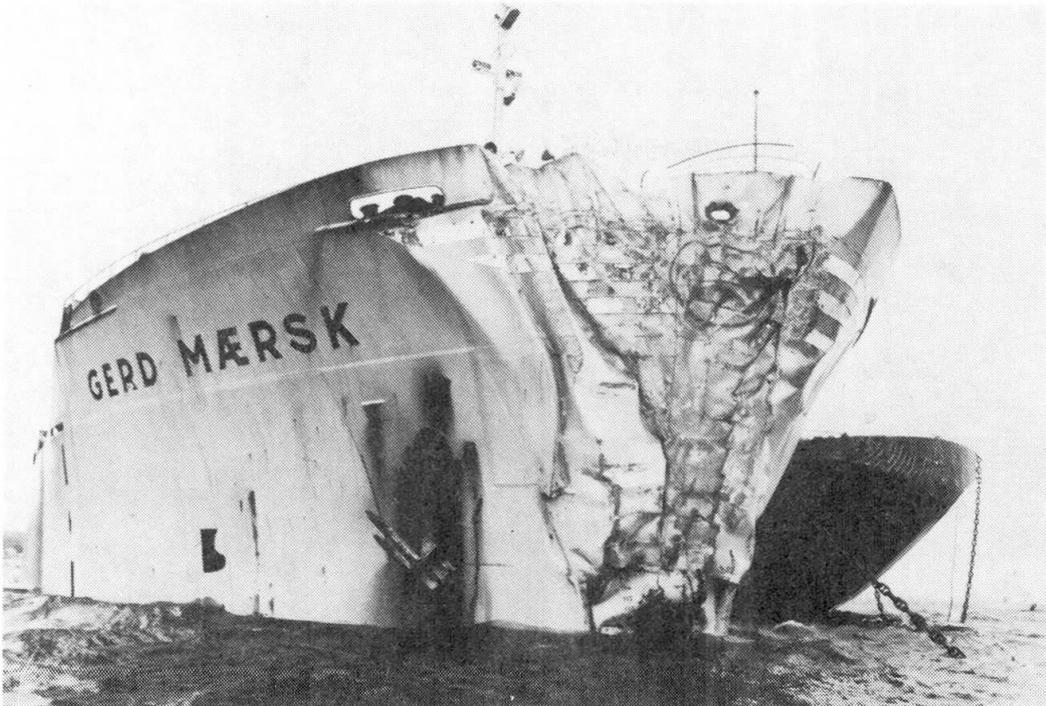
Fig. 2. Collision damage to tanker.

In 1981 a main tower pier of the 488-m Newport suspension bridge in Rhode Island, USA, was struck head on by a fully laden 45,000-ton tanker. The ship was shortened 3.5 m through bow crushing, but the bridge pier suffered only superficial damage. Details of bridge design and accident are given, and forces developed during the collision are derived.

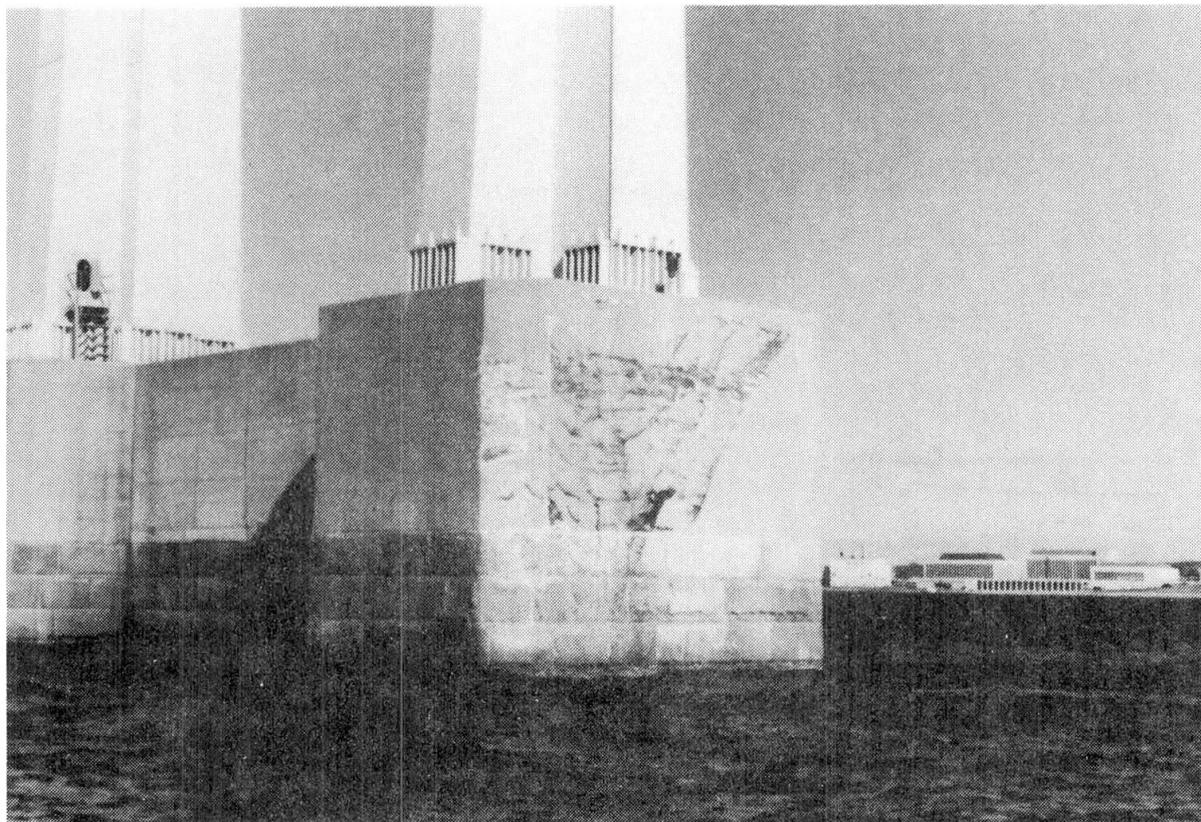
Fig. 3. Bridge pier damage.

Damage to the bridge was negligible. The pier suffered no displacement or rotation, and there was no misalignment of the roadway deck joints or any other superstructure elements. The side of the pier suffered extensive surface scrapes, gouges, and spalls of the concrete (Fig. 3) to a depth of 2 to 5 cm over an area roughly 7 m wide by 20 m high, approximately equally above and below the water line (Fig. 4).

There were a number of superficial tears in steel plating of the underwater caisson structure, but no damage to the concrete behind the plating. A spectacular blotch of gray paint decorated the side of the pier for several days before falling off.

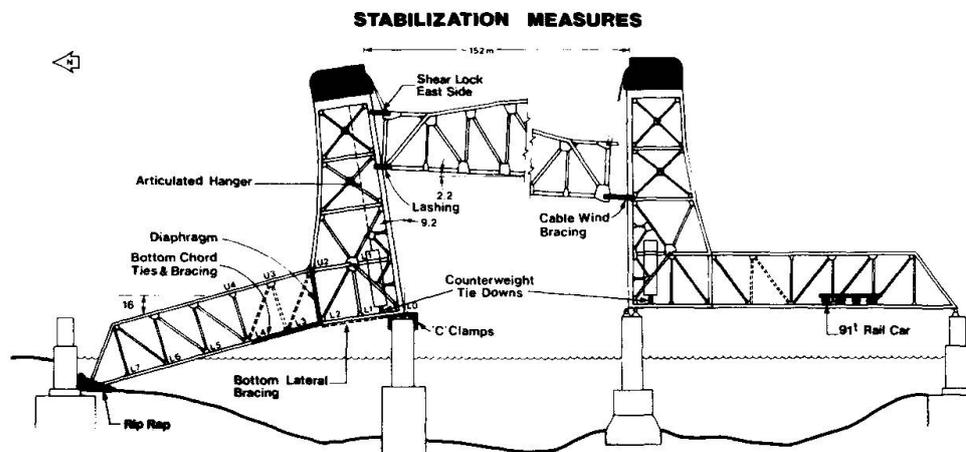
Figure 2

The initial appraisal of damage indicated a dramatic series of instantaneous failure mechanisms. The severe damage was limited to the bottom chord and web system between panel points (p.p.) L2 and L4 (see Fig. 2 for p.p. numbering). This damage permitted the remaining portion of the span to rotate against a plastic hinge which formed in the top chord at U2. An examination of the point of impact of the vessel at L3 failed to show any vertical striations in the paintwork indicating the explosive suddenness of the lateral displacement. Except for one member in the immediate area of impact, the top lateral system was undamaged, as was the portal bracing system.

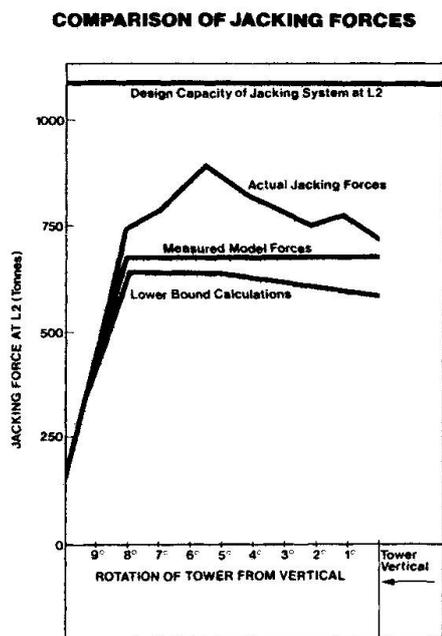
Figure 4 shows the accuracy that the various analyses achieved by plotting the jacking forces at L2 as the tower rotated to the vertical. The lower bound calculations were derived from measured forces and theoretical analysis and, as can be seen, are very close to the forces predicted by model analysis.

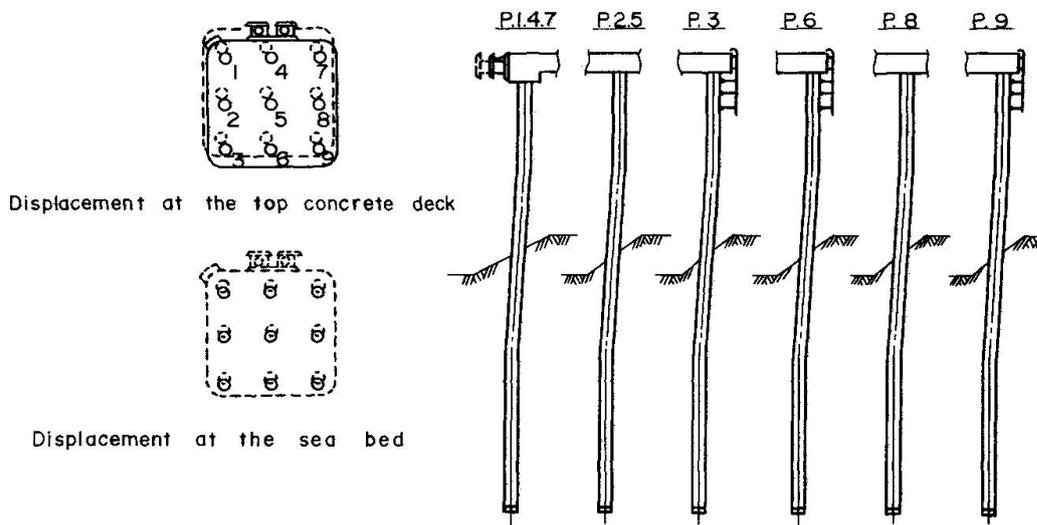
Fig.5 Deformation of Dolphin B-3

The results of our inspection carried out immediately after the accidents are briefly as follows: (See Fig.5)

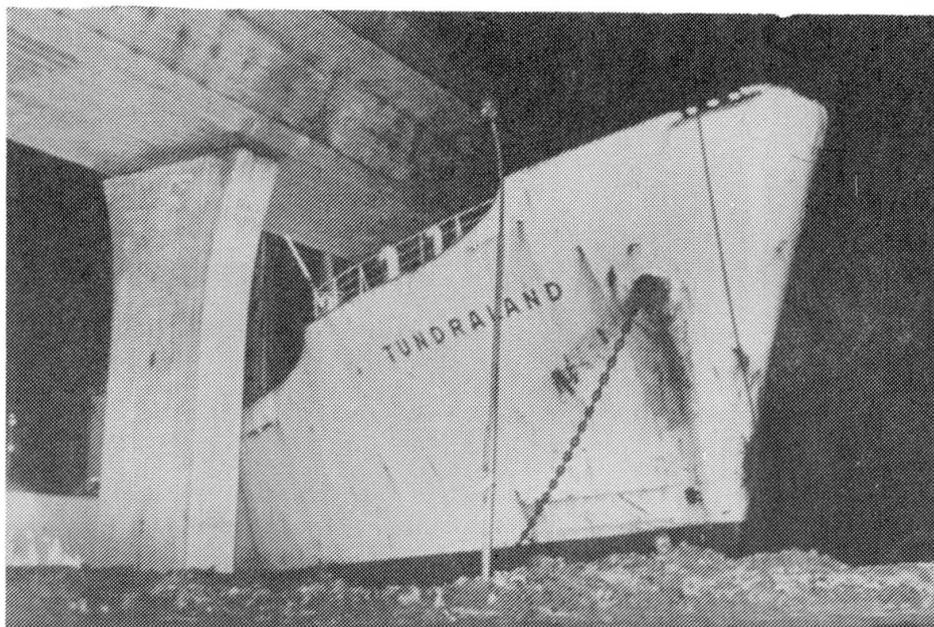
Fig. 8 Drammen Bridge; Nearly catastrophe

This motorway bridge was finished in 1975. It is a concrete box-section construction with spans around 50m. Close to the bridge is a quay in use for larger ships. In 1978 a ship of 4572 dwt was not able to reverse the engine. However, by very good seamanship the ship was grounded after manouvering between two columns. The superstructure of the ship only caused minor damages to the edges of the box-section. Fig. 8.
