Zeitschrift: IABSE reports = Rapports AIPC = IVBH Berichte

Band: 42 (1983)

Theme A

Case Stories of Recent Ship Collision Accidents
Rapports d'accidents de collisions de bateaux
Fälle von neueren Schiffskollisionen

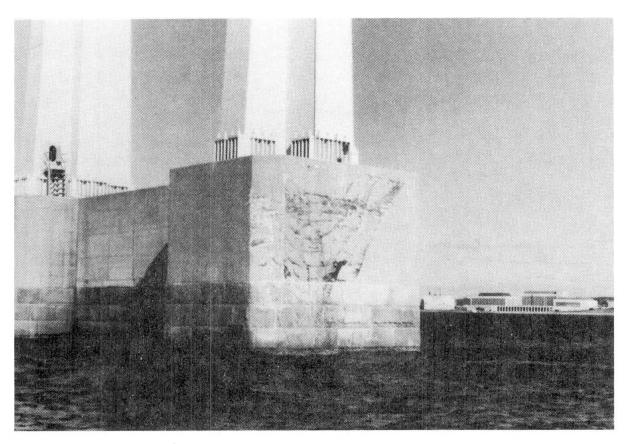
Damage to the bridge was negligible. The pier suffered no displacement or rotation, and there was no misalignment of the roadway deck joints or any other superstructure elements. The side of the pier suffered extensive surface scrapes, gouges, and spalls of the concrete (Fig. 3) to a depth of 2 to 5 cm over an area roughly 7 m wide by 20 m high, approximately equally above and below the water line (Fig. 4).

There were a number of superficial tears in steel plating of the underwater caisson structure, but no damage to the concrete behind the plating. A spectacular blotch of gray paint decorated the side of the pier for several days before falling off.

Fig. 3. Bridge pier damage.

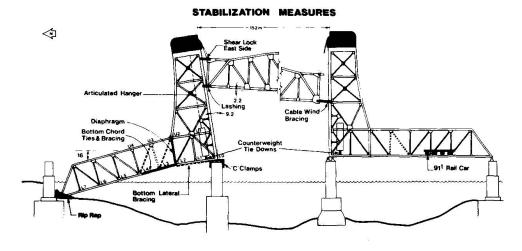
Figure 2

The initial appraisal of damage indicated a dramatic series of instantaneous failure The severe damage was limited mechanisms. to the bottom chord and web system between panel points (p.p.) L2 and L4 (see Fig. 2 for p.p. numbering). This damage permitted the remaining portion of the span to rotate against a plastic hinge which formed in the top chord at U2. An examination of the point of impact of the vessel at L3 failed to show any vertical striations in the paintwork indicating the suddenness of the lateral displacement. Except for one member in the immediate area of impact, the top lateral system was undamaged, as was the portal system.

All the bottom laterals which were visible from LO to L6 displayed compression failure, although the floor beams and stringers in the undamaged panels did not exhibit any distress.

The top chord members from U7 to U2 were virtually undamaged except for two significant areas. The first was the plastic hinge in the chords and the second was the compression failure of the diagonal brace from U3E to U2W. The latter was of great importance during truss separation.

Due to the loss of the web members in panel L2 to L4 it was necessary to inhibit any further tendency to hinge at U2. Accordingly, heavy structural sections were cut and fitted on site to make the bottom chord continuous from L2 to L4. A temporary vertical U3-L3 was installed and the vertical bracing in the plane of the north face of the tower was extended down through the truss to L2. The bottom lateral bracing system was restored from L0 to L2 and so transformed the tower portion of the structure into an integrated vertical box truss, a condition which was to present some problems during subsequent operations.

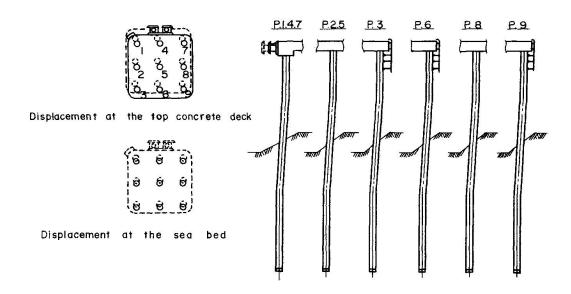
The results of our inspection carried out immediately after the accidents are briefly as follows: (See Fig.5)

Fig. 5 Deformation of Dolphin B-3

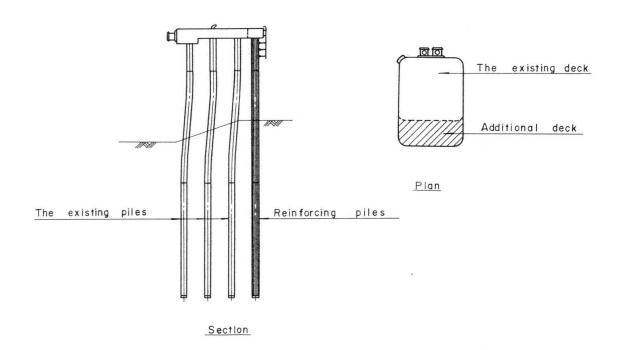
Fig. 7 Restoration of Dolphin B-3

However, on the basis of an accurate stress analysis of the materials, we selected a reinforcement method with additional piles, in which the structural system of the dolphin was not changed but improved in order to keep its stability. That is, if the residual yield strength of a damaged structure with residual deformation is accurately estimated, the structure can be restored by redistribution of the stress from its reinforcement. (See Fig. 7 & 8)

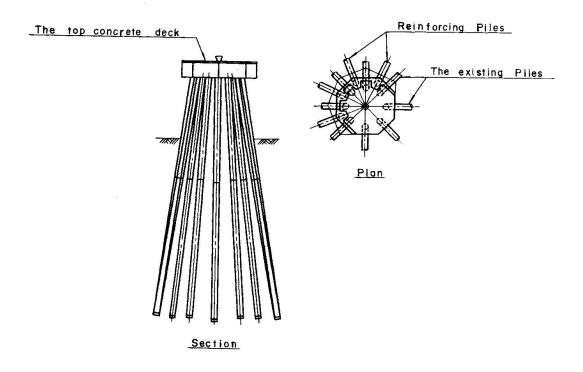
Fig.8 Restoration of Dolphin M-l
