Ship Collisions with Danish Lighthouses

Aksel MIKKELSEN
Civil Engineer
Administration of Navigation
and Hydrography
Copenhagen, Denmark

Since 1972, fourteen small lighthouses have been built in the Great Belt at water depths ranging between 8 and 17 m. Many of them have since then been exposed to ship collisions. Two of them, situated closely to the planned site of the Great Belt Bridge, have for instance been run into three and four times, respectively. The conclusion of the collision cases must be said to be negligence.

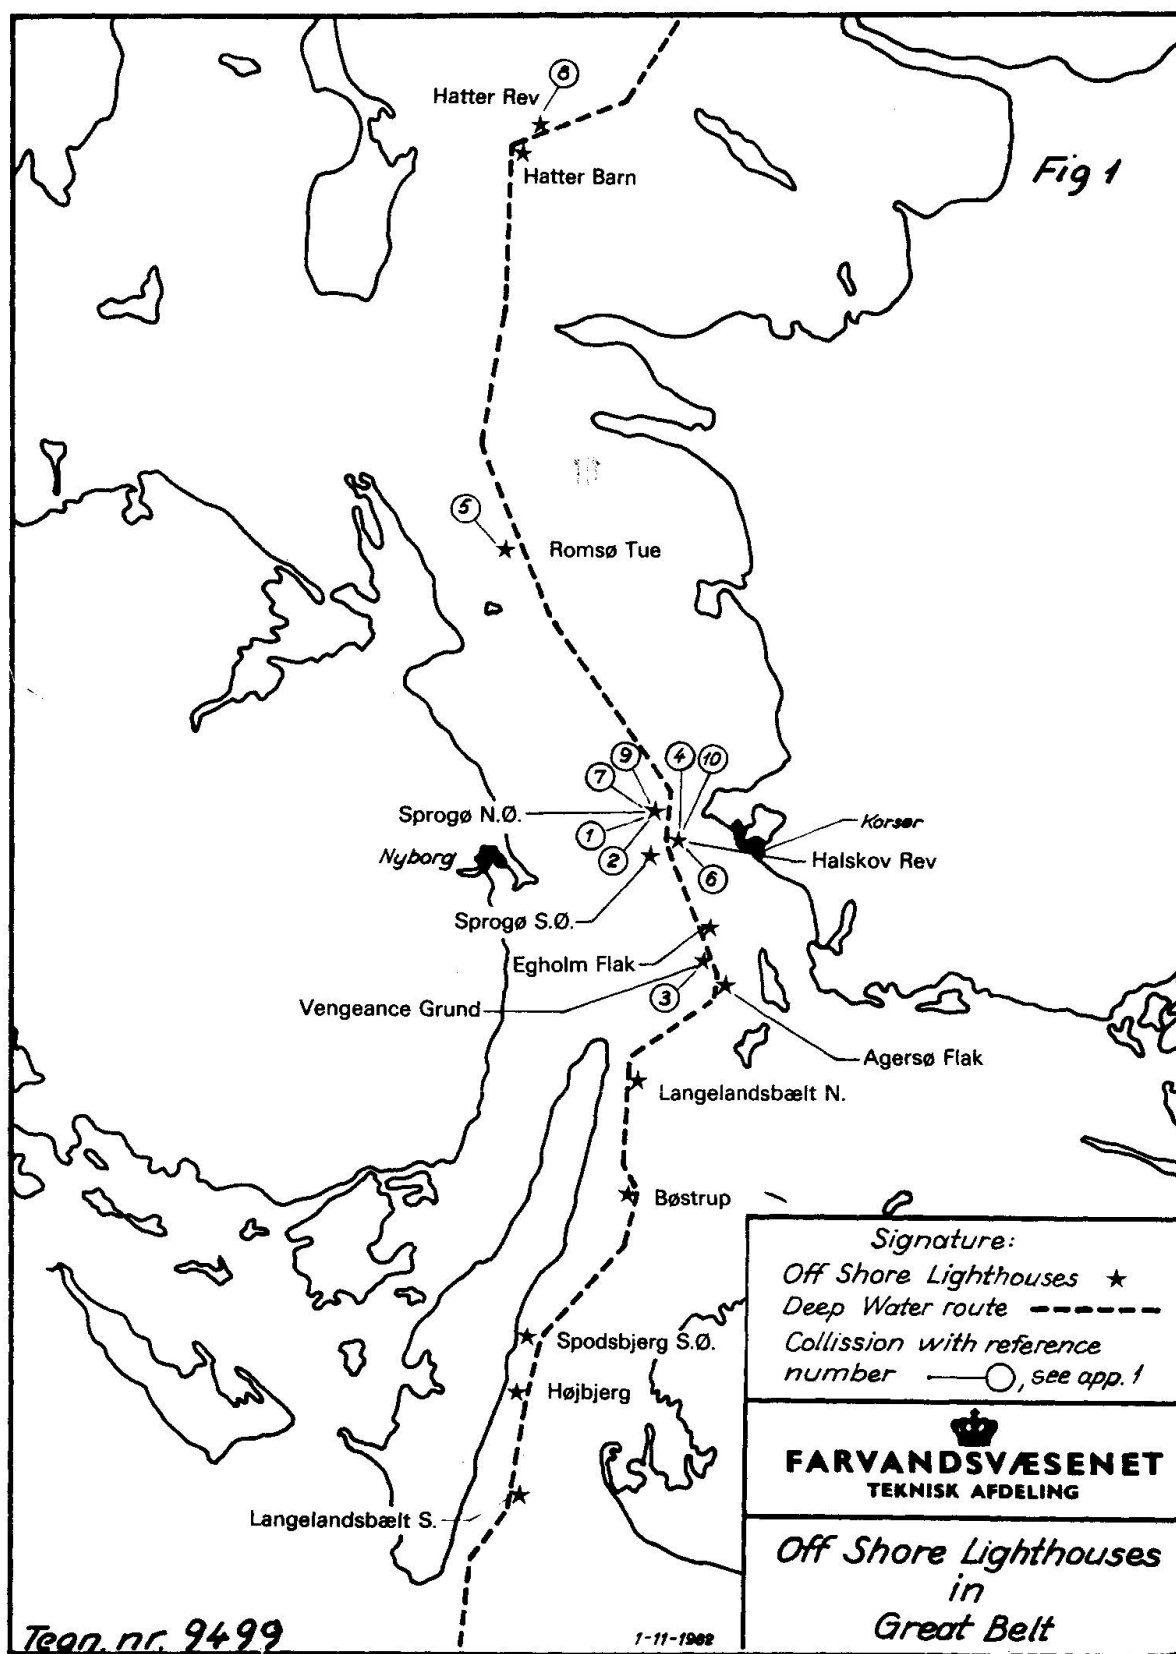
Fig. 1 Location of lighthouses in Great Belt

The placing of the lighthouses became a compromise between the best position for navigation purposes and the most advantageous technical solution. The lighthouses are placed as close to the deep fairway as possible, and preferably where there are bends or turns of the route.

In the placing of the two lighthouses, Halskov Rev and Sprogø N. Ø., it was taken into consideration - following consultation with the Great Belt Commission at that time - that the lighthouses were to assist navigation when vessels had to pass under the Great Belt Bridge, if this should become a reality.

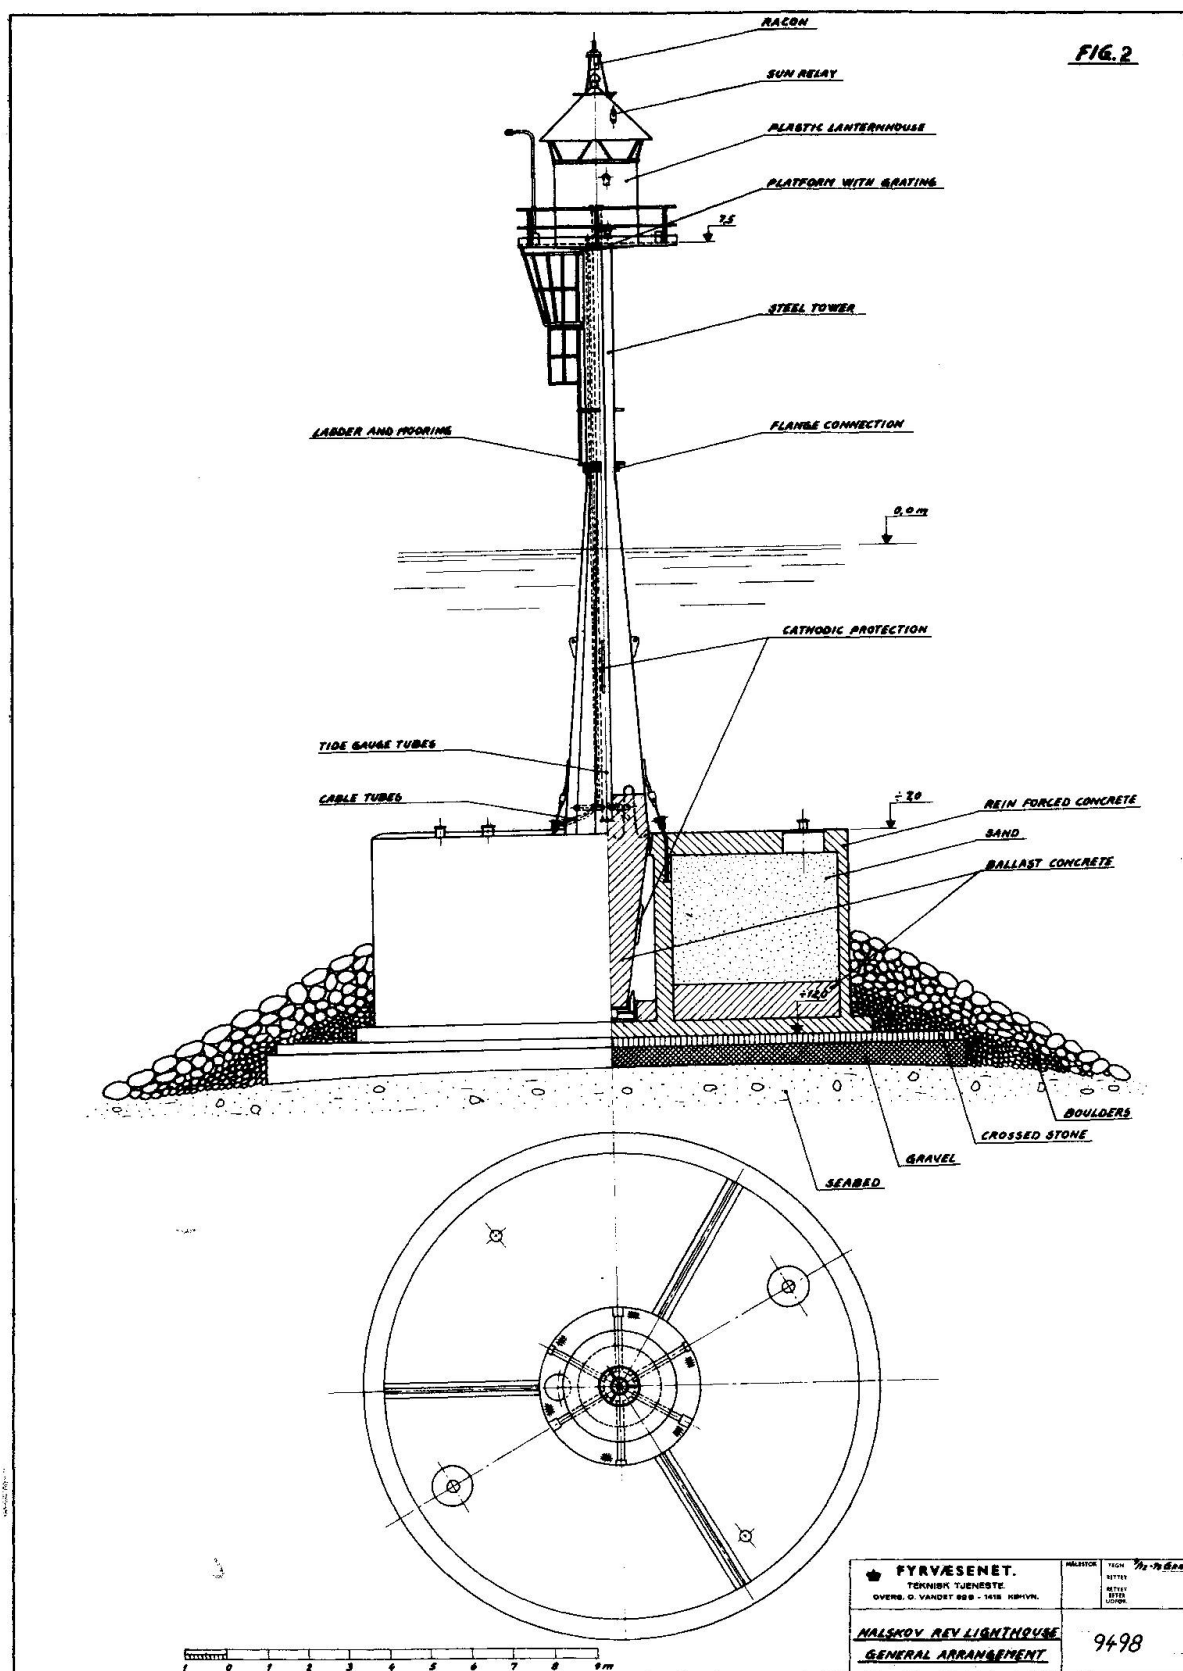
Fig. 2 Lighthouse. General arrangement

On account of the rather heavy drifting of ice in Danish waters, the lighthouses have been made as slender as possible in the area near the waterline. At a water depth of between 5 and 7 m, the steel lighthouse structure has been anchored in a round concrete caisson placed on a level layer of gravel on the sea bed.

At a height of approx. 10 m above sea level, a glasfiber reinforced plastic lantern house has been placed containing the light-house equipment which is based on gas and a battery-operated racon.

The lighthouses have been designed in such a way that if they are run into, damages to the ship should be as insignificant as possible, as this would be less costly, less dangerous to the crew, and reduce the risk of oil pollution.
