Ship Collisions with Danish Lighthouses

Aksel MIKKELSEN
Civil Engineer
Administration of Navigation
and Hydrography
Copenhagen, Denmark

Since 1972, fourteen small lighthouses have been built in the Great Belt at water depths ranging between 8 and 17 m. Many of them have since then been exposed to ship collisions. Two of them, situated closely to the planned site of the Great Belt Bridge, have for instance been run into three and four times, respectively. The conclusion of the collision cases must be said to be negligence.

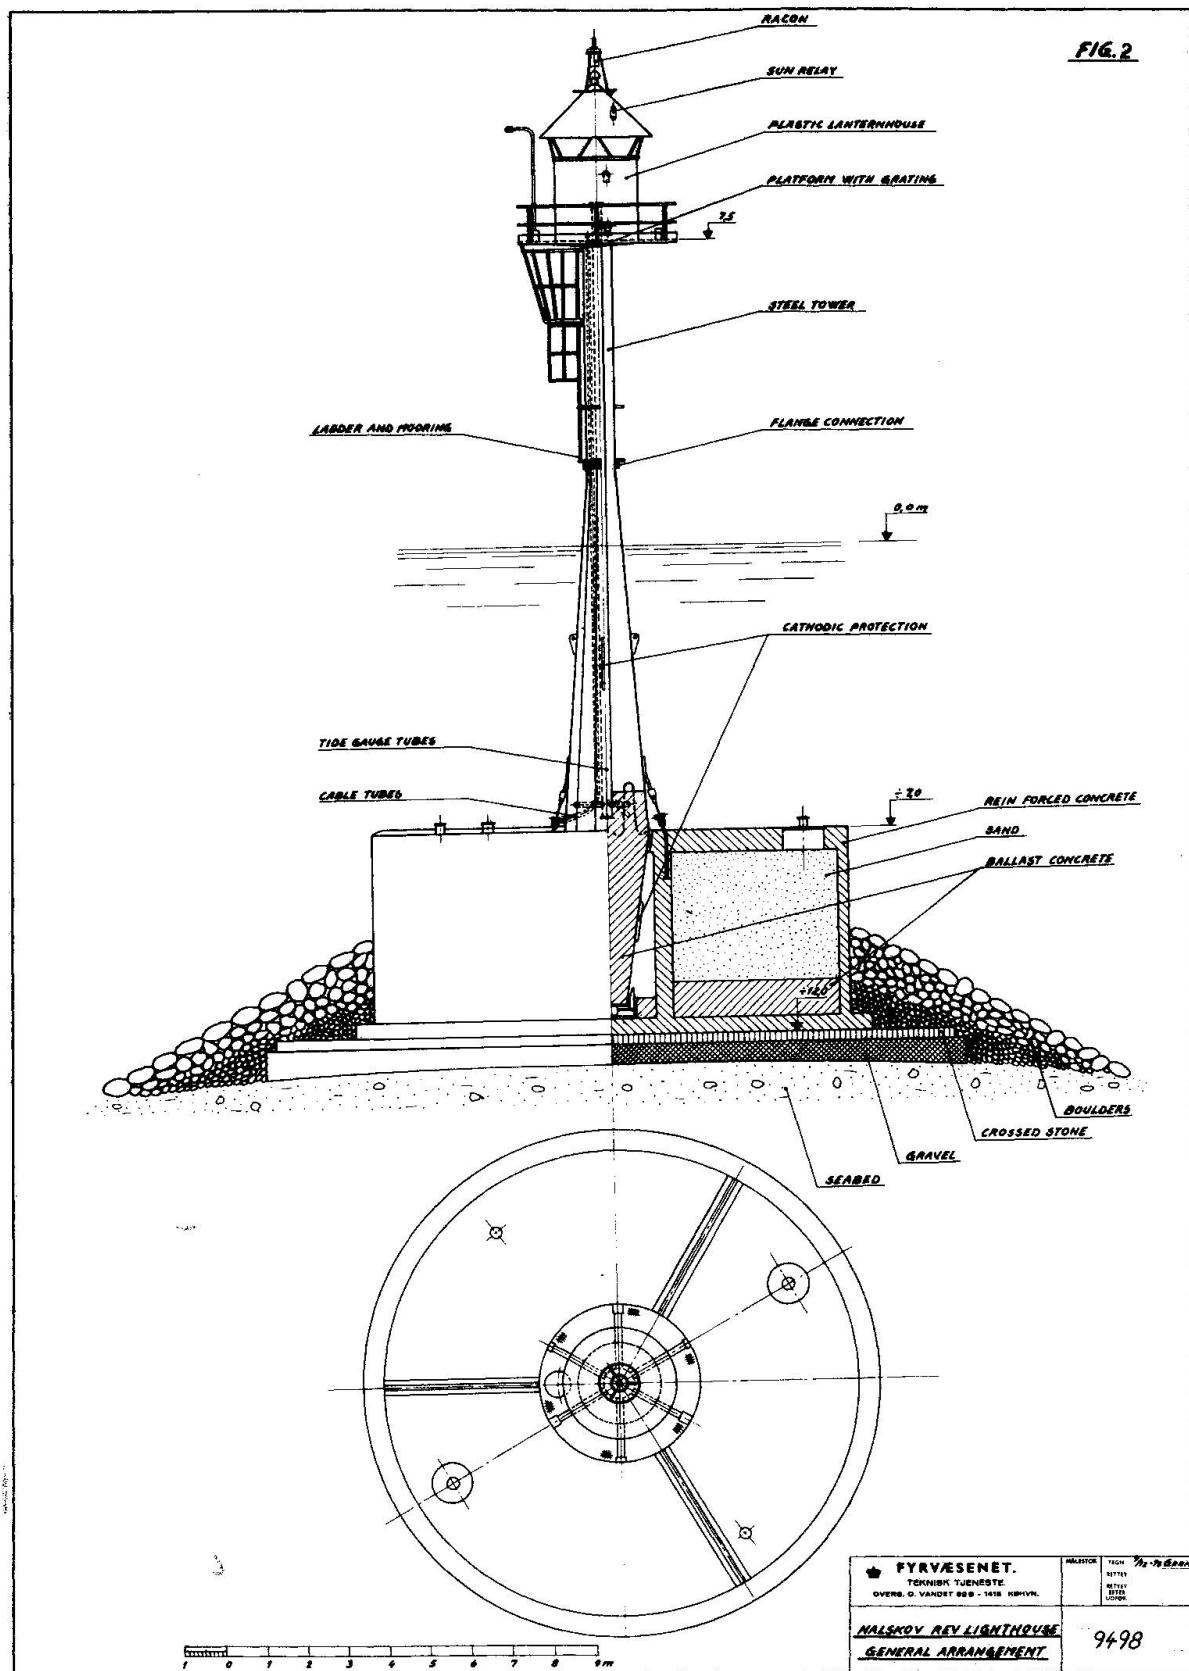
Fig. 2 Lighthouse. General arrangement

On account of the rather heavy drifting of ice in Danish waters, the lighthouses have been made as slender as possible in the area near the waterline. At a water depth of between 5 and 7 m, the steel lighthouse structure has been anchored in a round concrete caisson placed on a level layer of gravel on the sea bed.

At a height of approx. 10 m above sea level, a glassfiber reinforced plastic lantern house has been placed containing the lighthouse equipment which is based on gas and a battery-operated racon.

The lighthouses have been designed in such a way that if they are run into, damages to the ship should be as insignificant as possible, as this would be less costly, less dangerous to the crew, and reduce the risk of oil pollution.
