Newport Bridge Collision

Thomas R. KUESEL
Senior Vice President
Parsons Brinckerhoff
Quade & Douglas, Inc.
New York, NY, USA

In 1981 a main tower pier of the 488-m Newport suspension bridge in Rhode Island, USA, was struck head on by a fully laden 45,000-ton tanker. The ship was shortened 3.5 m through bow crushing, but the bridge pier suffered only superficial damage. Details of bridge design and accident are given, and forces developed during the collision are derived.

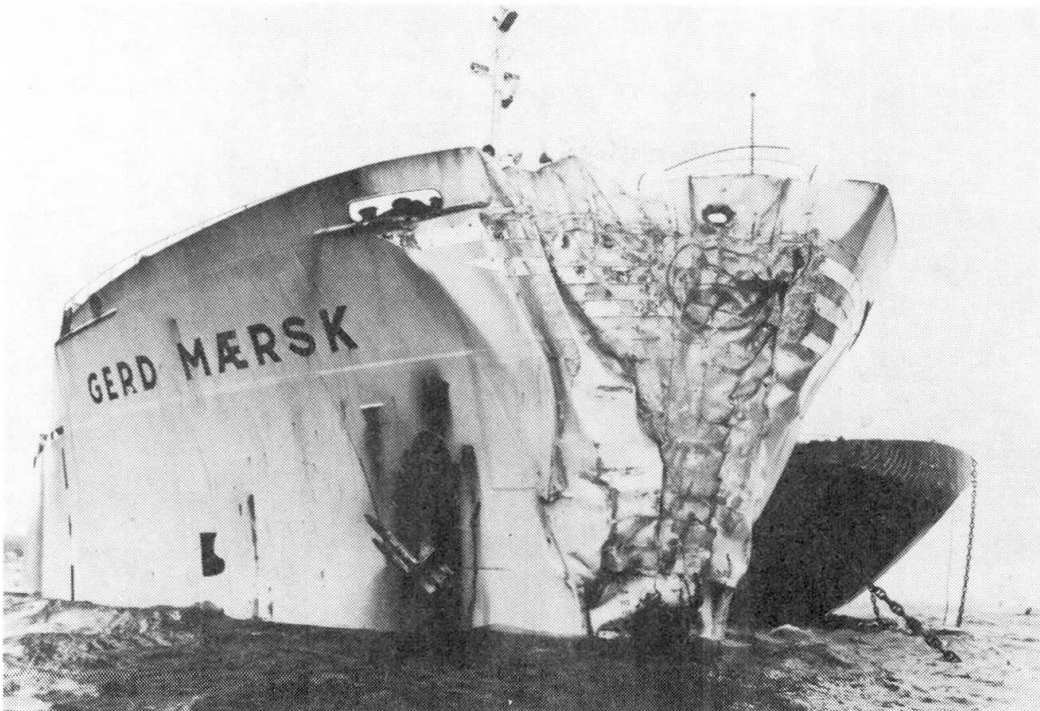
Fig. 2. Collision damage to tanker.

The bow of the ship was crushed in to the extent that the ship was shortened 3.5 m (Fig. 2). The ship came to a complete stop and then drifted off. Although it took on some water through sprung plates, no oil was spilled, and the ship was never in danger of sinking.

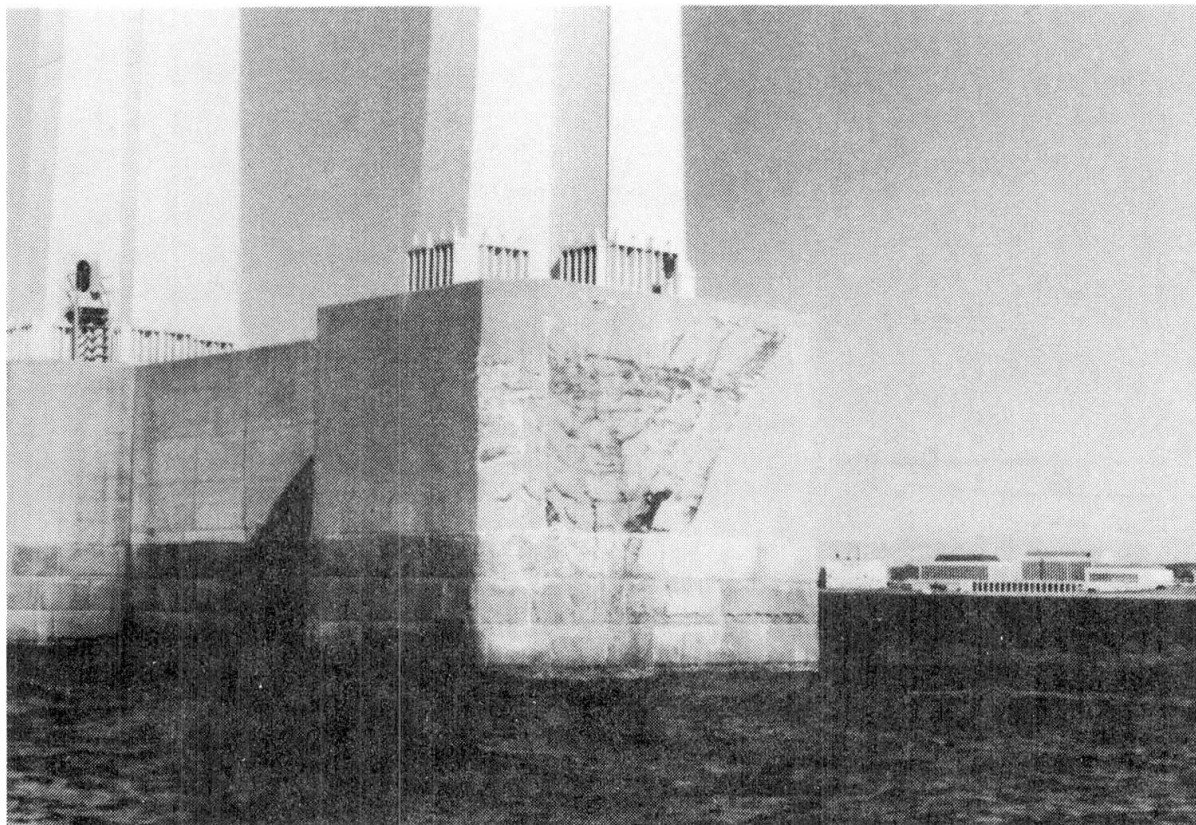
Fig. 3. Bridge pier damage.

Damage to the bridge was negligible. The pier suffered no displacement or rotation, and there was no misalignment of the roadway deck joints or any other superstructure elements. The side of the pier suffered extensive surface scrapes, gouges, and spalls of the concrete (Fig. 3) to a depth of 2 to 5 cm over an area roughly 7 m wide by 20 m high, approximately equally above and below the water line (Fig. 4).

There were a number of superficial tears in steel plating of the underwater caisson structure, but no damage to the concrete behind the plating. A spectacular blotch of gray paint decorated the side of the pier for several days before falling off.

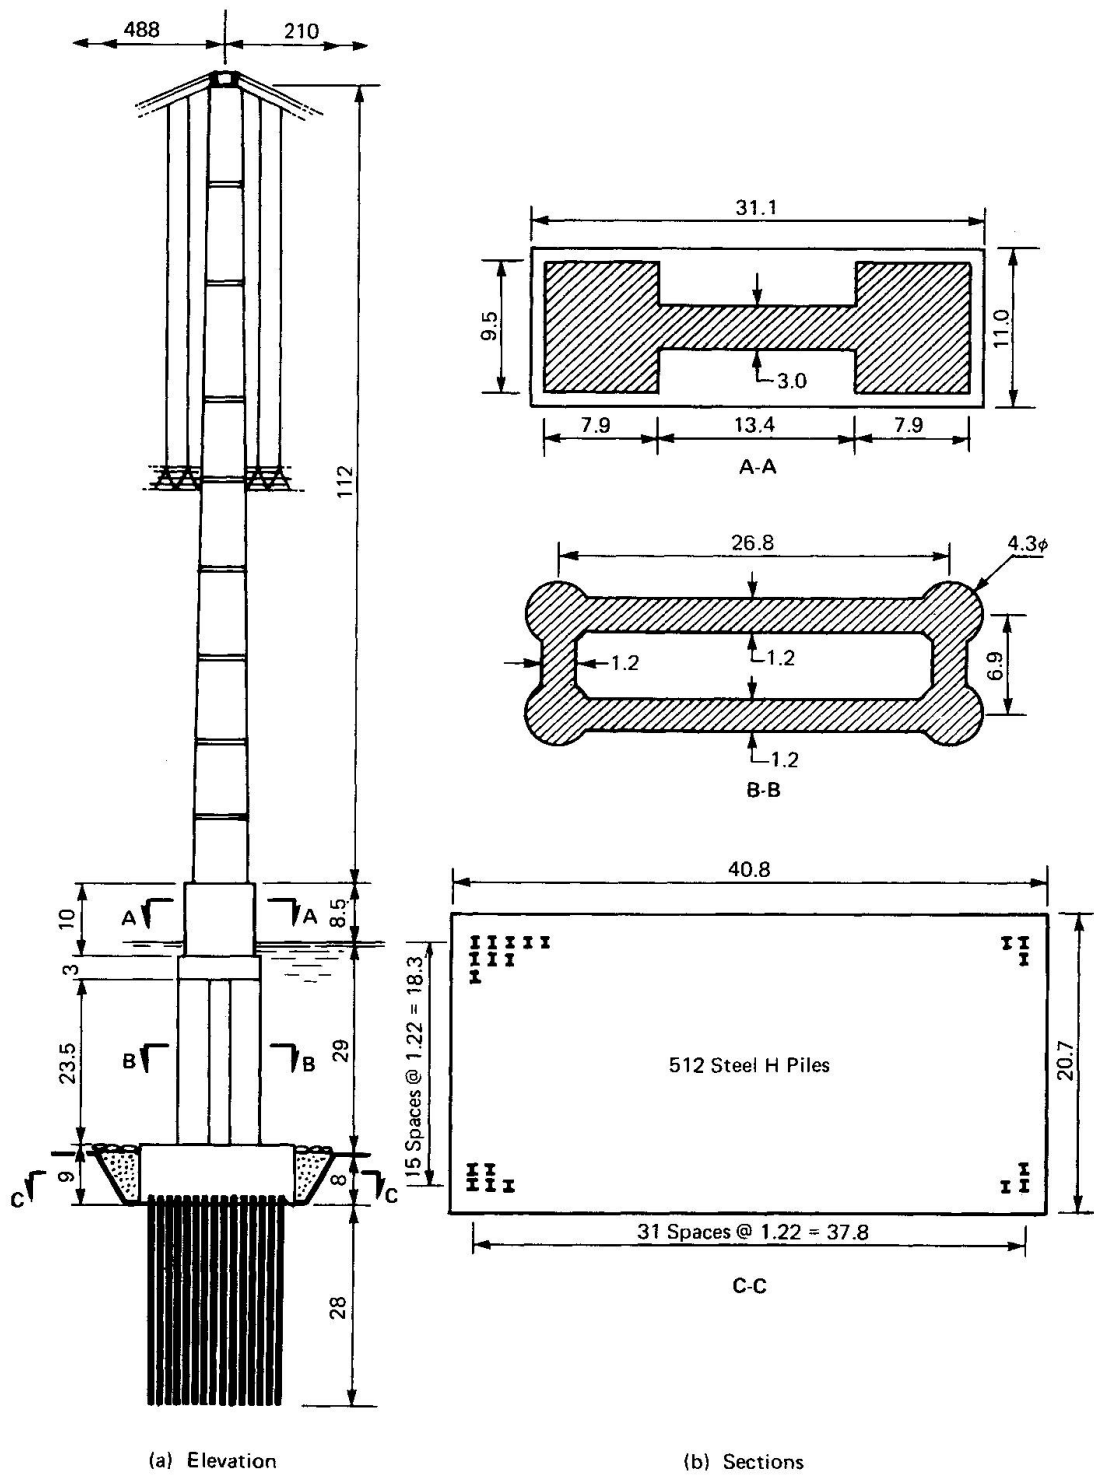
Fig. 5. Details and dimensions of pier.

Details and dimensions of the pier are shown in Figs. 5a and 5b. The dead weight of the pier (neglecting 12,000 tons buoyancy) is 32,000 tons, and the superstructure reaction to the piertop is an additional 11,000 tons.

The top of the pier pedestal is 8.5 m above sea level, and the bottom of footing is 37 m below sea level, or about 8 m below the natural bottom. This top layer of natural material was dredged out to permit placing the footing form on the excavated bottom. The overexcavated space around the footing was filled with dumped sand and covered with heavy stones for scour protection.

The pier is supported on 512 steel H-piles, driven an average of 28 m into the sand. The design capacity is 72 tons/pile. The footing and shaft are composed of reinforced structural tremie concrete, placed within steel shell forms that remain in place. The distribution slab and pedestal are composed of normal reinforced concrete placed in the dry in dewatered cofferdams.

It was considered impractical to provide free-standing fenders in 30-m water depth, and so the pier was designed for an arbitrary ship impact force of 1,650 tons, applied at Elev. +3 m. This was intended to represent the effect of a 20,000-ton ship traveling with a velocity component normal to the pier of 3 knots.

Analysis of stresses at the bottom of the shaft (top of footing) indicates that under a 6,000-ton collision load the resultant force lies close to the edge of the kern of the section. The maximum compressive stress in the concrete is about 35 kg/cm^2 , and a very slight tension exists on the impacted side. This is well within the capacity of the reinforcing steel, without counting on the steel shell form plate.
