Artikel: Newport bridge collision

Autor: Kuesel, Thomas R.

Newport Bridge Collision

Thomas R. KUESEL Senior Vice President Parsons Brinckerhoff Quade & Douglas, Inc. New York, NY, USA

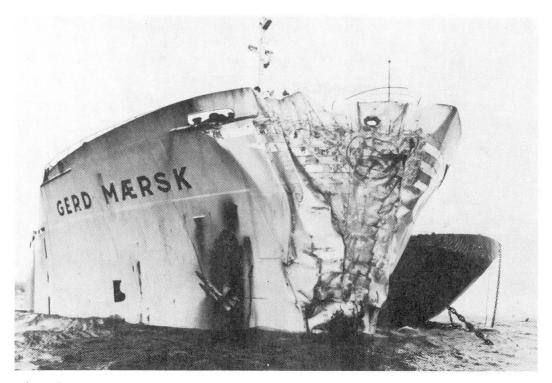
The bow of the ship was crushed in to the extent that the ship was shortened $3.5 \, \text{m}$ (Fig. 2). The ship came to a complete stop and then drifted off. Although it took on some water through sprung plates, no oil was spilled, and the ship was never in danger of sinking.

Fig. 2. Collision damage to tanker.

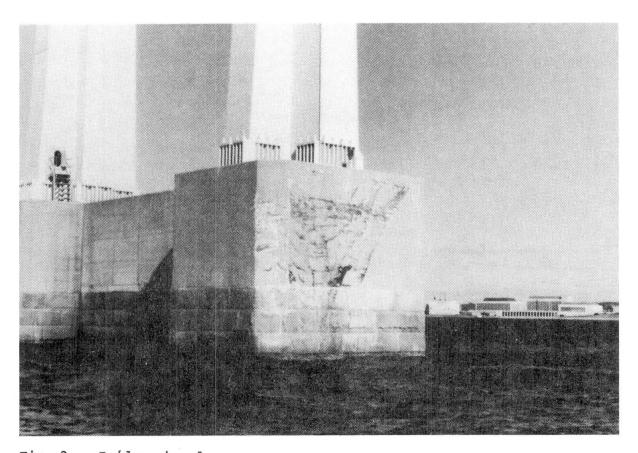
Damage to the bridge was negligible. The pier suffered no displacement or rotation, and there was no misalignment of the roadway deck joints or any other superstructure elements. The side of the pier suffered extensive surface scrapes, gouges, and spalls of the concrete (Fig. 3) to a depth of 2 to 5 cm over an area roughly 7 m wide by 20 m high, approximately equally above and below the water line (Fig. 4).

Fig. 3. Bridge pier damage.

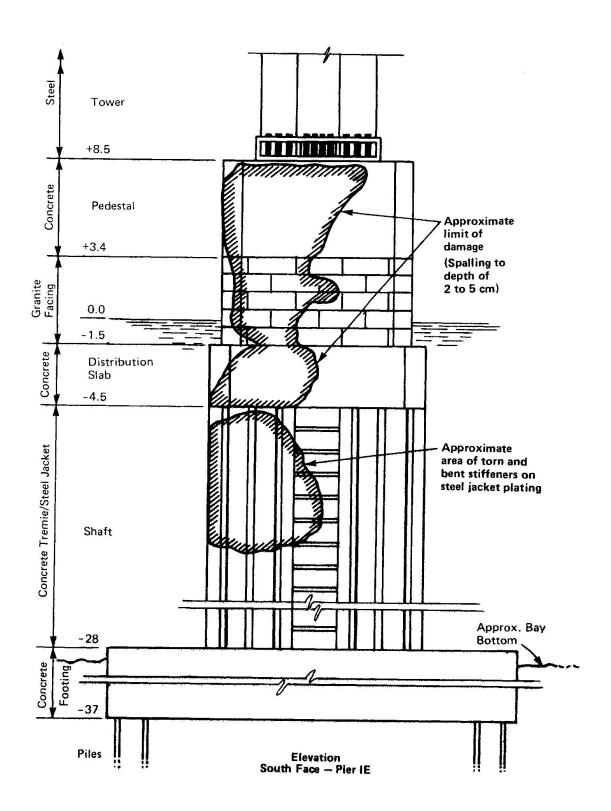
There were a number of superficial tears in steel plating of the underwater caisson structure, but no damage to the concrete behind the plating. A spectacular blotch of gray paint decorated the side of the pier for several days before falling off.

Fig. 4. Pier damage above and below waterline.

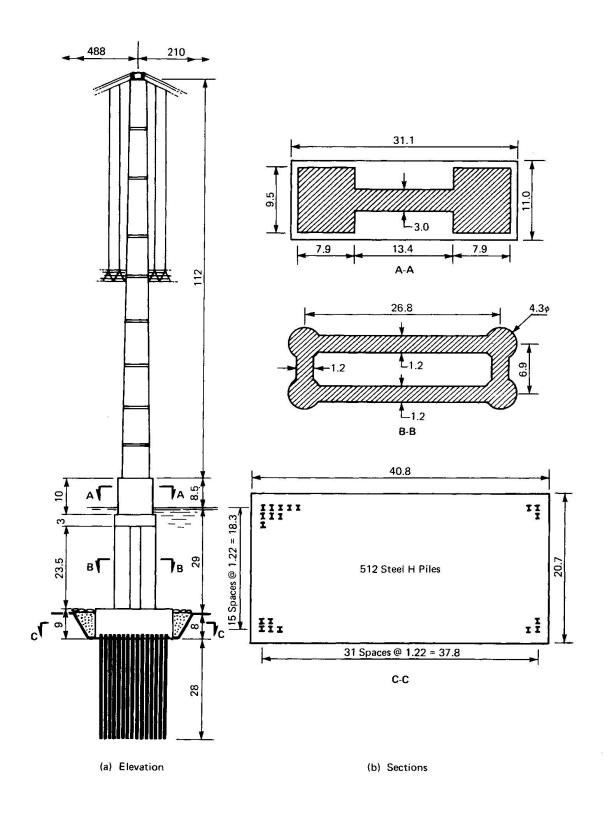
Fig. 5. Details and dimensions of pier.

Details and dimensions of the pier are shown in Figs. 5a and 5b. The dead weight of the pier (neglecting 12,000 tons buoyancy) is 32,000 tons, and the superstructure reaction to the piertop is an additional 11,000 tons.

Analysis of stresses at the bottom of the shaft (top of footing) indicates that under a 6,000-ton collision load the resultant force lies close to the edge of the kern of the section. The maximum compressive stress in the concrete is about 35 kg/cm 2 , and a very slight tension exists on the impacted side. This is well within the capacity of the reinforcing steel, without counting on the steel shell form plate.
