Artikel: Newport bridge collision
Autor: Kuesel, Thomas R.
DOI: <https://doi.org/10.5169/seals-32399>

Newport Bridge Collision

In 1981 a main tower pier of the 488-m Newport suspension bridge in Rhode Island, USA, was struck head on by a fully laden 45,000-ton tanker. The ship was shortened 3.5 m through bow crushing, but the bridge pier suffered only superficial damage. Details of bridge design and accident are given, and forces developed during the collision are derived.

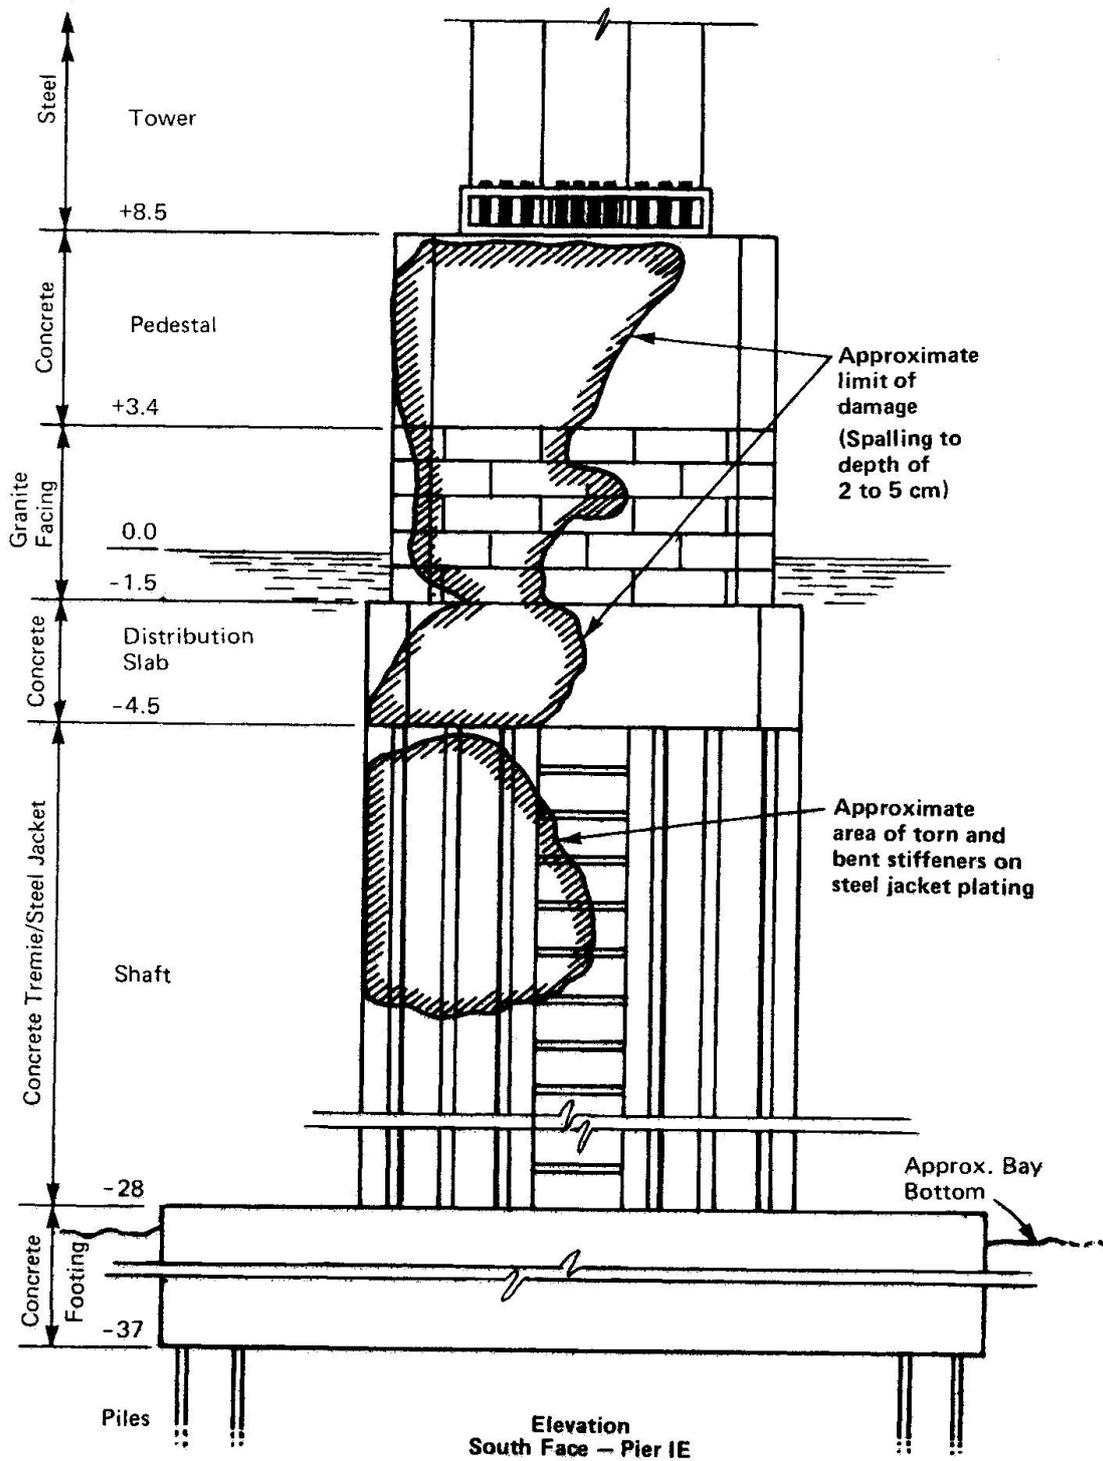
Damage to the bridge was negligible. The pier suffered no displacement or rotation, and there was no misalignment of the roadway deck joints or any other superstructure elements. The side of the pier suffered extensive surface scrapes, gouges, and spalls of the concrete (Fig. 3) to a depth of 2 to 5 cm over an area roughly 7 m wide by 20 m high, approximately equally above and below the water line (Fig. 4).

There were a number of superficial tears in steel plating of the underwater caisson structure, but no damage to the concrete behind the plating. A spectacular blotch of gray paint decorated the side of the pier for several days before falling off.

Fig. 4. Pier damage above and below waterline.

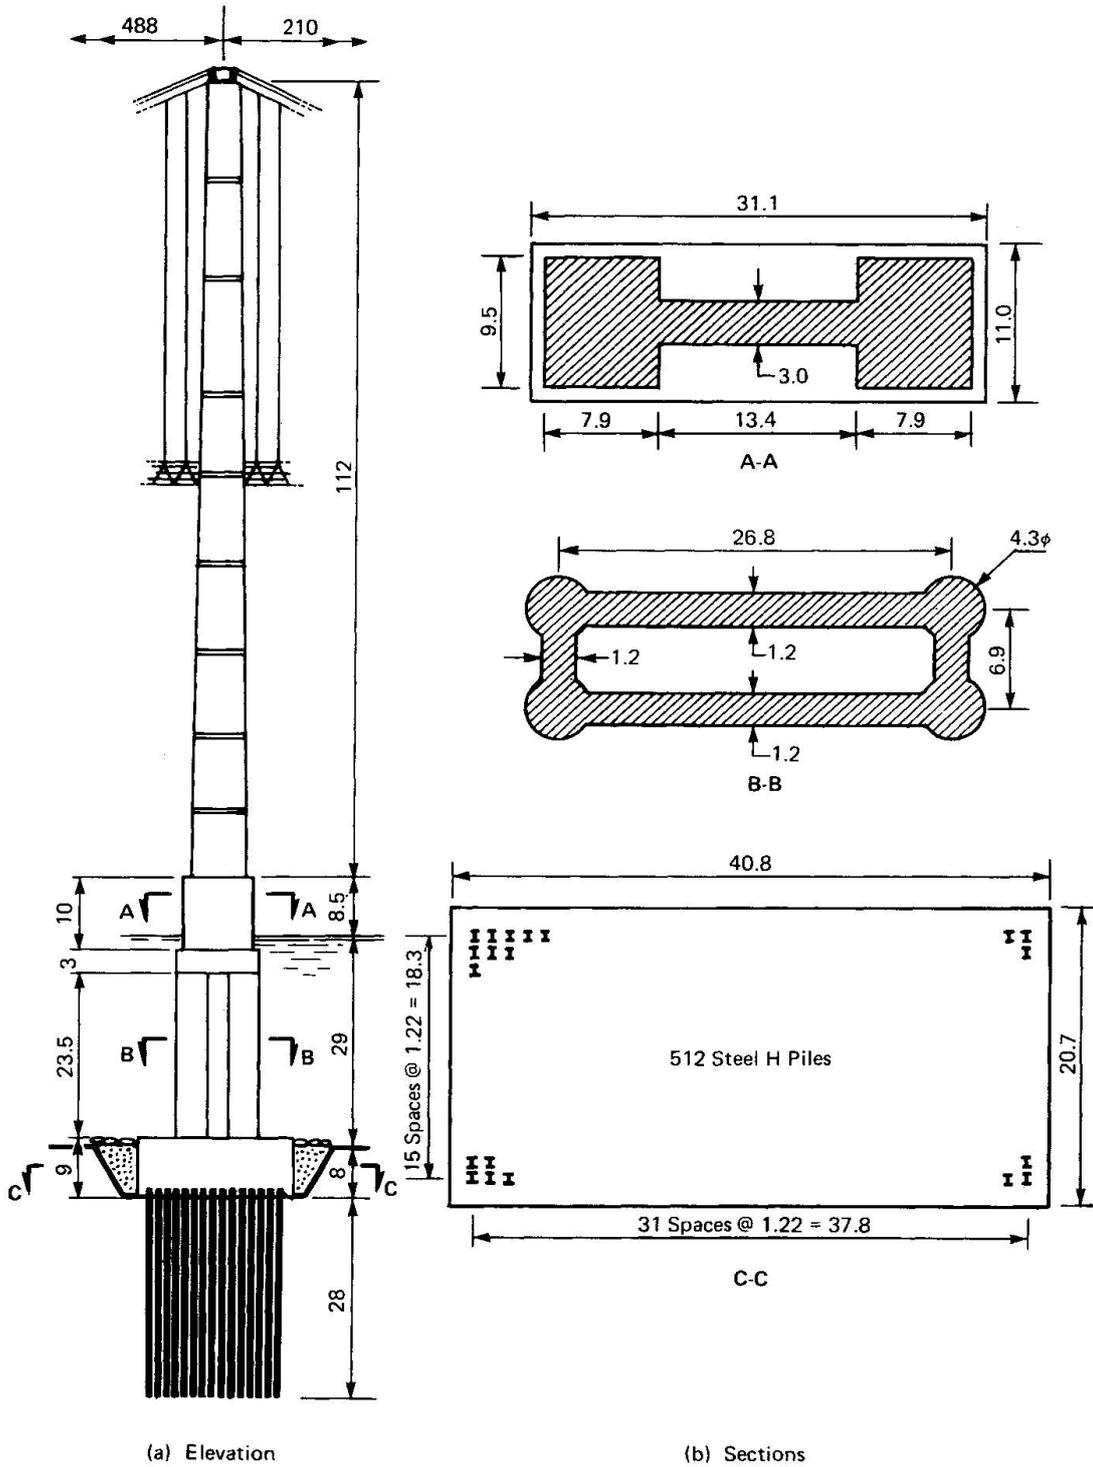
Fig. 5. Details and dimensions of pier.

Details and dimensions of the pier are shown in Figs. 5a and 5b. The dead weight of the pier (neglecting 12,000 tons buoyancy) is 32,000 tons, and the superstructure reaction to the piertop is an additional 11,000 tons.

The top of the pier pedestal is 8.5 m above sea level, and the bottom of footing is 37 m below sea level, or about 8 m below the natural bottom. This top layer of natural material was dredged out to permit placing the footing form on the excavated bottom. The overexcavated space around the footing was filled with dumped sand and covered with heavy stones for scour protection.

The pier is supported on 512 steel H-piles, driven an average of 28 m into the sand. The design capacity is 72 tons/pile. The footing and shaft are composed of reinforced structural tremie concrete, placed within steel shell forms that remain in place. The distribution slab and pedestal are composed of normal reinforced concrete placed in the dry in dewatered cofferdams.

Such an analysis yields maximum overturning forces of +70 tons/pile, compared to the dead load of 60 tons/pile. Since the piles were driven to resistance based on load tests to twice the 72-ton design load, and the uplift resistance of piles driven 28 m into sand is very large, it is reasonable to expect that the actual impact would not produce permanent tilting of the pier. Neglecting any passive pressure of the backfill around the footing, the average horizontal shear of 12 tons/pile would not be expected to produce translation of the pier.

Analysis of stresses at the bottom of the shaft (top of footing) indicates that under a 6,000-ton collision load the resultant force lies close to the edge of the kern of the section. The maximum compressive stress in the concrete is about 35 kg/cm^2 , and a very slight tension exists on the impacted side. This is well within the capacity of the reinforcing steel, without counting on the steel shell form plate.
