Artikel: Recovery and repair of the Second Narrows Railway Bridge
Autor: Jamieson, Donald H. / Calder, David G.
DOI: <https://doi.org/10.5169/seals-32400>

Recovery and Repair of the Second Narrows Railway Bridge
R habilitation et r paration du pont ferroviaire de Second Narrows
Wiederherstellung und Reparatur der zweiten Eisenbahnbr cke
von Second Narrows

The paper describes the damage caused by a ship collision with the Canadian National Railway Lift Span in Vancouver, British Columbia. The theoretical and practical consideration of the stabilisation and recovery schemes are discussed and the equipment and procedures used in the twenty weeks it took to restore the train service are described in detail.

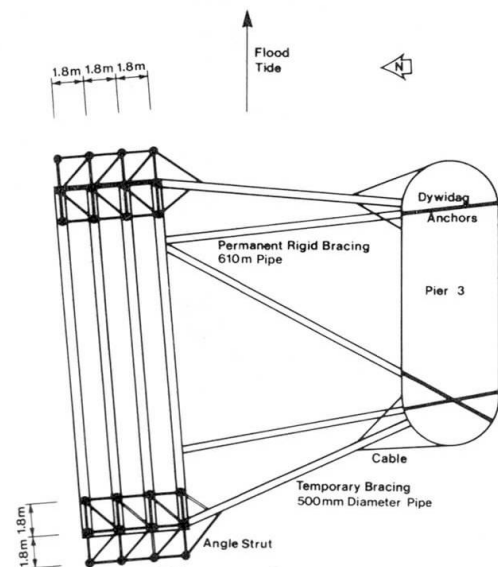
Figure 6

Figures 6 and 7 show the final configuration of the L2 bent. The table beside Figure 7 lists the variety of oscillations observed in the bent during construction. The amplitudes in most cases are visual estimates and therefore, are not too accurate. The measurement that is guaranteed, however, is the Stage 1 plus or minus 900 mm value. In this case the piles were driven at 1800 mm centres and during oscillations actually made contact with each other. Tidal flow and frequency were accurately measured. Vibrations only occurred for about 1 to 2 hours during every other tide during a two week period. It was unfortunate that the construction schedule did not fully coincide with the tidal cycle. Attempts to damp out the oscillations with ropes attached to the piers were unsuccessful. It was fortuitous that the oscillations almost always occurred after the dayshift was complete (7 p.m. to 9 p.m.) or before it started (3 a.m. to 5 a.m.) and work could always continue on bent completion during daylight hours with no oscillations. The Stage II oscillations came as a considerable surprise since group oscillation was considered to be unlikely. The east pile group survived the first set of oscillations, but top bracing of the west group was partially destroyed and was subsequently re-installed.

Temporary 500 mm dia. tube struts were installed from the bents to the piers which eliminated the violent crossflow vibrations but replaced them with plus or minus 76 mm in-line vibrations.
