**Recovery and Repair of the Second Narrows Railway Bridge**  
R habilitation et r paration du pont ferroviaire de Second Narrows  
Wiederherstellung und Reparatur der zweiten Eisenbahnbr cke  
von Second Narrows

**Donald H. JAMIESON**  
Professional Engineer  
Canron Inc.  
Vancouver, BC, Canada

**David G. CALDER**  
Professional Engineer  
Swan Wooster Eng. Co. Ltd.  
Vancouver, BC, Canada

The paper describes the damage caused by a ship collision with the Canadian National Railway Lift Span in Vancouver, British Columbia. The theoretical and practical consideration of the stabilisation and recovery schemes are discussed and the equipment and procedures used in the twenty weeks it took to restore the train service are described in detail.

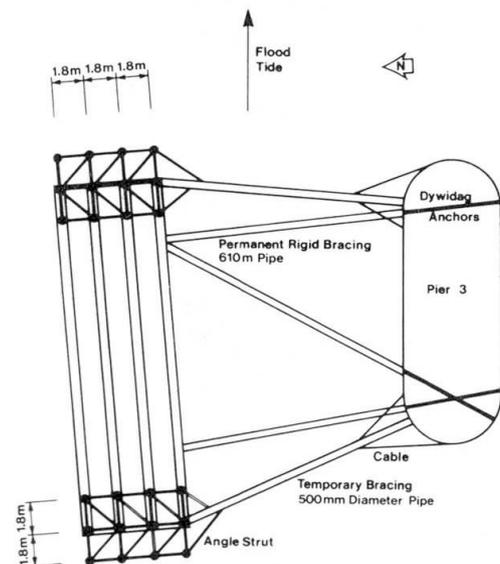
Figure 6

Figures 6 and 7 show the final configuration of the L2 bent. The table beside Figure 7 lists the variety of oscillations observed in the bent during construction. The amplitudes in most cases are visual estimates and therefore, are not too accurate. The measurement that is guaranteed, however, is the Stage 1 plus or minus 900 mm value. In this case the piles were driven at 1800 mm centres and during oscillations actually made contact with each other. Tidal flow and frequency were accurately measured. Vibrations only occurred for about 1 to 2 hours during every other tide during a two week period. It was unfortunate that the construction schedule did not fully coincide with the tidal cycle. Attempts to damp out the oscillations with ropes attached to the piers were unsuccessful. It was fortuitous that the oscillations almost always occurred after the dayshift was complete (7 p.m. to 9 p.m.) or before it started (3 a.m. to 5 a.m.) and work could always continue on bent completion during daylight hours with no oscillations. The Stage II oscillations came as a considerable surprise since group oscillation was considered to be unlikely. The east pile group survived the first set of oscillations, but top bracing of the west group was partially destroyed and was subsequently re-installed.

Temporary 500 mm dia. tube struts were installed from the bents to the piers which eliminated the violent crossflow vibrations but replaced them with plus or minus 76 mm in-line vibrations.

The jacking bent was completed as designed with 600 mm dia. pipe bracing and no serious vibrations were detected thereafter.

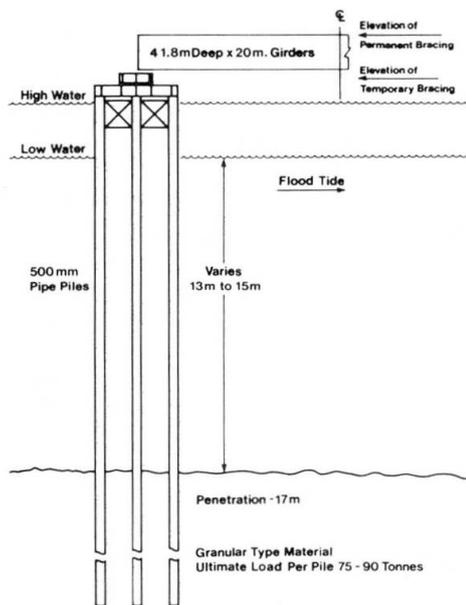
Figure 7

STAGE	HALF AMPLITUDE	DIRECTION	CYCLES/MINUTE	CURRENT (KNOTS)
I	900 mm	N/S crossflow	35	4 to 6
II East	220 mm	N/S crossflow	50	4 to 5
II West	450 mm	Do	35	4 to 5
III	75 mm	E/W in line	50	2 to 5
IV	75 mm	Do	50	2 to 5
V	7.5 mm	E/W	180	5.4
	2.5 mm	Bowstring	180	4.0
	.75 mm	E/W Random	Random	4.0
