Techniques for Testing, Analyzing and Rehabilitation of Terra-Cotta

Sven E. THOMASEN

Wiss, Janney, Elstner Assoc.
Emeryville, CA, USA

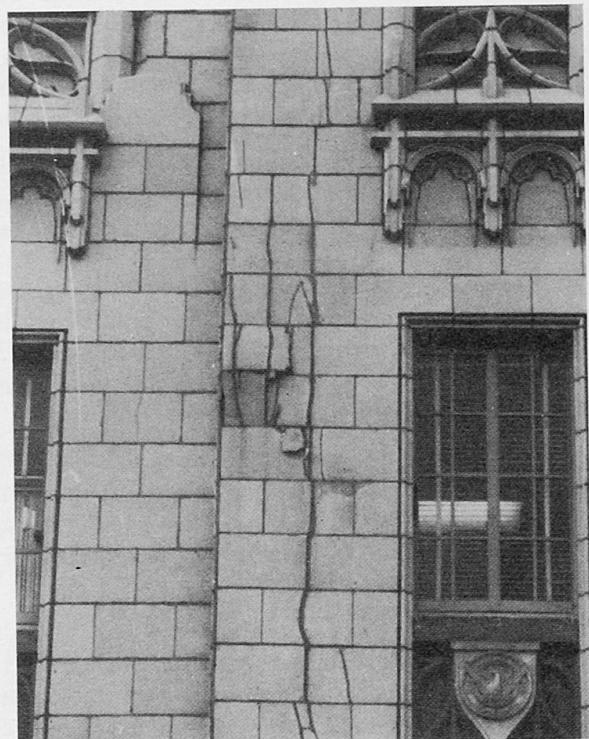
Terra-cotta buildings with concrete frames often experience long-term shrinkage of the frames, but most terra-cotta failures result from temperature and moisture expansion of the clay body. Thermal and wet/drying cycles are often associated with permanent lengthening of the terra-cotta blocks, and this, plus the absence of expansion joints in the facade, creates high compressive stresses. Failure can be in the form of buckling of block units, as seen in Figure 2, or crushing at the base of the facade where expansion stresses are combined with compressive gravity loads.

Fig. 2: Expansion failure

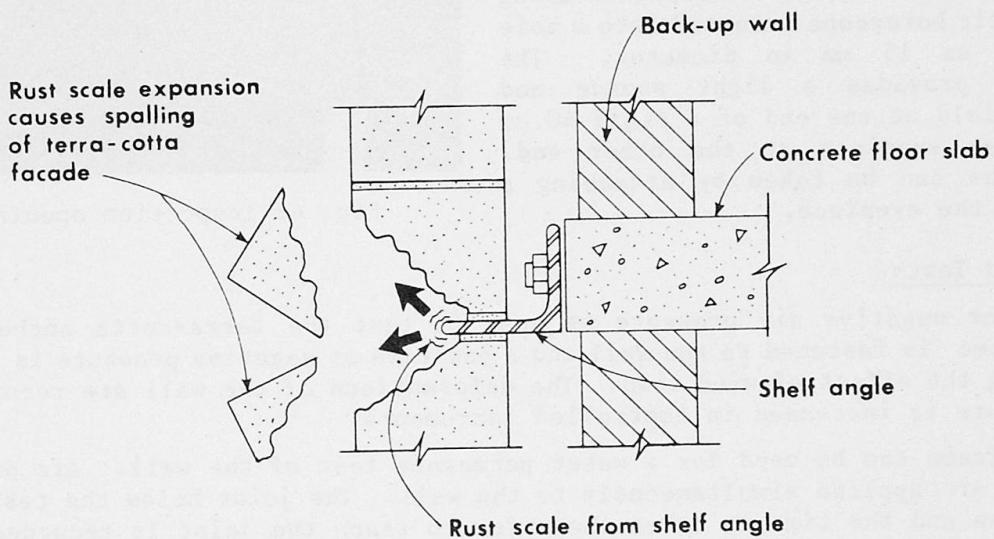
Spalling of the glaze and cracks caused by expansion allows water to enter the wall and results in further damage to the terra-cotta from freeze/thaw action. The moisture corrodes the anchors and the pressure from the volume expansion of the rust cracks the blocks, as seen in Figure 3.

Fig. 3: Terra-cotta spalling caused by corrosion of shelf angle.

Corroded or missing shelf angles and wall anchors are replaced. New anchors and angles should be given rust protection or be of stainless steel, especially in walls with past leakage problems. Consideration should also be given to installing flashing and weep holes in the wall cladding.

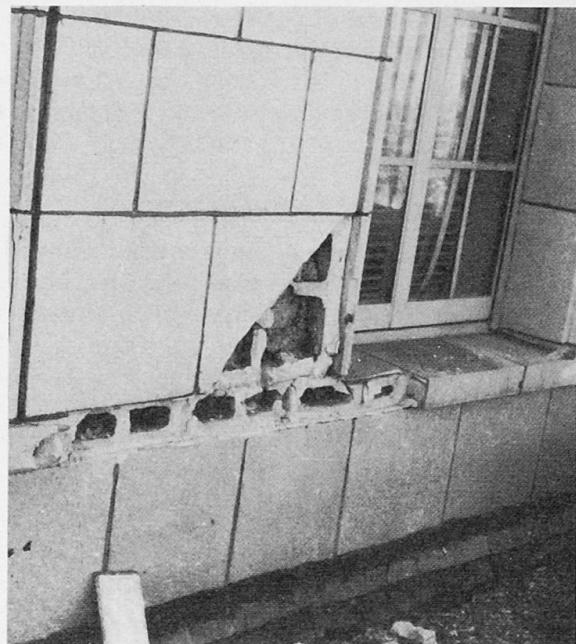
Inspection openings, as seen in Figure 4, are the best method to verify the location and the condition of the wall supports, and especially, to detect corrosion of the embedded metal anchors.

Fig. 4: Inspection opening

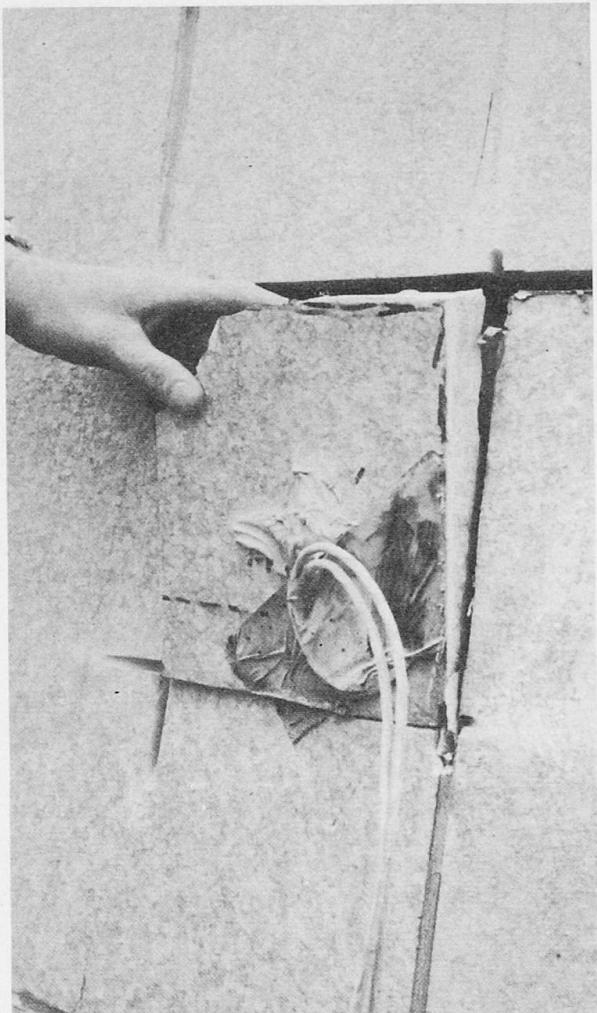
Fig. 6: Terra-cotta block, with strain gages attached, is cut loose.

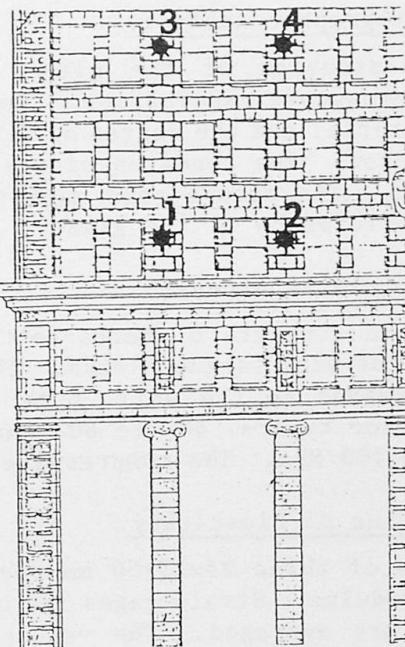
Fig. 5: Strain relief test

STRAIN RELIEF TEST DATA				
GAGE	VERTICAL		HORIZONTAL	
	STRAIN μ cm/cm	STRESS kPa	STRAIN μ cm/cm	STRESS kPa
1	450	9315	50	345
2	283	5858	24	497
3	320	6624	30	621
4	171	3540	7	145

Compressive vertical stresses as high as 23 MPa have been recorded. This is close to the compressive strength of the terra-cotta wall. From multiple strain measurements, a stress map can be made for the exterior elevation. The map is used to evaluate if cutting of expansion joints into the facade will relieve the built-up terra-cotta stresses.

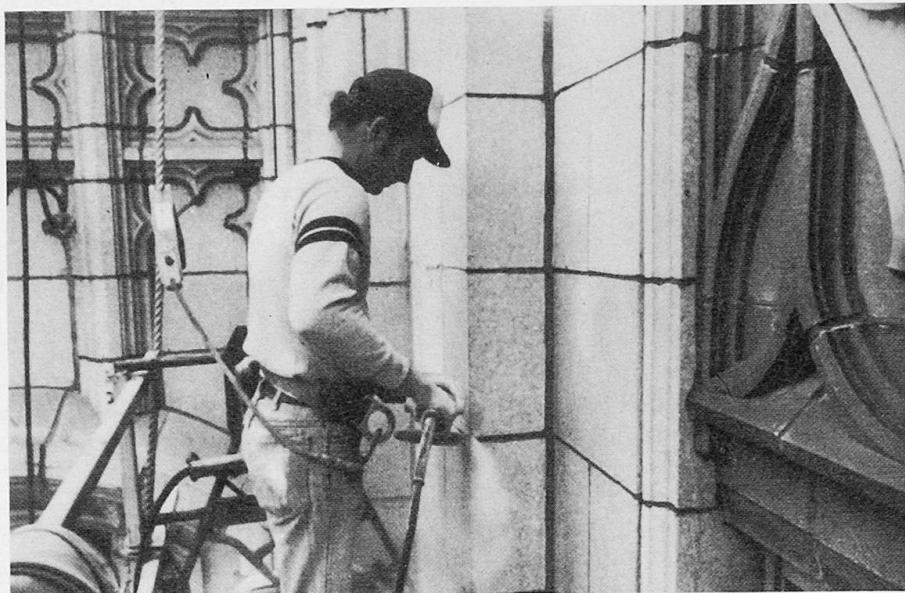
Fig. 7: Cutting of new expansion joints.

Vertical expansion joints are generally cut near corners and wall returns, while horizontal expansion joints are cut below relieveing angles, as seen in Figure 7. The joint location is determined from stress measurements of the terra-cotta. The joints are made watertight with elastomeric sealants. Cutting of expansion joints can disturb the fastening of the terra-cotta and will often require the installation of new anchors.
