**Zeitschrift:** IABSE reports = Rapports AIPC = IVBH Berichte  
**Band:** 46 (1983)

## Techniques for Testing, Analyzing and Rehabilitation of Terra-Cotta

### Sven E. THOMASEN

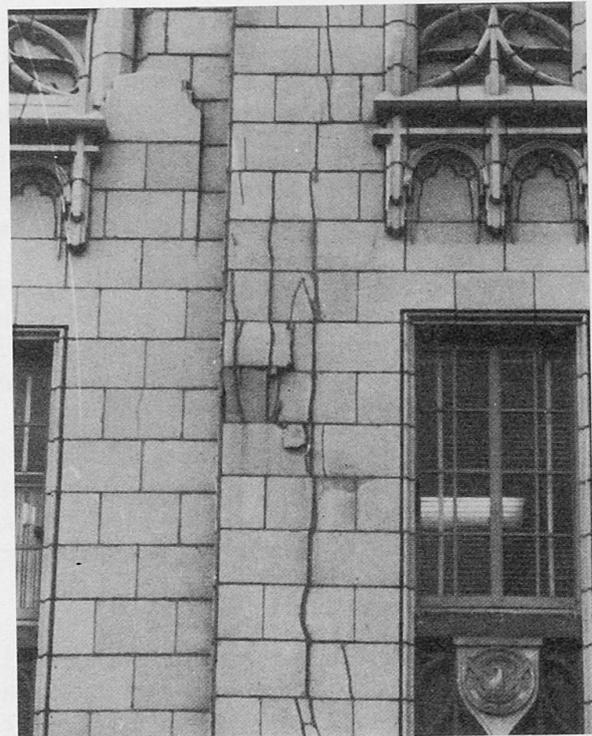
Fig. 2: Expansion failure

Terra-cotta buildings with concrete frames often experience long-term shrinkage of the frames, but most terra-cotta failures result from temperature and moisture expansion of the clay body. Thermal and wet/drying cycles are often associated with permanent lengthening of the terra-cotta blocks, and this, plus the absence of expansion joints in the facade, creates high compressive stresses. Failure can be in the form of buckling of block units, as seen in Figure 2, or crushing at the base of the facade where expansion stresses are combined with compressive gravity loads.

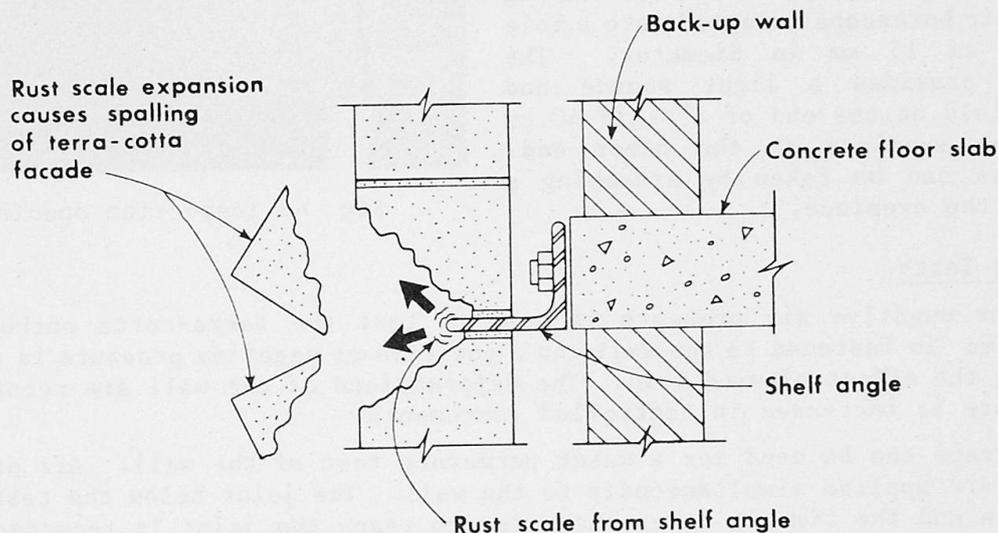
Spalling of the glaze and cracks caused by expansion allows water to enter the wall and results in further damage to the terra-cotta from freeze/thaw action. The moisture corrodes the anchors and the pressure from the volume expansion of the rust cracks the blocks, as seen in Figure 3.

Fig. 3: Terra-cotta spalling caused by corrosion of shelf angle.

Corroded or missing shelf angles and wall anchors are replaced. New anchors and angles should be given rust protection or be of stainless steel, especially in walls with past leakage problems. Consideration should also be given to installing flashing and weep holes in the wall cladding.

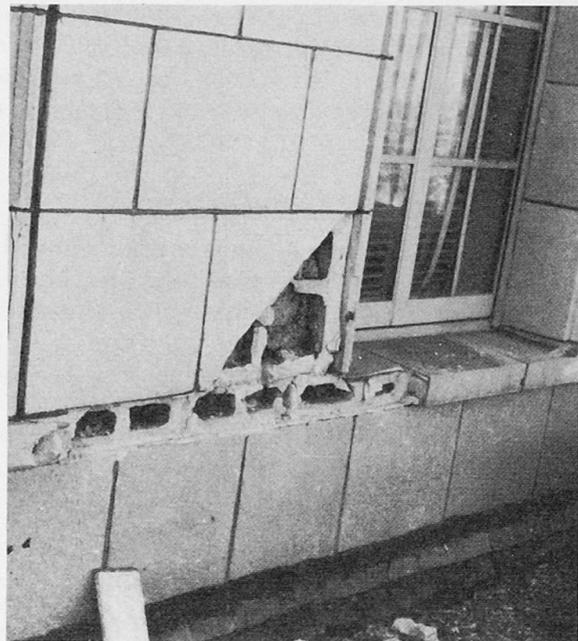
Inspection openings, as seen in Figure 4, are the best method to verify the location and the condition of the wall supports, and especially, to detect corrosion of the embedded metal anchors.

Fig. 4: Inspection opening

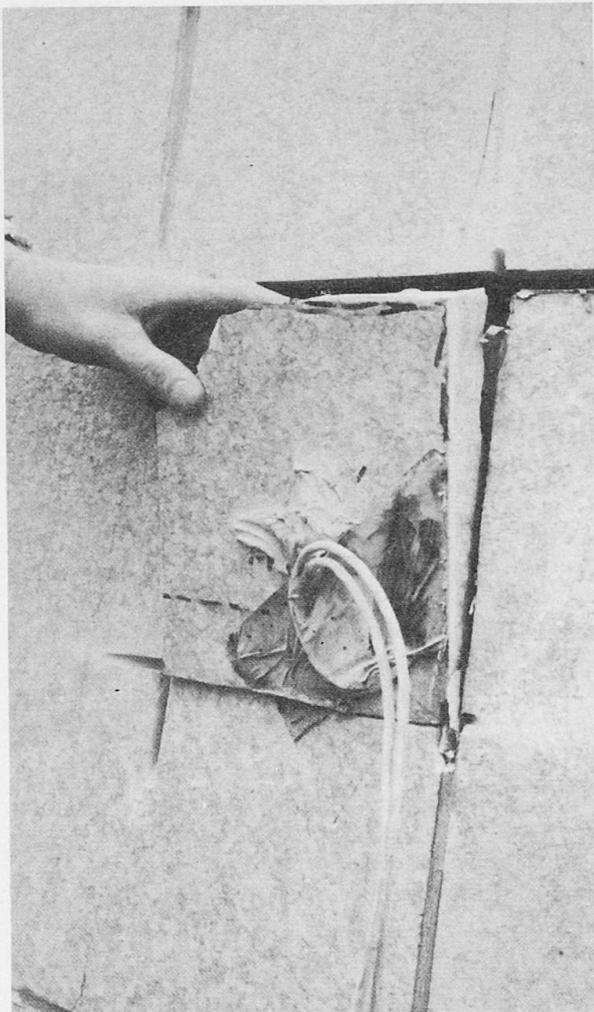
Electrical resistance strain gages are attached to the terra-cotta surface and the gages are read. Then the terra-cotta block, with the gages attached, is cut loose from the wall and the gages are read again, as seen in Figure 6. The change in gage reading is a measure of the strain in the block. The stress in the block is found by multiplying the measured strain difference by the modulus of elasticity, as determined by laboratory tests.

Fig. 6: Terra-cotta block, with strain gages attached, is cut loose.

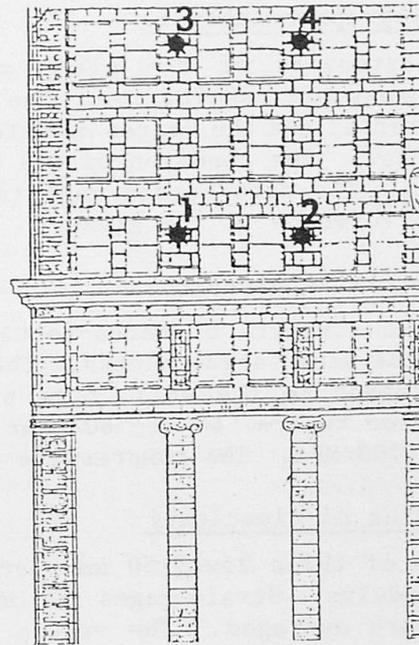
Fig. 5: Strain relief test

STRAIN RELIEF TEST DATA				
GAGE	VERTICAL		HORIZONTAL	
	STRAIN $\mu$ cm/cm	STRESS kPa	STRAIN $\mu$ cm/cm	STRESS kPa
1	450	9315	50	345
2	283	5858	24	497
3	320	6624	30	621
4	171	3540	7	145

Compressive vertical stresses as high as 23 MPa have been recorded. This is close to the compressive strength of the terra-cotta wall. From multiple strain measurements, a stress map can be made for the exterior elevation. The map is used to evaluate if cutting of expansion joints into the facade will relieve the built-up terra-cotta stresses.

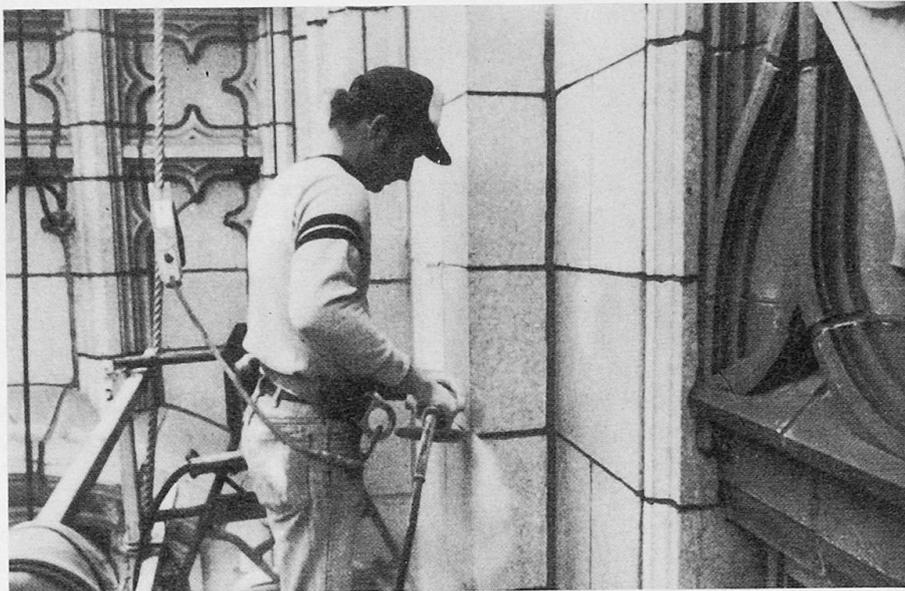
Fig. 7: Cutting of new expansion joints.

Vertical expansion joints are generally cut near corners and wall returns, while horizontal expansion joints are cut below relieving angles, as seen in Figure 7. The joint location is determined from stress measurements of the terra-cotta. The joints are made watertight with elastomeric sealants. Cutting of expansion joints can disturb the fastening of the terra-cotta and will often require the installation of new anchors.
