**Artikel:** Strengthening and/or repairing of existing structures  
**Autor:** Grill, Leon A.  
**DOI:** <https://doi.org/10.5169/seals-35866>

## Strengthening and/or Repairing of Existing Structures

### Leon A. GRILL

Civil Eng.  
Rankine & Hill Assoc.  
Sydney, Australia

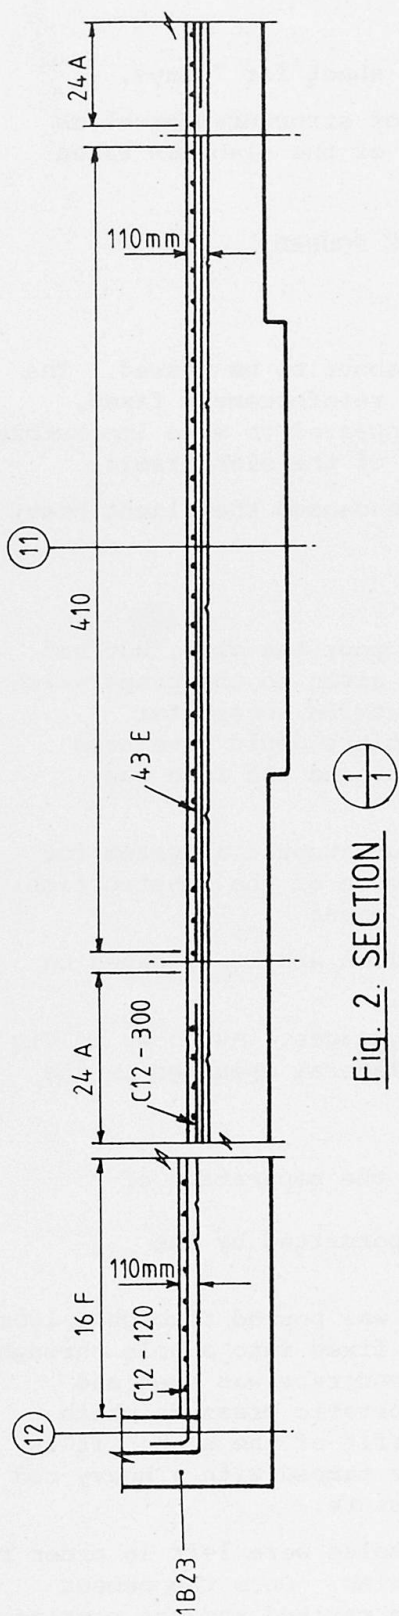
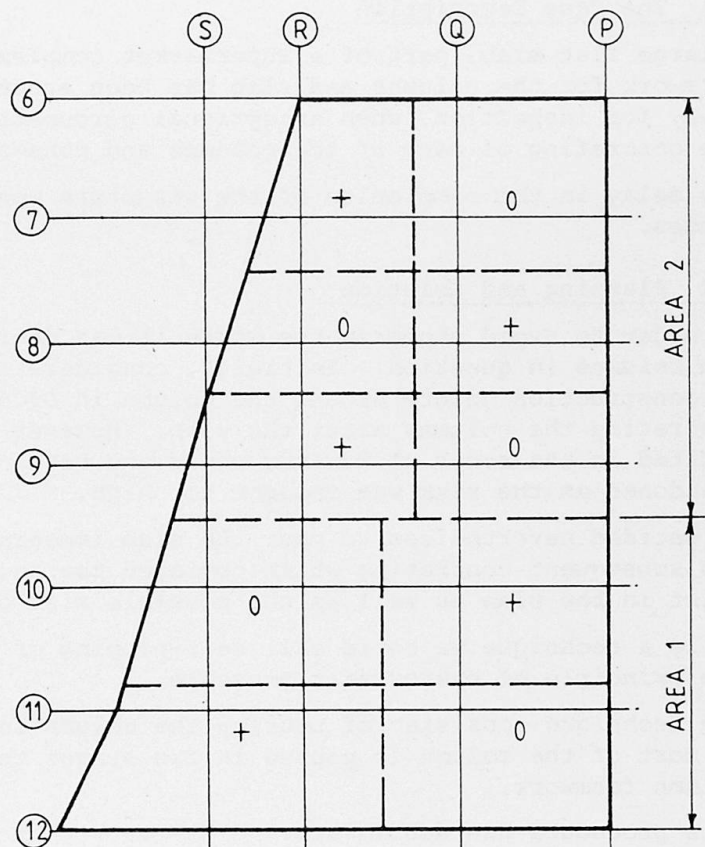
The existing structure was a flat plate reinforced concrete floor with drop panels supported on concrete column, the slab thickness varying from 250mm to 400mm, to achieve falls to sumps. The structure was analysed by computer firstly for dead load only and then for live load. (Fig. 1). The live load consisted of trucks (D.M.R. H10 loading, equivalent to 10 tonne trucks) passing on the slab, two trucks to each dock. This loading pattern resulted in excessive overstress. However, the slab as constructed was adequate for trucks of up to 8 tonne (an acceptable overstress was indicated for this condition).

High positive moments at mid-span in the column strip produced greater stress than allowable in the bottom reinforcement. Even by increasing the negative moments 15%, the existing bottom reinforcement was still overstressed (even though the calculated stress was only 65% of yield stress).

To increase the capacity of the slab it was proposed to add 110mm of reinforced concrete on top of the existing slab, keyed to the existing slab by scabbling the contact surface and using a wet to dry epoxy. Special attention was given to this detail to insure a sufficient bond to resist the horizontal sliding shear (Fig. 2).

- a. pouring breaks shall be located in the position shown on the key diagram [Fig. 3].
- b. reinforcement shall be continuous through the joint. Joint surfaces shall be prepared and treated as specified above.

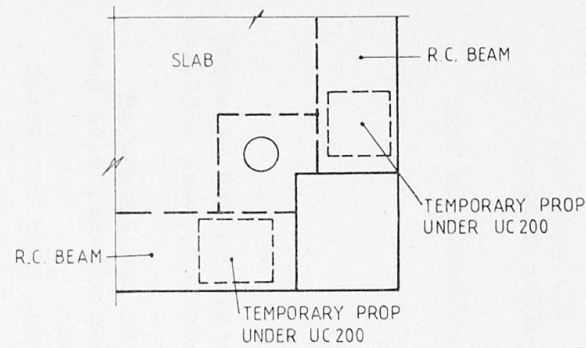
FIG. 6

The corner ground floor column of an eight storey building located in Newcastle close to the sea was suffering severe spalling of the concrete as well as advanced corrosion of the reinforcement.

A closer examination revealed that some of the longitudinal bars had rusted completely.

It was evident that some local repairs and patches made several years before had been unsuccessful and a radical solution was required.

- expose the foundation to support the propping system under the two beams converging onto the column to be replaced. (Fig. 5 and 6).
- erect two temporary props 200 UC 52 with large base plates. Use expanding grout.
- demolish existing column.
- expose and sand blast existing column reinforcement left at the top and the bottom.
- weld new column steel to the existing.
- replace column.

But we did not want to take any risks and an additional U.C. 150 prop was located in the axis of the column to be poured, in order to offer support for the duration of the works.

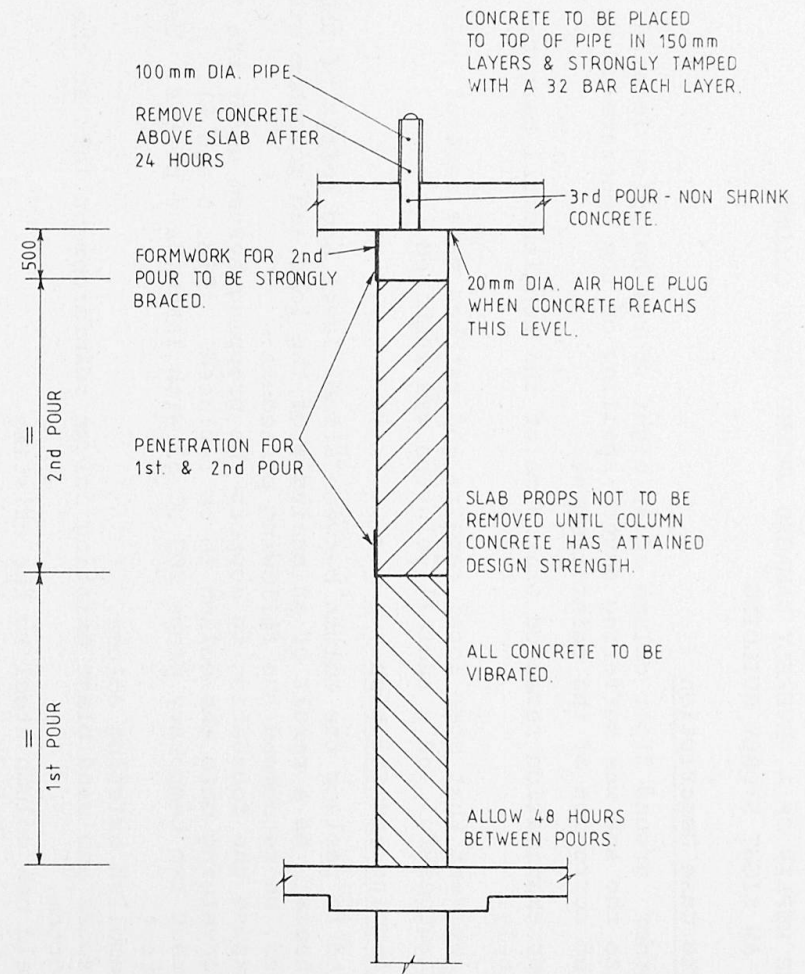
Fig. 4

The technique consisted of pouring the column in three stages. As shown in Fig. 4, most of the column is poured in two stages through lateral openings in the column formwork.

The third and shortest part, at the top of the column, was poured through a 100mm diameter pipe projecting some 900mm above the slab and fixed into a hole through it (Fig. 4). For this third and last pour non-shrink concrete was used and poured to the top of the pipe forming a column of hydrostatic pressure which produced an upward pressure of concrete against the soffit of the slab. It is recommended that the wet concrete in the pipe should be tamped with a heavy rod during the pouring in order to increase the upward pressure.

At the very top of the column's formwork several 20mm holes were left in order to avoid the formation of air pockets between column and slab. Once the cement slurry started to emerge through these holes, they were caulked and the pouring of the pipe finished as described before.
