Repair and Strengthening of Reinforced Concrete Buildings

In 1978, a severe earthquake shook the Peninsula Izu located 120 km southwest of Tokyo, Japan. Several R/C school buildings were damaged. This paper presents the damage, the method of repair and strengthening, and the seismic capacity of the pre- and post-strengthened buildings.

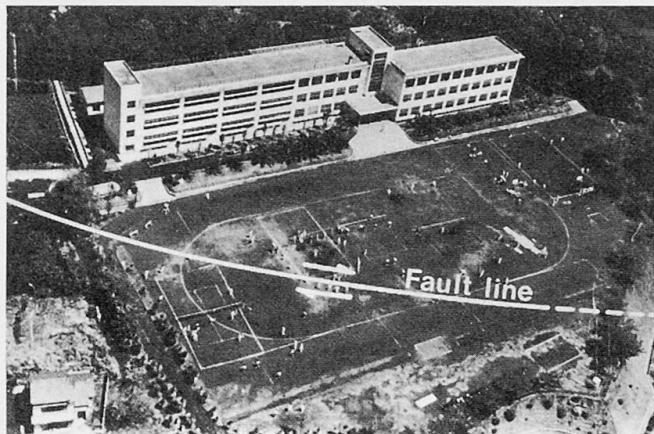
Fig. 3 Bird's eye view of Inatori
Junior High School

A short description about earthquake damage is shown in Table 1. Among them, the damage of Inatori junior high school building was most severe, while the frames could maintain structural performance after the earthquake. As shown in Fig. 3, a major fault line was found across the ground. A number of cracks were found in columns, beams, walls and slabs. The damage was most significant in the slabs at the center core. The crack pattern showed that the east wing and the west wing moved in the opposite direction (Fig. 4).

In the case of Inatori junior high school buildings, the center core was demolished immediately and reconstructed. The expansion joints were newly provided between the center core and both wings. The cracks in the west and east wing were repaired by epoxy injection. Cracks in other buildings were also repaired by epoxy injection.

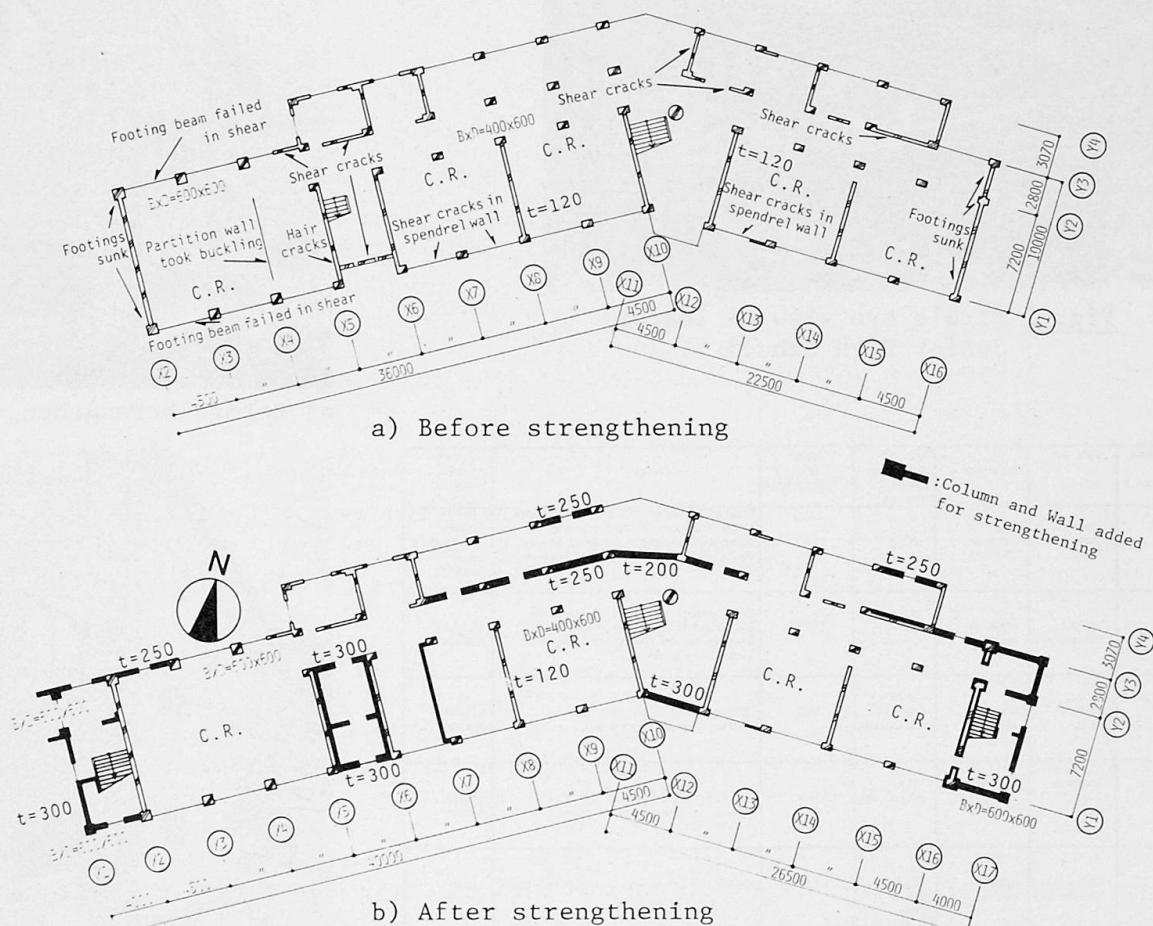
Fig. 7 Plan of Atagawa Junior High School

Atagawa junior high school building was one of the damaged buildings. A number of cracks were seen in columns, beams and walls. Both ends of the building were sunk several centimeters. By the excavation of ground, it was found that the footing beams at the west end were failed in shear. Seismic performance of other school buildings were quite well, while hair cracks in the structures, and damage to the non-structural elements were found.

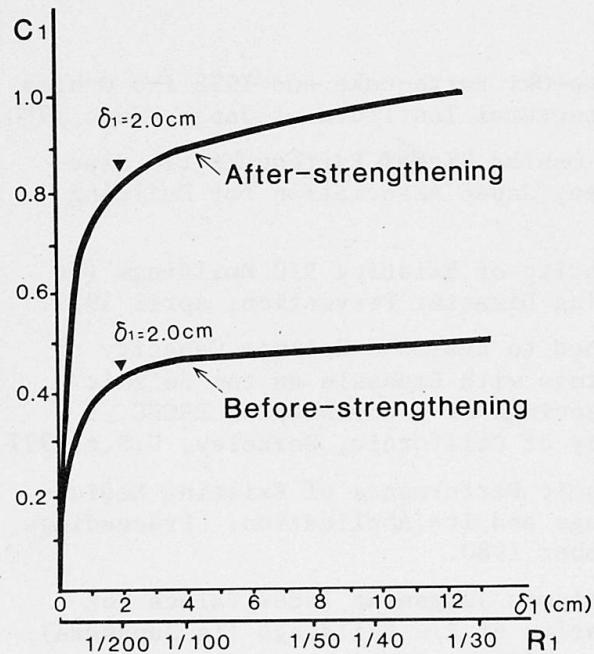
Fig. 11 Base shear coefficient - story drift relationship of Atagawa Junior High School (1st story)

Base shear coefficient-story drift relationship at the first story is shown in Fig.11. At the stage of the displacement of 2cm, where shear failure occurs

in beams adjacent to walls, base shear coefficient(C) of strengthened building is about 0.85 which is approximately double before strengthening. Fig.12 shows the displacement mode at that stage. It is clear that the sway at the first story before strengthening has been also improved by the strengthening. In order to estimate the ductility of the buildings, failure mechanisms of structures were examined. Failure mechanisms of the frame #Y3 at the displacement stage mentioned above are shown in Fig.10. Dominated mechanisms are rotation of walls with shear failure and flexural yielding of beams. Since the frame #Y3 is estimated to carry more than 40 and 60 percent of total lateral force before and after strengthening, respectively, the mechanism of the building is considered as same as the frame #Y3.
