Artikel: Repair and strengthening of reinforced concrete buildings
Autor: Okada, Tsuneo / Murakami, Masaya / Seki, Matsutaro
DOI: <https://doi.org/10.5169/seals-35872>

Repair and Strengthening of Reinforced Concrete Buildings

In 1978, a severe earthquake shook the Peninsula Izu located 120 km southwest of Tokyo, Japan. Several R/C school buildings were damaged. This paper presents the damage, the method of repair and strengthening, and the seismic capacity of the pre- and post-strengthened buildings.

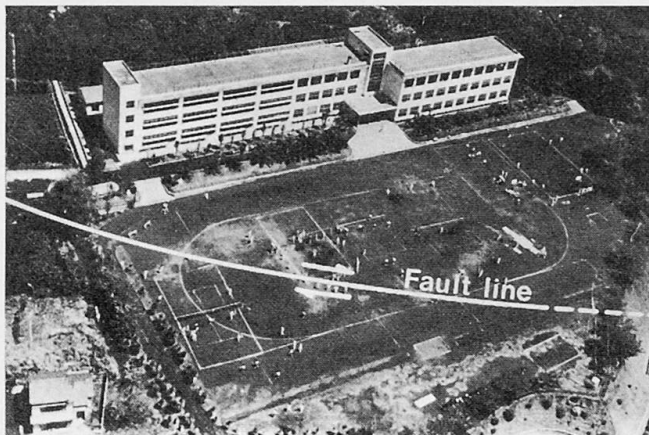
Fig. 3 Bird's eye view of Inatori Junior High School

A short description about earthquake damage is shown in Table 1. Among them, the damage of Inatori junior high school building was most severe, while the frames could maintain structural performance after the earthquake. As shown in Fig.3, a major fault line was found across the ground. A number of cracks were found in columns, beams, walls and slabs. The damage was most significant in the slabs at the center core. The crack pattern showed that the east wing and the west wing moved in the opposite direction (Fig.4).

In the case of Inatori junior high school buildings, the center core was demolished immediately and reconstructed. The expansion joints were newly provided between the center core and both wings. The cracks in the west and east wing were repaired by epoxy injection. Cracks in other buildings were also repaired by epoxy injection.

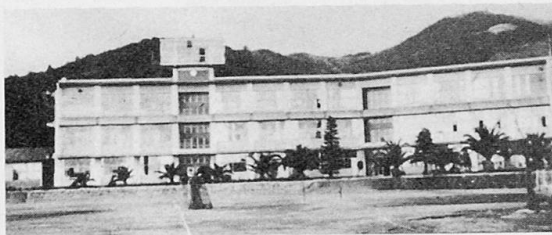
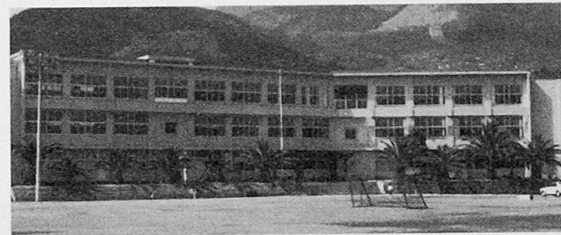
Fig. 6 Overall views of Atagawa Junior High School

Atagawa junior high school building was one of the damaged buildings. A number of cracks were seen in columns, beams and walls. Both ends of the building were sunk several centimeters. By the excavation of ground, it was found that the footing beams at the west end were failed in shear. Seismic performance of other school buildings were quite well, while hair cracks in the structures, and damage to the non-structural elements were found.

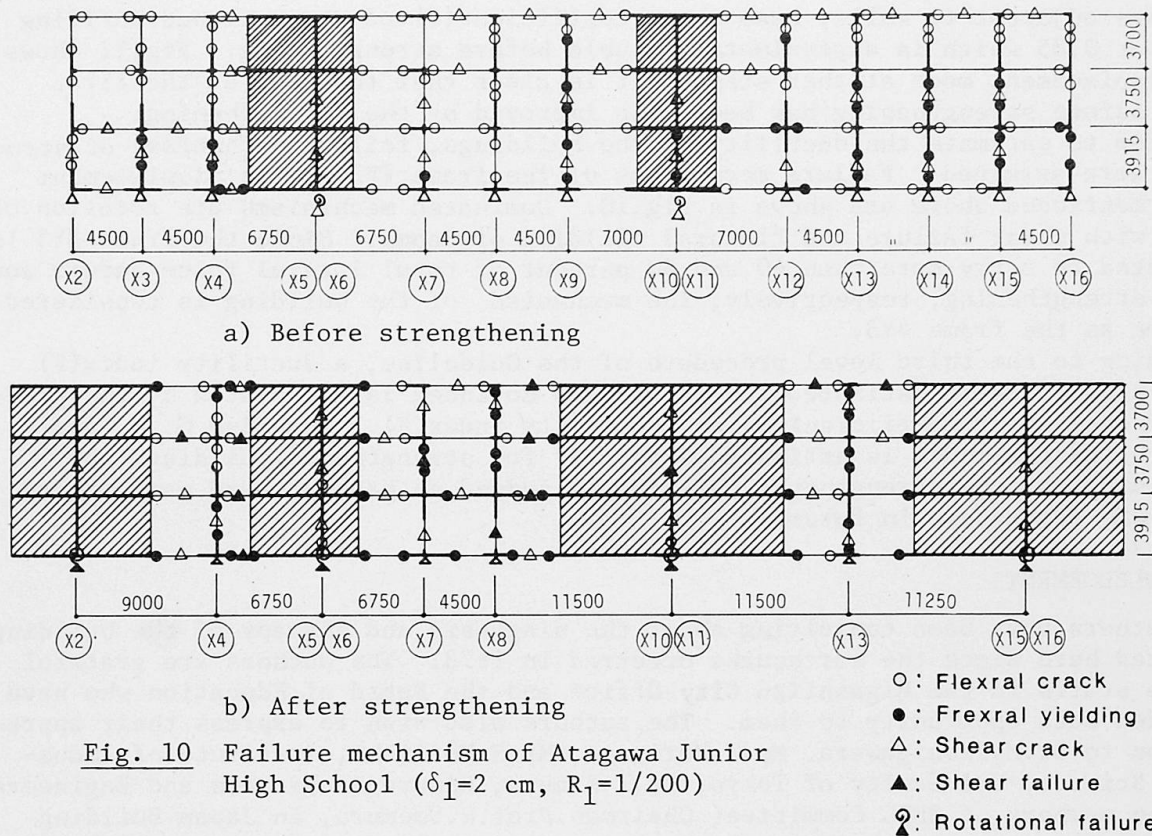
Fig. 10 Failure mechanism of Atagawa Junior High School ($\delta_1=2$ cm, $R_1=1/200$)

In order to estimate the ductility of the buildings, failure mechanisms of structures were examined. Failure mechanisms of the frame #Y3 at the displacement stage mentioned above are shown in Fig.10. Dominated mechanisms are rotation of walls with shear failure and flexural yielding of beams. Since the frame #Y3 is estimated to carry more than 40 and 60 percent of total lateral force before and after strengthening, respectively, the mechanism of the building is considered as same as the frame #Y3.

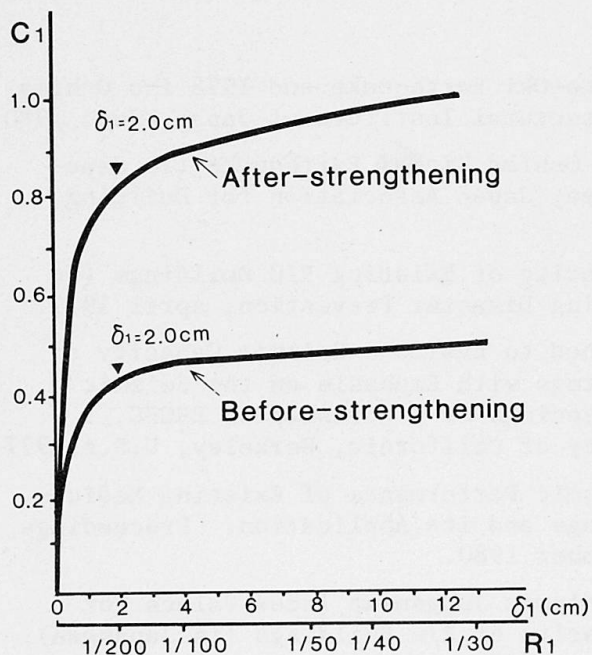
Fig. 11 Base shear coefficient - story drift relationship of Atagawa Junior High School (1st story)

Base shear coefficient-story drift relationship at the first story is shown in Fig.11. At the stage of the displacement of 2cm, where shear failure occurs

in beams adjacent to walls, base shear coefficient(C) of strengthened building is about 0.85 which is approximately double before strengthening. Fig.12 shows the displacement mode at that stage. It is clear that the sway at the first story before strengthening has been also improved by the strengthening.
