Repair and Strengthening of Reinforced Concrete Buildings

In 1978, a severe earthquake shook the Peninsula Izu located 120 km southwest of Tokyo, Japan. Several R/C school buildings were damaged. This paper presents the damage, the method of repair and strengthening, and the seismic capacity of the pre- and post-strengthened buildings.

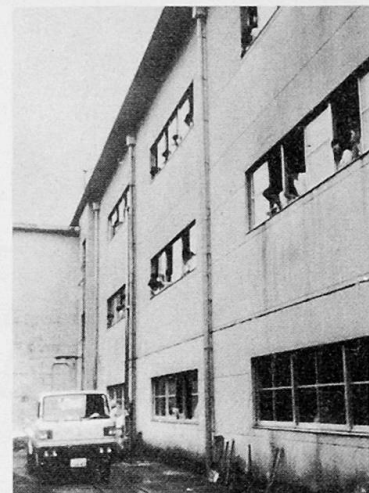
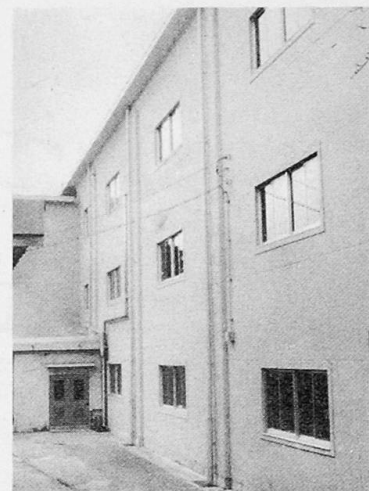
Fig. 5 Shear walls of Inatori Junior High School

Considering these analyses and the grade of damage, the following permanent therapy was adopted for two junior high school buildings : 1) Inatori Junior High School - The east wing was also demolished and replaced to new building in 1983. The west wing was strengthened by adding reinforced concrete shear walls in the existing frames(Fig.4,5). By this therapy, the I_s -index of the west wing is estimated more than 1.0. 2) Atagawa Junior High School - This building was also strengthened in 1983 as shown in Fig.6,7,8. Reinforced concrete walls were added in the existing frames. Reinforced concrete cores were newly constructed at the both ends of the building and jointed to the existing part. The penthouse was taken off to reduce the building weight.

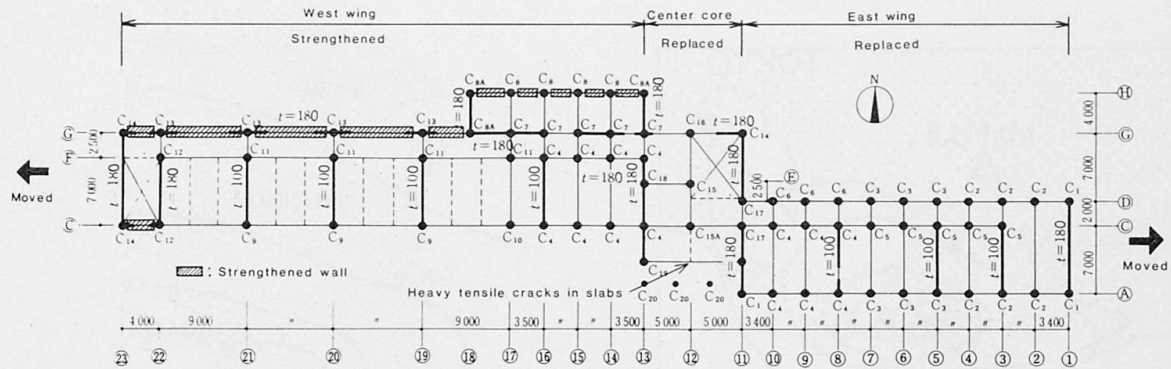
A short description about earthquake damage is shown in Table 1. Among them, the damage of Inatori junior high school building was most severe, while the frames could maintain structural performance after the earthquake. As shown in Fig.3, a major fault line was found across the ground. A number of cracks were found in columns, beams, walls and slabs. The damage was most significant in the slabs at the center core. The crack pattern showed that the east wing and the west wing moved in the opposite direction (Fig.4).

Fig. 4 Plan of Inatori Junior High School

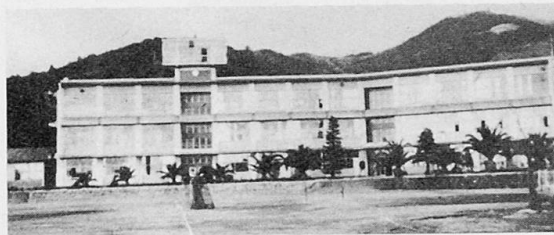
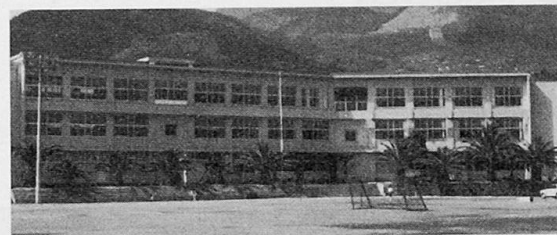
Atagawa junior high school building was one of the damaged buildings. A number of cracks were seen in columns, beams and walls. Both ends of the building were sunk several centimeters. By the excavation of ground, it was found that the footing beams at the west end were failed in shear. Seismic performance of other school buildings were quite well, while hair cracks in the structures, and damage to the non-structural elements were found.

Fig. 6 Overall views of Atagawa Junior High School

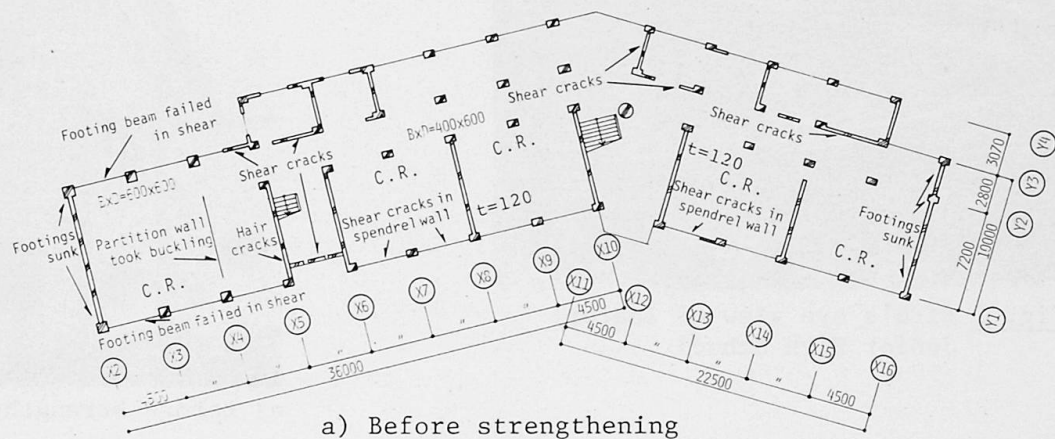
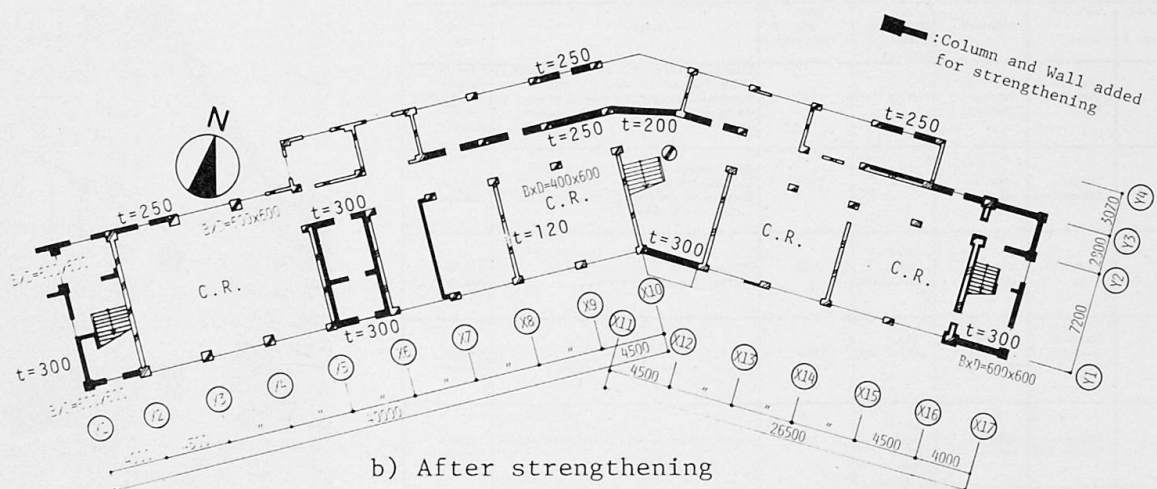
Fig. 7 Plan of Atagawa Junior High School

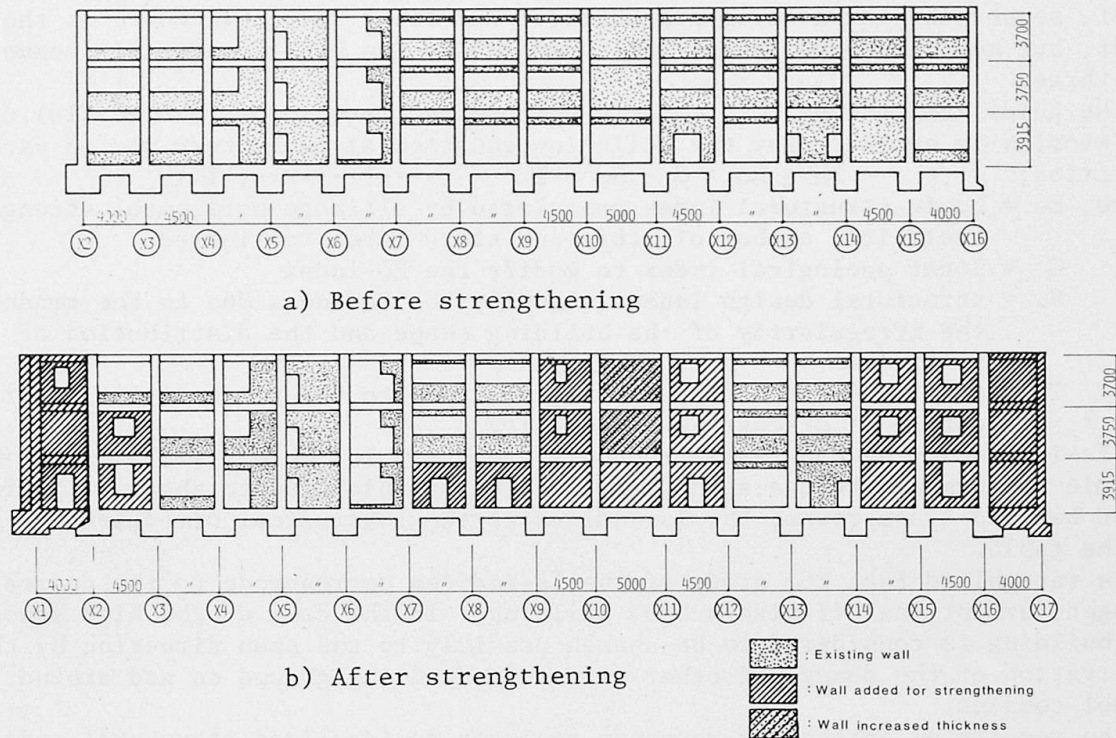
Fig. 8 Frame #Y3 of Atagawa Junior High School

In order to estimate the ductility of the buildings, failure mechanisms of structures were examined. Failure mechanisms of the frame #Y3 at the displacement stage mentioned above are shown in Fig.10. Dominated mechanisms are rotation of walls with shear failure and flexural yielding of beams. Since the frame #Y3 is estimated to carry more than 40 and 60 percent of total lateral force before and after strengthening, respectively, the mechanism of the building is considered as same as the frame #Y3.

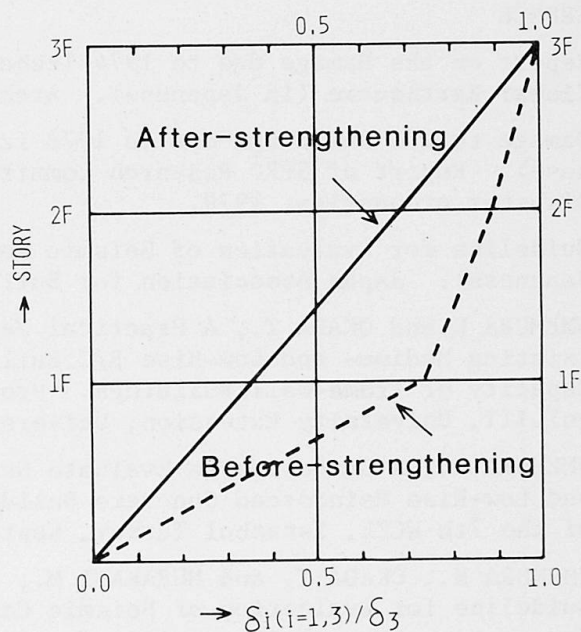
Fig. 12 Mode of displacement ($\delta_1=2$ cm) of Atagawa Junior High School

in beams adjacent to walls, base shear coefficient(C) of strengthened building is about 0.85 which is approximately double before strengthening. Fig.12 shows the displacement mode at that stage. It is clear that the sway at the first story before strengthening has been also improved by the strengthening.
