Artikel: Repair and strengthening of reinforced concrete buildings

Repair and Strengthening of Reinforced Concrete Buildings

In 1978, a severe earthquake shook the Peninsula Izu located 120 km southwest of Tokyo, Japan. Several R/C school buildings were damaged. This paper presents the damage, the method of repair and strengthening, and the seismic capacity of the pre- and post-strengthened buildings.

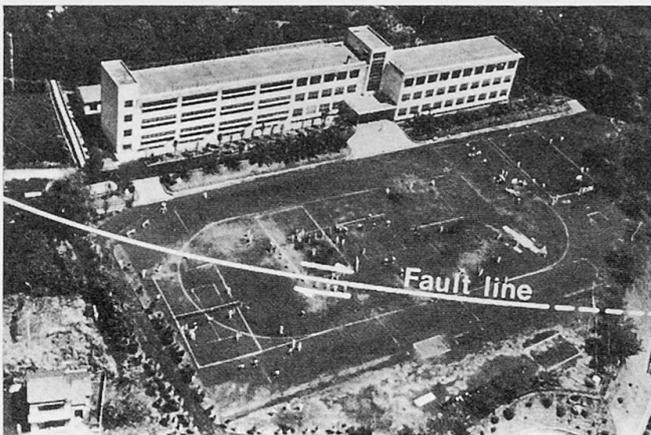
Fig. 3 Bird's eye view of Inatori Junior High School

A short description about earthquake damage is shown in Table 1. Among them, the damage of Inatori junior high school building was most severe, while the frames could maintain structural performance after the earthquake. As shown in Fig.3, a major fault line was found across the ground. A number of cracks were found in columns, beams, walls and slabs. The damage was most significant in the slabs at the center core. The crack pattern showed that the east wing and the west wing moved in the opposite direction (Fig.4).

In the case of Inatori junior high school buildings, the center core was demolished immediately and reconstructed. The expansion joints were newly provided between the center core and both wings. The cracks in the west and east wing were repaired by epoxy injection. Cracks in other buildings were also repaired by epoxy injection.

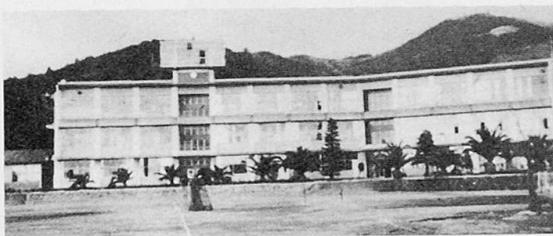
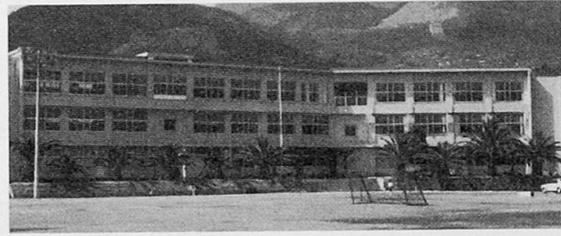
Fig. 6 Overall views of Atagawa Junior High School

Atagawa junior high school building was one of the damaged buildings. A number of cracks were seen in columns, beams and walls. Both ends of the building were sunk several centimeters. By the excavation of ground, it was found that the footing beams at the west end were failed in shear. Seismic performance of other school buildings were quite well, while hair cracks in the structures, and damage to the non-structural elements were found.

Considering these analyses and the grade of damage, the following permanent therapy was adopted for two junior high school buildings : 1) Inatori Junior High School - The east wing was also demolished and replaced to new building in 1983. The west wing was strengthened by adding reinforced concrete shear walls in the existing frames(Fig.4,5). By this therapy, the I_s -index of the west wing is estimated more than 1.0. 2) Atagawa Junior High School - This building was also strengthened in 1983 as shown in Fig.6,7,8. Reinforced concrete walls were added in the existing frames. Reinforced concrete cores were newly constructed at the both ends of the building and jointed to the existing part. The penthouse was taken off to reduce the building weight.

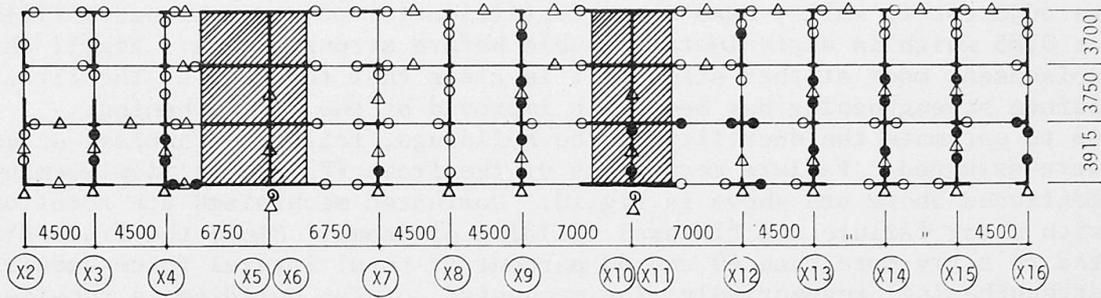
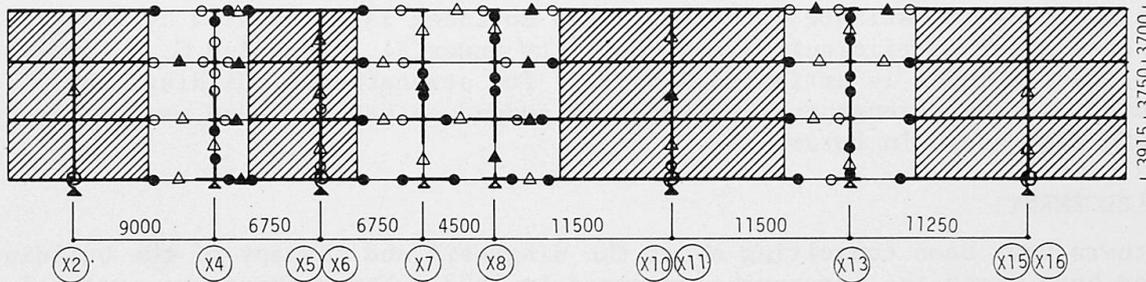
Fig. 10 Failure mechanism of Atagawa Junior High School ($\delta_1=2$ cm, $R_1=1/200$)

In order to estimate the ductility of the buildings, failure mechanisms of structures were examined. Failure mechanisms of the frame #Y3 at the displacement stage mentioned above are shown in Fig.10. Dominated mechanisms are rotation of walls with shear failure and flexural yielding of beams. Since the frame #Y3 is estimated to carry more than 40 and 60 percent of total lateral force before and after strengthening, respectively, the mechanism of the building is considered as same as the frame #Y3.

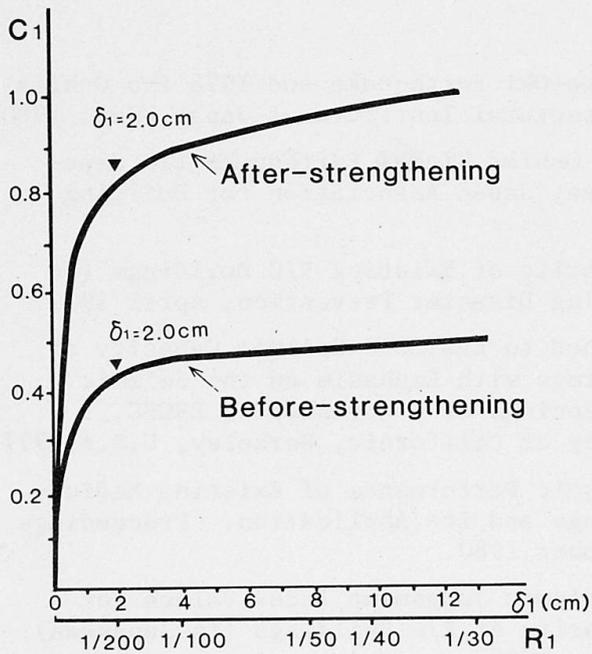
Fig. 11 Base shear coefficient - story drift relationship of Atagawa Junior High School (1st story)

Base shear coefficient-story drift relationship at the first story is shown in Fig.11. At the stage of the displacement of 2cm, where shear failure occurs

in beams adjacent to walls, base shear coefficient(C) of strengthened building is about 0.85 which is approximately double before strengthening. Fig.12 shows the displacement mode at that stage. It is clear that the sway at the first story before strengthening has been also improved by the strengthening.
