**Artikel:** Repair of damaged floor slabs

Autor: Higashi, Yoichi

Réparation de planchers endommagés
Instandsetzung von Gebäudedecken

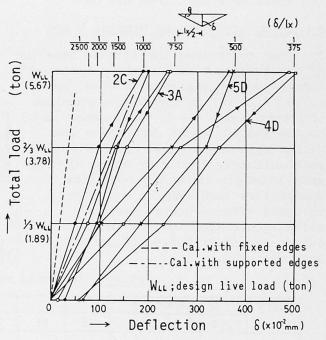
Fig.5 Loading tests results

Figure 5 shows the load-deflection curves of the slabs. The values of calculated stiffness with fixed edges and with supported edges were shown by the dotted lines, in this figure. The stiffness of the slab in 2C, which were damaged little, was intermediate between the both calculated values. But the stiffness and residual deflection ratio showed tendency to be larger, corresponding to their damageness. However, these slabs were confirmed to have enough load capacity, because the slabs were kept in elastic under design live load, as shown in Fig.5.
