Repair of Damaged Floor Slabs

Yoichi HIGASHI

The crack pattern and deflection of 48 damaged slabs in a 5-story reinforced concrete building with wide cracks and large deflections were measured. Two repair methods proposed were injection of epoxy resin into the cracks, and the casting of a concrete or mortar layer over the damaged slabs, depending on the degree of damage. Loading tests on one-way slab specimens similar to the actual slabs, and vibration tests on the actual slabs were carried out before and after repairing. The results of these tests show that the proposed methods of repair were very effective for the damaged slabs.

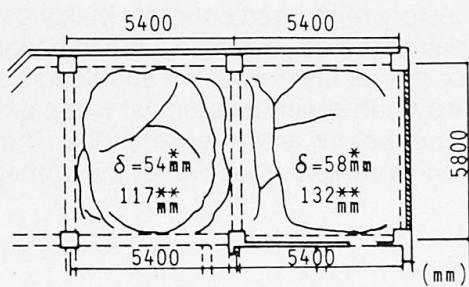
Fig.1 Square slabs with wide span⁶⁾

- 1) construction year : 1961
- 2) girder section : $350 \times 700 \text{ mm}$
- 3) design depth : 130 mm
- 4) natural frequency :
(12.5-13.0 Hz, before repair)
(18.2-20.5 Hz, after repair)

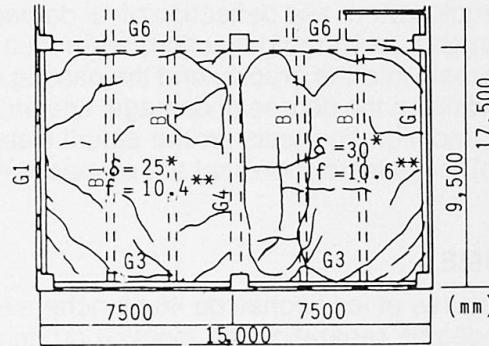
Fig.2 Slabs with beams in a office⁶⁾ Building

- 1) construction year : 1972
- 2) girder section(G1,G6); $350 \times 750 \text{ mm}$
(G3,G6); $400 \times 750 \text{ mm}$
- 3) beam section B1 ; $300 \times 650 \text{ mm}$
- 4) design depth ; 120 mm

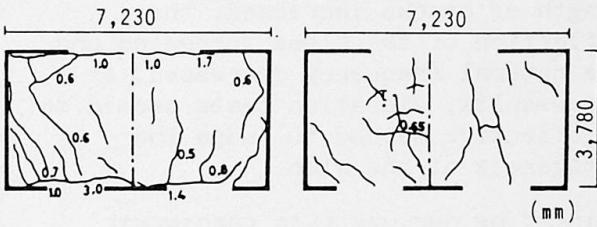
Fig.4 Crack Patterns of the most damaged slab
(a) Upper surface (b) Lower surface

Figure 4 shows crack patterns of the most damaged slab. Cracks by constrain and shrinkage and by bending moment were mixed in the slab, but almost of wide cracks seemed to be by bending moment, judging from their occurred place. There were many cracks whose width was more than 1.0 mm, and the width of a few cracks along the edges of short span reached 3.0 mm.

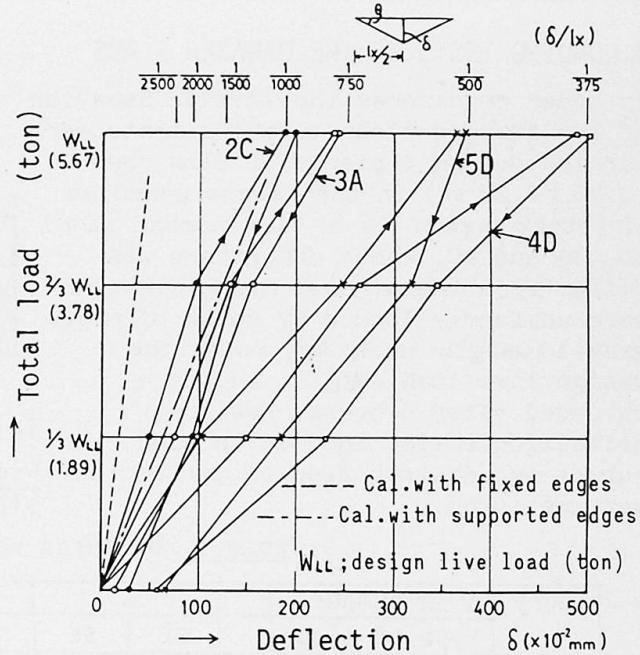
Fig.5 Loading tests results

Figure 5 shows the load-deflection curves of the slabs. The values of calculated stiffness with fixed edges and with supported edges were shown by the dotted lines, in this figure. The stiffness of the slab in 2C, which were damaged little, was intermediate between the both calculated values. But the stiffness and residual deflection ratio showed tendency to be larger, corresponding to their damageness. However, these slabs were confirmed to have enough load capacity, because the slabs were kept in elastic under design live load, as shown in Fig.5.

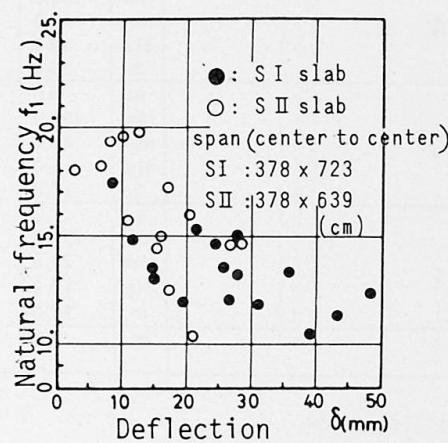
Fig.6 Vibration tests results

The free vibration waves of the slabs were measured by the pick-up for vertical motions, when the steel ball fallen on the slabs from a height of 28 cm. Reading the natural frequency and maximum amplitude of the slabs from those waves, the stiffness decreasing of the slab was discussed.⁵⁾ The tests results were shown in Table 1 and Fig.6. It was found that the natural frequency decreased as the deflection of the damaged slabs increased. It showed a similar tendency to the results of other's studies.^{2), 6)} Judging from Table 1, as the total length of cracks increased, the deflection of the slabs increased and the natural frequency decreased. As the results, vibration tests seemed to be effective method to judge the damageness of the slab.

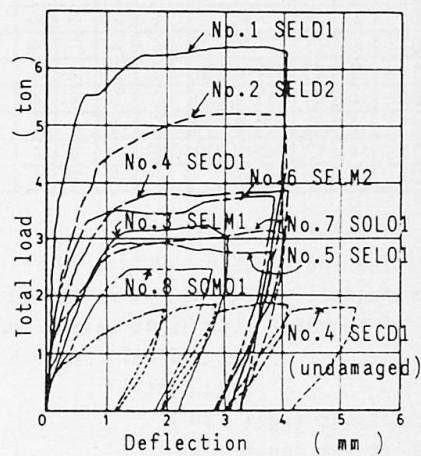
Fig.9 Load-deflection curves of the short-term loading tests

after repaired as shown in Fig.8. The load-deflection curves of the specimens were shown in Fig.9, and the natural frequency by vibration tests and the stiffness and deflection were shown in Table 2. The stiffness of the slabs repaired by injecting epoxy resin into cracks increased by 0.78-0.96 as that of the damaged slab.

Moreover, the stiffness, natural frequency and load capacity of the slabs repaired by casting concrete increased, as the depth of concrete increased. Especially, the stiffness, natural frequency and load capacity of the slabs repaired by casting concrete after injecting epoxy resin were by far more than those of the undamaged slabs. These repair methods seemed to be very effective for the damaged slabs.

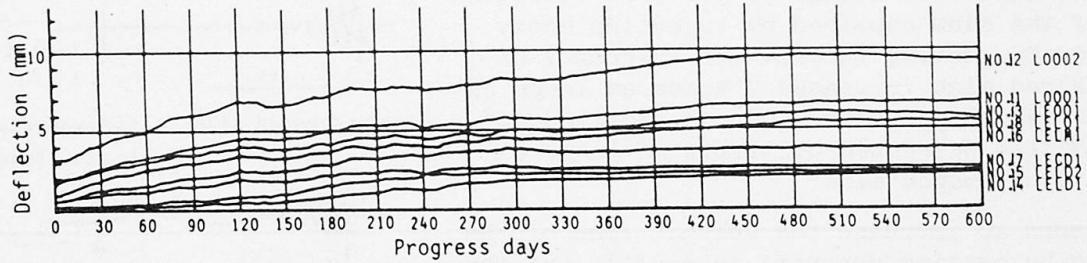
Fig.11 Long-term deflection increasing

The long-term deflection increase of each specimens was shown in Fig.11. The deflection increase of all slabs were almost constant after 450 days. The deflection of No.13 slab repaired by injecting epoxy resin into cracks was 60 % of No.12 slab damaged and was almost equal to that of No.11 slab undamaged. As the depth of casting concrete increased, the degree of the deflection increase became smaller than that of the undamaged slab.

The repair method by casting concrete after injecting epoxy resin into cracks did not only increase the stiffness and load capacity of the damaged slabs under short-term loading, but also was very effective for decreasing the deflection under long-term loading.

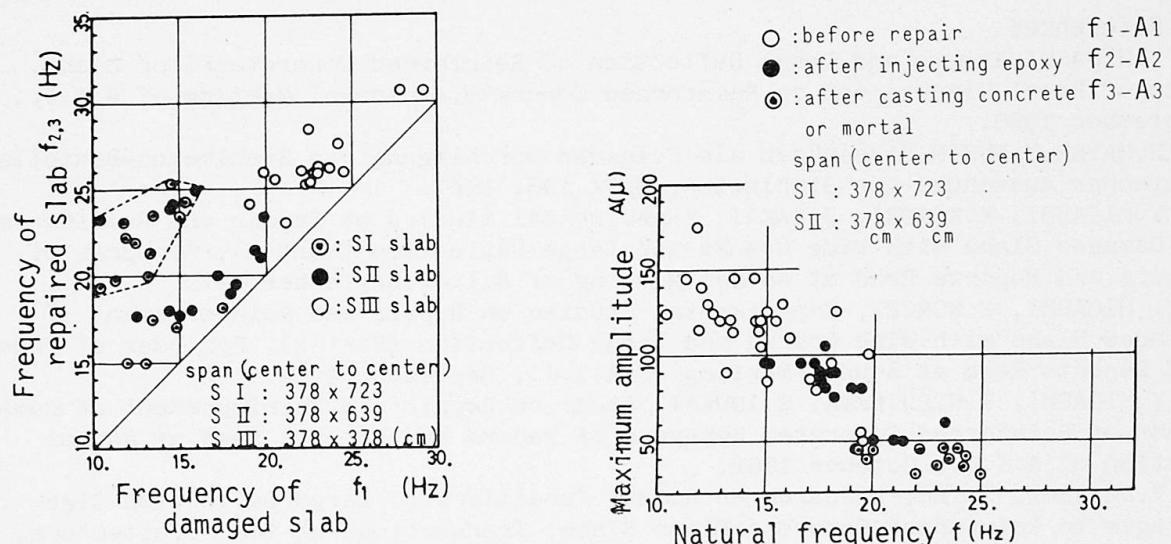
Fig.12 Increase of the Natural frequency of the slabs

Figure 12 shows the change of the natural frequency of the slabs repaired by injecting epoxy resin into cracks. The natural frequency of repaired slabs increased about 20-30 % than that of the damaged slabs. The measured results of the slabs repaired by casting mortal or concrete were shown in the dotted lines of Fig.12, and the natural frequency of such repaired slabs increased remarkably.

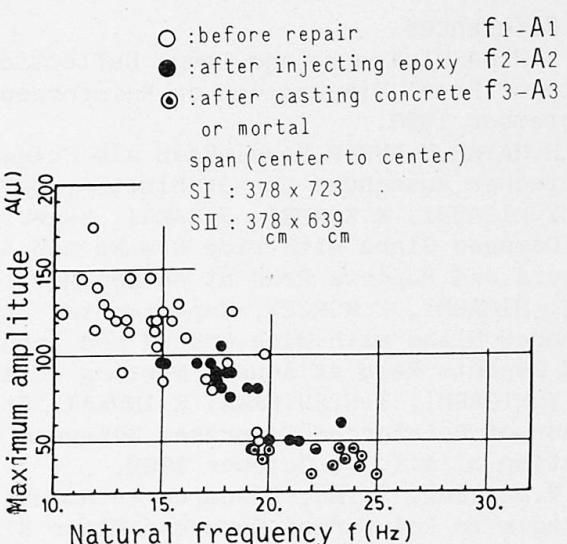
Fig.13 Relations between natural frequency and maximum amplitude

Figure 13 shows the relations between the natural frequency and maximum amplitude of the repaired slabs. The frequency increased and the amplitude decreased by injecting epoxy resin and still more by casting mortal or concrete.

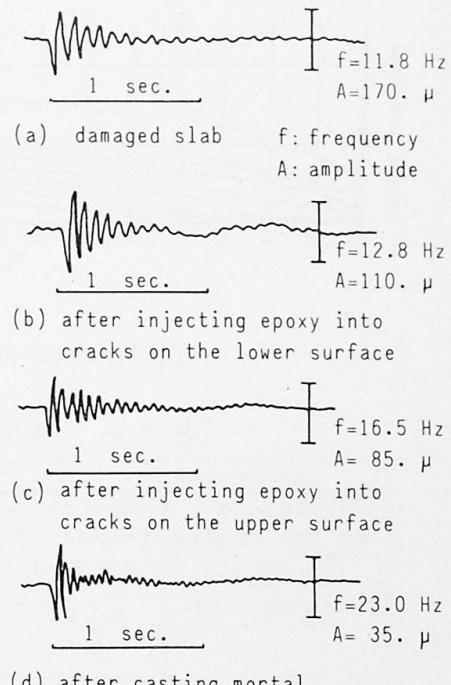
Fig.14 Waves changing of the repaired slab

Figure 14 shows the change of the free vibration waves of the slab repaired by injecting epoxy resin and by casting mortal. The frequency of the repaired slab increased 2 times as large as that of the damaged slab, and the amplitude of repaired slab decreased 0.2 times as large as that of the damaged slab.
