**Zeitschrift:** IABSE reports = Rapports AIPC = IVBH Berichte  
**Band:** 46 (1983)

**Artikel:** Repair of damaged floor slabs  
**Autor:** Higashi, Yoichi  
**DOI:** <https://doi.org/10.5169/seals-35874>

## Repair of Damaged Floor Slabs

### Yoichi HIGASHI

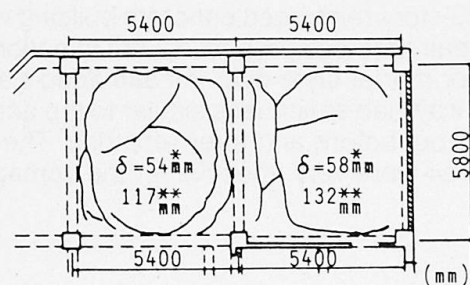
Fig.1 Square slabs with wide span<sup>6)</sup>

- 1) construction year : 1961
- 2) girder section : 350 x 700 mm
- 3) design depth : 130 mm
- 4) natural frequency :  
(12.5-13.0 Hz, before repair)  
(18.2-20.5 Hz, after repair)
- \* : measured deflection at the center
- \*\* : measured depth

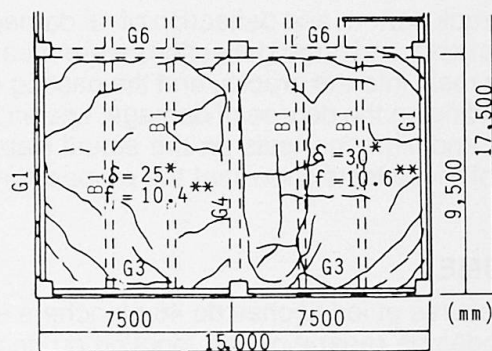
Fig.2 Slabs with beams in a office Building<sup>6)</sup>

- 1) construction year : 1972
- 2) girder section (G1, G4); 350 x 750 mm  
(G3, G6); 400 x 750 mm
- 3) beam section B1 : 300 x 650 mm
- 4) design depth : 120 mm
- \* : measured deflection at the center
- \*\* : measured frequency

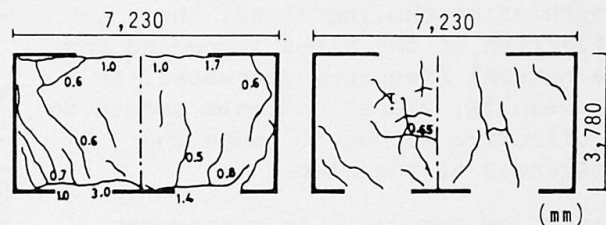
Fig.4 Crack Patterns of the most damaged slab

Figure 4 shows crack patterns of the most damaged slab. Cracks by constrain and shrinkage and by bending moment were mixed in the slab, but almost of wide cracks seemed to be by bending moment, judging from their occurred place. There were many cracks whose width was more than 1.0 mm, and the width of a few cracks along the edges of short span reached 3.0 mm.

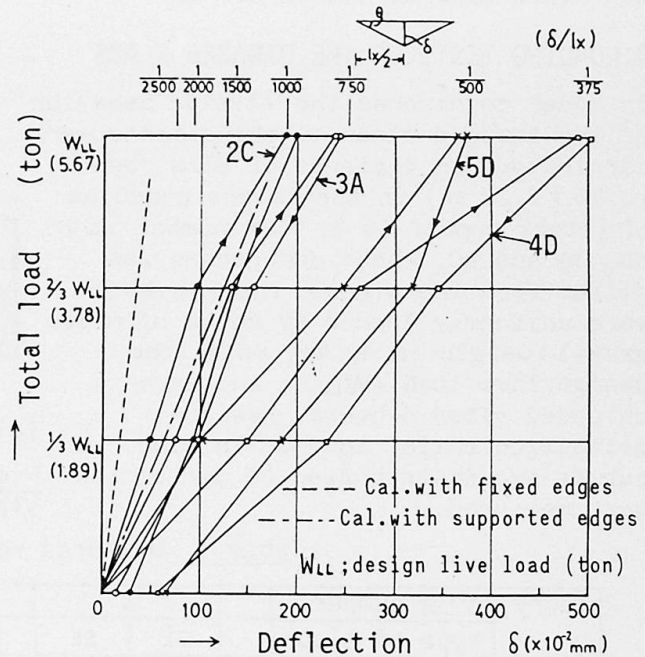
Fig.5 Loading tests results

Figure 5 shows the load-deflection curves of the slabs. The values of calculated stiffness with fixed edges and with supported edges were shown by the dotted lines, in this figure. The stiffness of the slab in 2C, which were damaged little, was intermediate between the both calculated values. But the stiffness and residual deflection ratio showed tendency to be larger, corresponding to their damageness. However, these slabs were confirmed to have enough load capacity, because the slabs were kept in elastic under design live load, as shown in Fig.5.

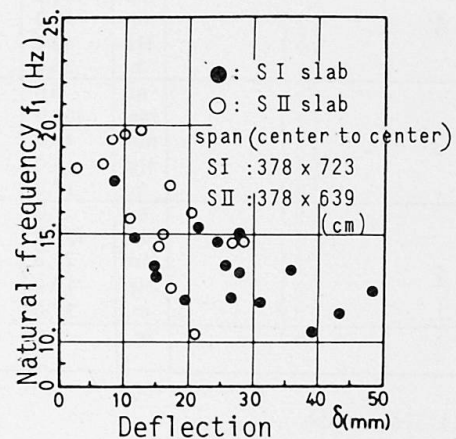
Fig.6 Vibration tests results

The free vibration waves of the slabs were measured by the pick-up for vertical motions, when the steel ball fell on the slabs from a height of 28 cm. Reading the natural frequency and maximum amplitude of the slabs from those waves, the stiffness decreasing of the slab was discussed.<sup>5)</sup> The tests results were shown in Table 1 and Fig.6. It was found that the natural frequency decreased as the deflection of the damaged slabs increased. It showed a similar tendency to the results of other's studies.<sup>2), 6)</sup> Judging from Table 1, as the total length of cracks increased, the deflection of the slabs increased and the natural frequency decreased. As the results, vibration tests seemed to be effective method to judge the damageness of the slab.

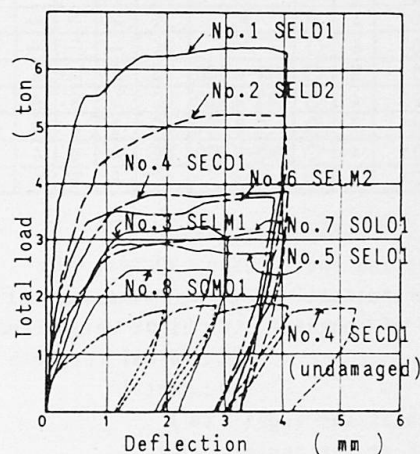
Fig.9 Load-deflection curves of the short-term loading tests

after repaired as shown in Fig.8. The load-deflection curves of the specimens were shown in Fig.9, and the natural frequency by vibration tests and the stiffness and deflection were shown in Table 2. The stiffness of the slabs repaired by injecting epoxy resin into cracks increased by 0.78-0.96 as that of the damaged slab.

Moreover, the stiffness, natural frequency and load capacity of the slabs repaired by casting concrete increased, as the depth of concrete increased. Especially, the stiffness, natural frequency and load capacity of the slabs repaired by casting concrete after injecting epoxy resin were by far more than those of the undamaged slabs. These repair methods seemed to be very effective for the damaged slabs.

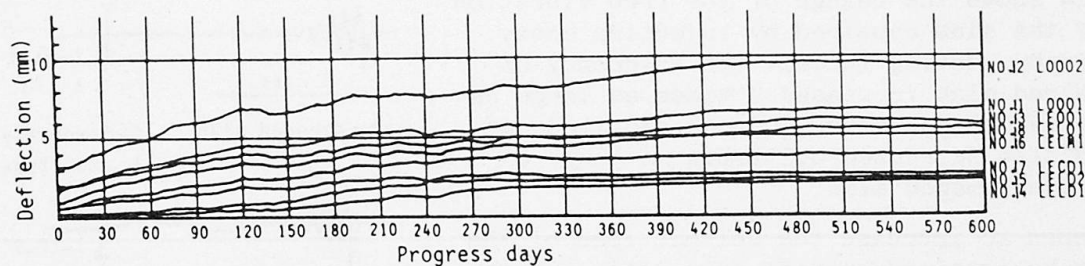
Fig.11 Long-term deflection increasing

The long-term deflection increase of each specimens was shown in Fig.11. The deflection increase of all slabs were almost constant after 450 days. The deflection of No.13 slab repaired by injecting epoxy resin into cracks was 60 % of No.12 slab damaged and was almost equal to that of No.11 slab undamaged. As the depth of casting concrete increased, the degree of the deflection increase became smaller than that of the undamaged slab.

The repair method by casting concrete after injecting epoxy resin into cracks did not only increase the stiffness and load capacity of the damaged slabs under short-term loading, but also was very effective for decreasing the deflection under long-term loading.

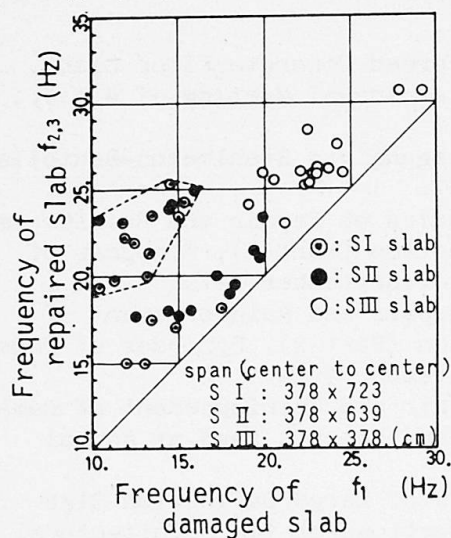
Fig.12 Increase of the Natural frequency of the slabs

Figure 12 shows the change of the natural frequency of the slabs repaired by injecting epoxy resin into cracks. The natural frequency of repaired slabs increased about 20-30 % than that of the damaged slabs. The measured results of the slabs repaired by casting mortal or concrete were shown in the dotted lines of Fig.12, and the natural frequency of such repaired slabs increased remarkably.

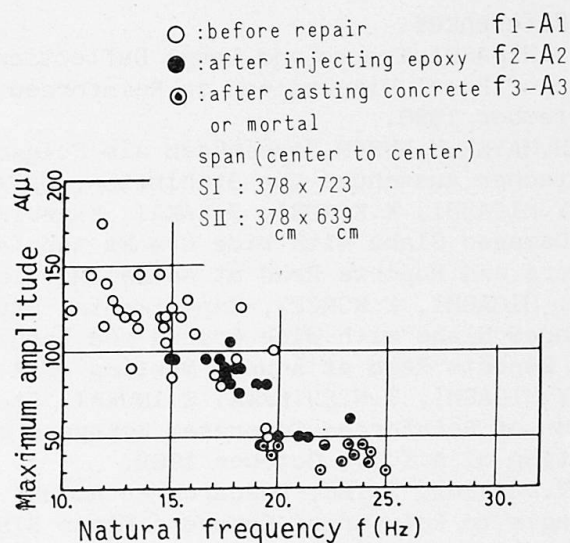
Fig.13 Relations between natural frequency and maximum amplitude

Figure 13 shows the relations between the natural frequency and maximum amplitude of the repaired slabs. The frequency increased and the amplitude decreased by injecting epoxy resin and still more by casting mortal or concrete.

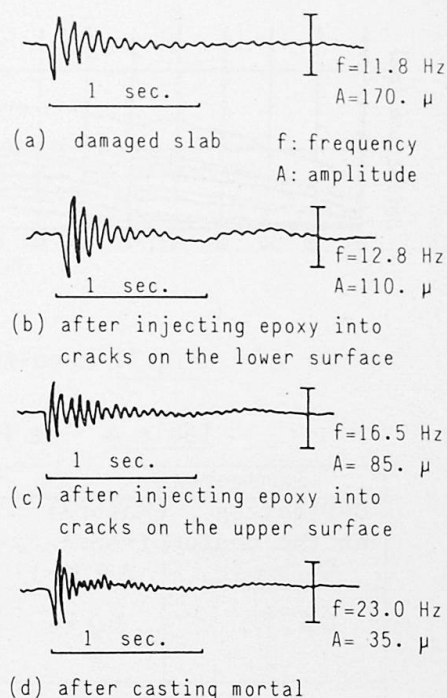
Fig.14 Waves changing of the repaired slab

Figure 14 shows the change of the free vibration waves of the slab repaired by injecting epoxy resin and by casting mortal. The frequency of the repaired slab increased 2 times as large as that of the damaged slab, and the amplitude of repaired slab decreased 0.2 times as large as that of the damaged slab.
