Strengthening of a Prestressed Concrete Shell Structure

Hassan HOSNY

In this paper, strengthening of a prestressed concrete shell in a chemical factory, in Cairo, is presented. The valley beams were strengthened by external prestressing cables anchored outside the building in precast end blocks. The shells were strengthened by casting 4 cm thick resin concrete on top of the existing shell.

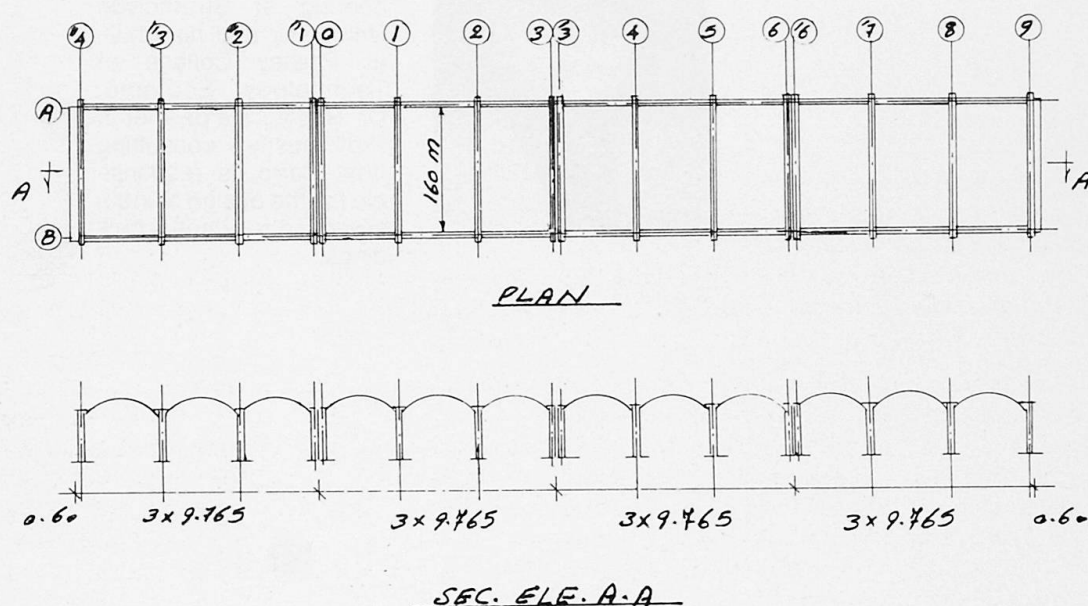
Fig. 1 General Layout

The building is divided into four identical parts separated by three expansion joints as shown in fig.1. Each part is composed of three cylindrical reinforced concrete shells with prestressed edge beams. Each shell is 10ms wide, 16ms long and 6cm thick. The intermediate edge, valley, beams were prestressed with three FREYSSINET cables 12 o 5 mm while the exterior beams were prestressed with only two cables of the same type.

In 1978 i.e. thirty years after construction, sudden collapse of the first part took place.

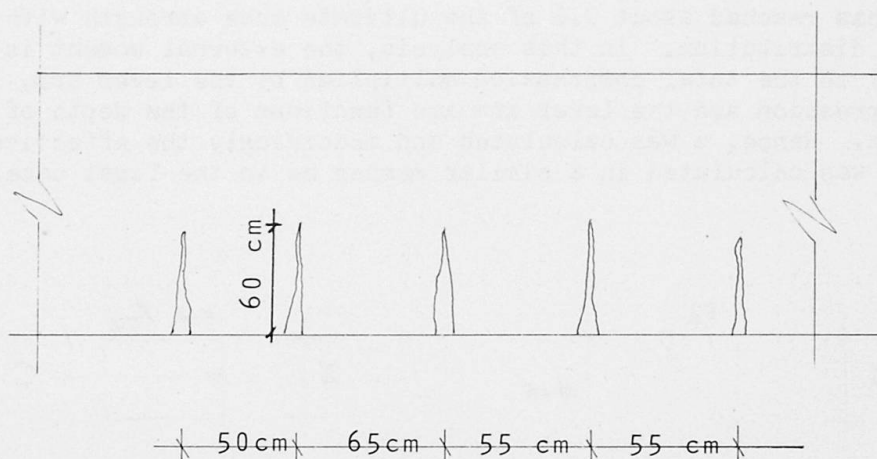
Fig. 2 Cracks At Mid Span Of Beams

- In the webs of the prestressed beams - especially for those of the intermediate beams- several cracks spaced about 50cm between each other were noticed at mid-span. These cracks were extending vertically about 60cm from the bottom surface of the beams with crack widths varying from 0.5 to 3mm on both sides and on the bottom surface of the beams as shown in fig.2.
- In some localized areas of the shells, longitudinal and transversal cracks on the inside face and sometimes on the outside face were noticed. In these areas one can assume that the concrete is linked together along the cracks - which act as hinges- only by the reinforcing bars.

The main reasons for the damages were the miss use and bad maintenance. A steel water tank of two cubic meters capacity was located on top of one of the shells. Plenty of pipe networks were also located on top of the shells. These pipes were not well connected and leakage of water and chemicals was noticed. The gutters over the valley beams, between adjacent shells, were found to be almost filled with mud which prevented proper drainage of water to take place. This mud and water added an extra load on the beams which was not taken in to account in the original design.

Due to the above mentioned reasons, the beams were cracked and the prestressing cables started to corrode. Accordingly, the effective prestressing forces were reduced considerably, followed by rupture of prestressing cables and sudden collapse.

- In the second method, the beams were to be strengthened by the use of external prestressing cables. These cables were to be anchored - outside the building - in precast concrete end blocks. Fig. 6 & 7 show the end blocks used for the intermediate beams and that used at the expansion joints. It should be noted that for the end blocks at expansion joints neoprene sheets were installed between the columns and the blocks in order to allow for expansion movements. Fig. 8,9&10 show the repair for the exterior beams, for the intermediate beams and for the beams at the expansion joints respectively. The advantage of this method over the first method is that it saves time, it is easy to perform, it does not add any more weight to the beams and it needs no shuttering, i.e. the repair can be carried out without the need of stopping the production of the factory. However, it needs especial prestressing equipments to be available.

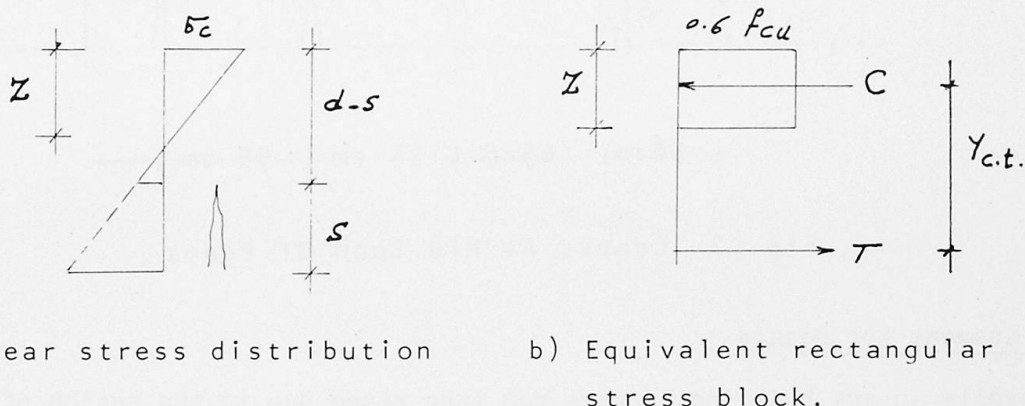
Fig. 3 Assumptions Of Stress Distribution

- In the first case, fig. 3a, the stress distribution was assumed to be linear. In this case it was assumed that the tensile stress at the level of the top end of the crack is equal to the tensile strength of the concrete which can be evaluated. The actual external moment applied on the section was calculated, i.e. it was known. Thus from first principals, the total compression was calculated which is equal to the total tension. The effective prestressing force was accordingly estimated.
- In the second case, fig. 3b, it was assumed that the compressive stress in

the concrete has reached about 0.6 of the ultimate cube strength with a non-linear stress distribution. In this analysis, the external moment is known which is equal to the total compression multiplied by the lever arm, Y_{ct} . Both the total compression and the lever arm are functions of the depth of the neutral axis, z . Hence, z was calculated and accordingly the effective prestressing force was calculated in a similar manner as in the first case.

It should be noted that the problem under consideration is not that straight forward and some engineering judgment had to be made. From the crack pattern in the valley beams together with the above mentioned calculations, it was estimated that a maximum loss of about 40% in the original prestressing force has taken place.

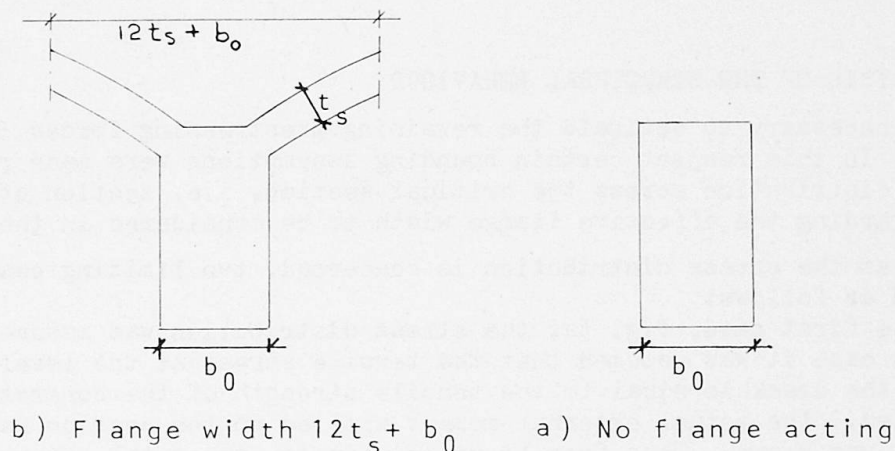
Fig. 4 Assumption Of Effective Flange Width Acting

- The beam was considered to be as a rectangular section without any flanges acting as shown in fig.4a. This case gave the highest value of loss of prestressing.
- The beam was considered to have an effective flange width equal to the web breadth plus twelve times the shell thickness as shown in fig. 4b.
