Strengthening of a Prestressed Concrete Shell Structure

Hassan HOSNY

In this paper, strengthening of a prestressed concrete shell in a chemical factory, in Cairo, is presented. The valley beams were strengthened by external prestressing cables anchored outside the building in precast end blocks. The shells were strengthened by casting 4 cm thick resin concrete on top of the existing shell.

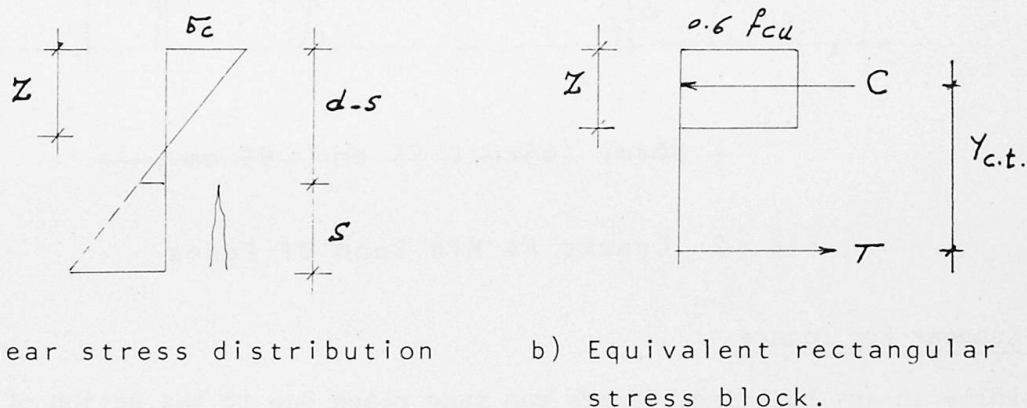
Fig. 3 Assumptions Of Stress Distribution

- In the first case, fig. 3a, the stress distribution was assumed to be linear. In this case it was assumed that the tensile stress at the level of the top end of the crack is equal to the tensile strength of the concrete which can be evaluated. The actual external moment applied on the section was calculated, i.e. it was known. Thus from first principals, the total compression was calculated which is equal to the total tension. The effective prestressing force was accordingly estimated.
- In the second case, fig. 3b, it was assumed that the compressive stress in

the concrete has reached about 0.6 of the ultimate cube strength with a non-linear stress distribution. In this analysis, the external moment is known which is equal to the total compression multiplied by the lever arm, Y_{ct} . Both the total compression and the lever arm are functions of the depth of the neutral axis, z . Hence, z was calculated and accordingly the effective prestressing force was calculated in a similar manner as in the first case.

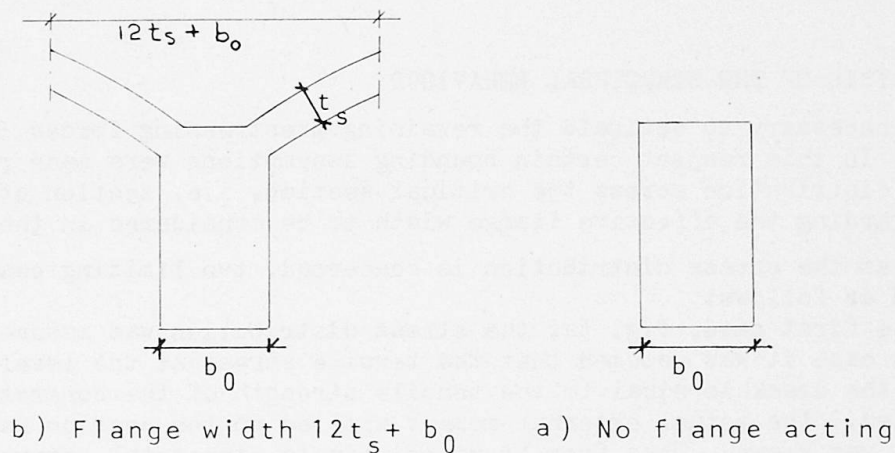
Fig. 4 Assumption Of Effective Flange Width Acting

- The beam was considered to be as a rectangular section without any flanges acting as shown in fig.4a. This case gave the highest value of loss of prestressing.
- The beam was considered to have an effective flange width equal to the web breadth plus twelve times the shell thickness as shown in fig. 4b.

It should be noted that the problem under consideration is not that straight forward and some engineering judgment had to be made. From the crack pattern in the valley beams together with the above mentioned calculations, it was estimated that a maximum loss of about 40% in the original prestressing force has taken place.
