Artikel: Strengthening of a prestressed concrete shell structure

Strengthening of a Prestressed Concrete Shell Structure

Hassan HOSNY

In this paper, strengthening of a prestressed concrete shell in a chemical factory, in Cairo, is presented. The valley beams were strengthened by external prestressing cables anchored outside the building in precast end blocks. The shells were strengthened by casting 4 cm thick resin concrete on top of the existing shell.

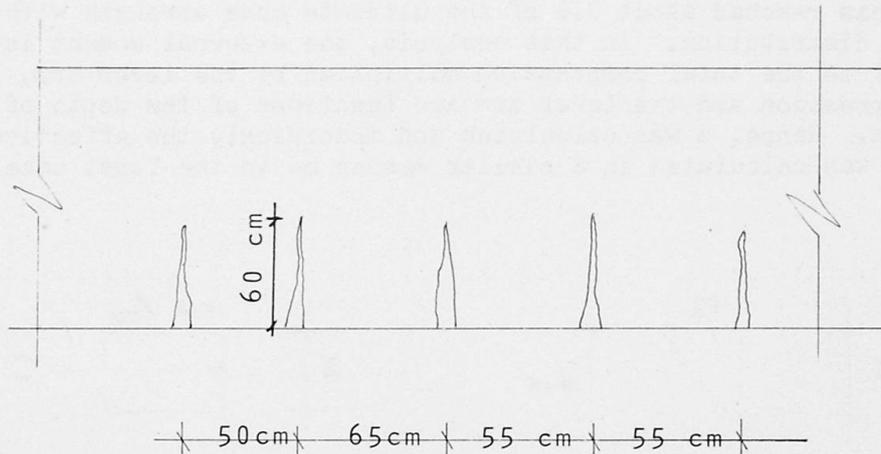
Fig. 2 Cracks At Mid Span Of Beams

- In the webs of the prestressed beams - especially for those of the intermediate beams- several cracks spaced about 50cm between each other were noticed at mid-span. These cracks were extending vertically about 60cm from the bottom surface of the beams with crack widths varying from 0.5 to 3mm on both sides and on the bottom surface of the beams as shown in fig.2.
- In some localized areas of the shells, longitudinal and transversal cracks on the inside face and sometimes on the outside face were noticed. In these areas one can assume that the concrete is linked together along the cracks - which act as hinges- only by the reinforcing bars.

The main reasons for the damages were the miss use and bad maintenance. A steel water tank of two cubic meters capacity was located on top of one of the shells. Plenty of pipe networks were also located on top of the shells. These pipes were not well connected and leakage of water and chemicals was noticed. The gutters over the valley beams, between adjacent shells, were found to be almost filled with mud which prevented proper drainage of water to take place. This mud and water added an extra load on the beams which was not taken in to account in the original design.

Due to the above mentioned reasons, the beams were cracked and the prestressing cables started to corrode. Accordingly, the effective prestressing forces were reduced considerably, followed by rupture of prestressing cables and sudden collapse.

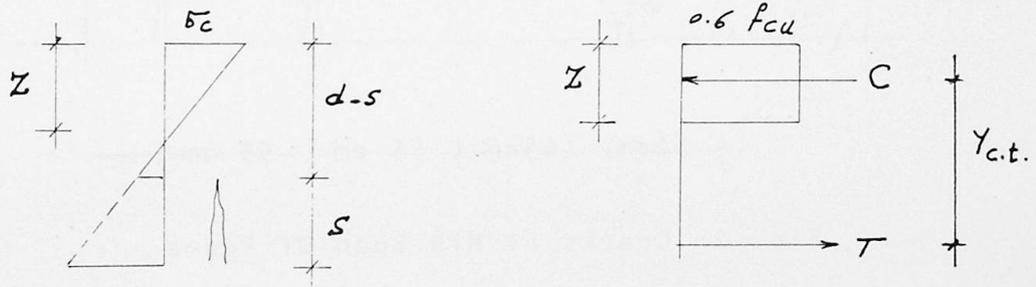
Fig. 3 Assumptions Of Stress Distribution

- In the first case, fig. 3a, the stress distribution was assumed to be linear. In this case it was assumed that the tensile stress at the level of the top end of the crack is equal to the tensile strength of the concrete which can be evaluated. The actual external moment applied on the section was calculated, i.e. it was known. Thus from first principals, the total compression was calculated which is equal to the total tension. The effective prestressing force was accordingly estimated.
- In the second case, fig. 3b, it was assumed that the compressive stress in

the concrete has reached about 0.6 of the ultimate cube strength with a non-linear stress distribution. In this analysis, the external moment is known which is equal to the total compression multiplied by the lever arm, $Y_{c.t.}$. Both the total compression and the lever arm are functions of the depth of the neutral axis, z . Hence, z was calculated and accordingly the effective prestressing force was calculated in a similar manner as in the first case.

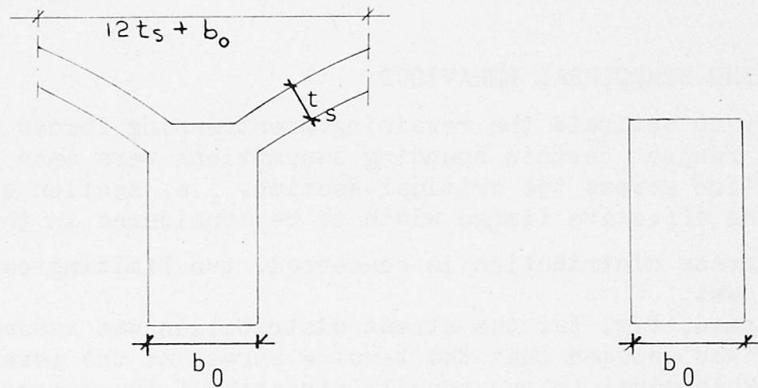
Fig. 4 Assumption Of Effective Flange Width Acting

- The beam was considered to be as a rectangular section without any flanges acting as shown in fig.4a. This case gave the highest value of loss of prestressing.
- The beam was considered to have an effective flange width equal to the web breadth plus twelve times the shell thickness as shown in fig. 4b.

It should be noted that the problem under consideration is not that straight forward and some engineering judgment had to be made. From the crack pattern in the valley beams together with the above mentioned calculations, it was estimated that a maximum loss of about 40% in the original prestressing force has taken place.
