Repair Works on the Main Pavilion at Tohdaiji Temple

Kiyoshi KANETA
Prof.
Kyoto University
Kyoto, Japan

The world's largest timber building, located at the Tohdaiji temple in Nara, Japan, underwent large scale repairs in the period 1905 to 1915 and again in the 1970s. The first major repair work might be especially interesting to structural and architectural engineers from the view-point of strengthening of building structures, because there have been a number of new ideas and practical applications used in the strengthening of decayed structural members and the joints of the building.

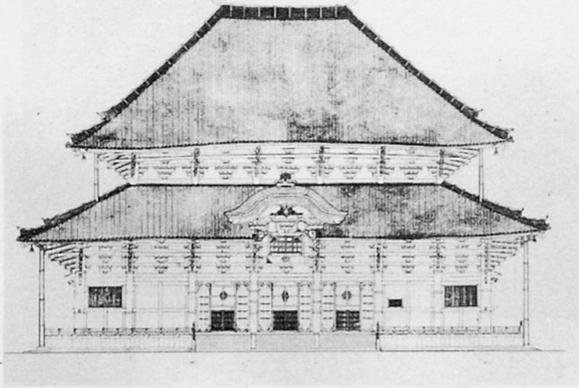
Fig.1 Front elevation in 1905

About 80 years ago, it was observed that the roof of the pavilion hang, its eaves had become wavy, and the large beams inside sagged down more than 30 cm. The reinforcing posts set up in the four corners of the pavilion to support the upper and lower roofs, barely prevented the building from collapse, and structurally the entire pavilion was in a very dangerous state. (Fig.1)

The so-called great repair work of the Meiji era (overhauling for repairs) on the main pavilion was carried out from 1905 through 1915. For this purpose,

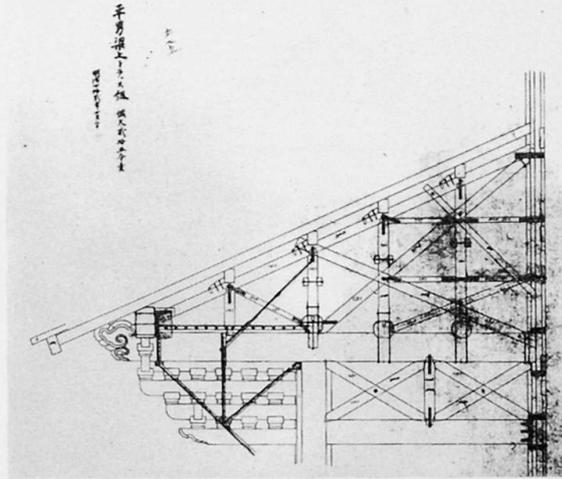
Fig.2 Reinforcement with steel

However, if we closely examine the outward appearance of the pavilion, particularly, the conditions of the square framings of the upper and lower roofs, we note that the flat steel bars which support the square framings from two sides on the outside are themselves bent and are protruding at many places. These steel bars were apparently provided to prevent square bearing blocks and bracket arms from being pushed outward at different places as the square framings and brackets are deformed under the weight of the roofs with long protruding eaves. However, so far as the results of these reinforcements are concerned, they did not necessarily achieve their purpose, and today these ugly-looking flat bars are still there without any structural contribution.

1. Tiles on the ridges of the roofs were fixed with mortar using Portland cement which was imported into Japan for the first time in the 1900s.
2. Flat steel bars were used for the protection and preservation of the square framings of eaves and brackets. (Fig.2)
3. Rafters and extended beams, which are structural members to support the upper and lower roofs, were reinforced by using steel shapes and thick steel plates.
4. Steel frames made of rolled I-beams and channels, together with plates and angles, were embedded in the central parts of the cross-sections of wooden columns to enable them to withstand the bending moments on the columns. (Fig.3)
5. Hot-formed rivets were used to fasten the steel materials.
6. Double Warren steel trusses were provided under the existing huge timber beams in order to strengthen the frame for the large roofs and to enable them to

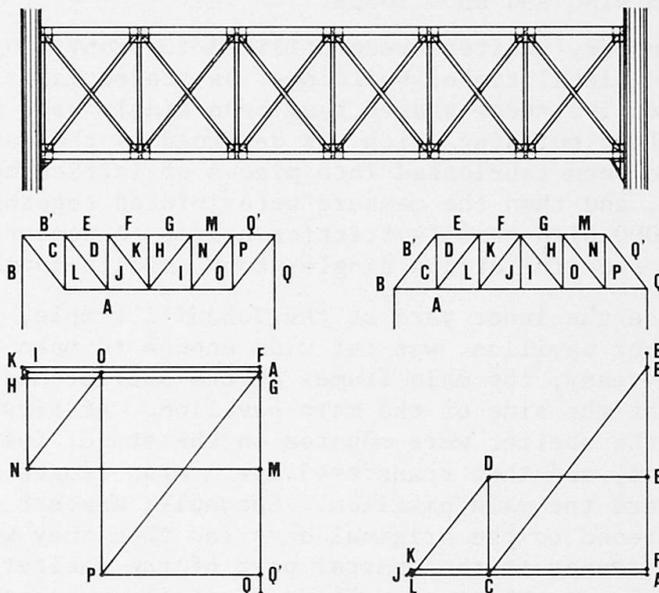
Fig.6 The truss and the results of solution

It may be interesting for structural engineers to see how the working stress on the members of the statically indeterminate trusses under the given vertical loads was obtained in that period of 75 years ago. As shown in Fig.6, there are the results obtained from graphical solutions of a Maxwell diagram for two trusses illustrated in the middle of the figure. It should be noticed that these two are the statically determinate trusses, and that each of them was looking like an elementary system of the double Warren trusses to be solved.

The result of the graphical solutions shows us that the Japanese engineer must have applied design vertical loads on both the elementary systems. After comparing the axial forces calculated for the members of the two statically determinate trusses with each other, he has adopted the larger value in either one of them as the stress for choosing cross-sections of the truss members.

Thus, we can say now that the engineer has tried his own approach of obtaining the approximate values of the working stress on his statically indeterminate structure, without consulting the theories of structures being developed in the European countries at that time. Nevertheless, the author has proved a number of years ago that his results were not inadequate but his values were different from the exact values by only 10.7 % toward the safe side.
