Artikel: Repair works on the main pavilion at Tohdaiji temple
Autor: Kaneta, Kiyoshi
DOI: <https://doi.org/10.5169/seals-35879>

Repair Works on the Main Pavilion at Tohdaiji Temple

Kiyoshi KANETA

SUMMARY

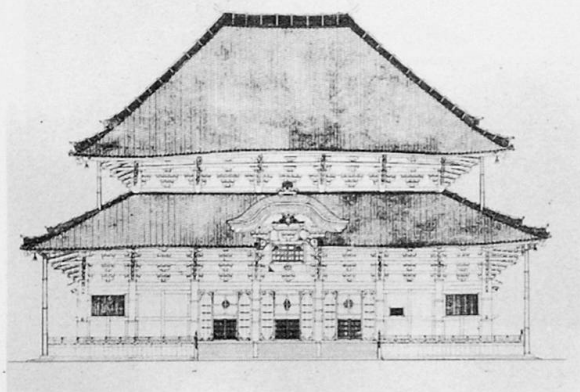
About 80 years ago, it was observed that the roof of the pavilion hang, its eaves had become wavy, and the large beams inside sagged down more than 30 cm. The reinforcing posts set up in the four corners of the pavilion to support the upper and lower roofs, barely prevented the building from collapse, and structurally the entire pavilion was in a very dangerous state. (Fig.1)

Fig.1 Front elevation in 1905

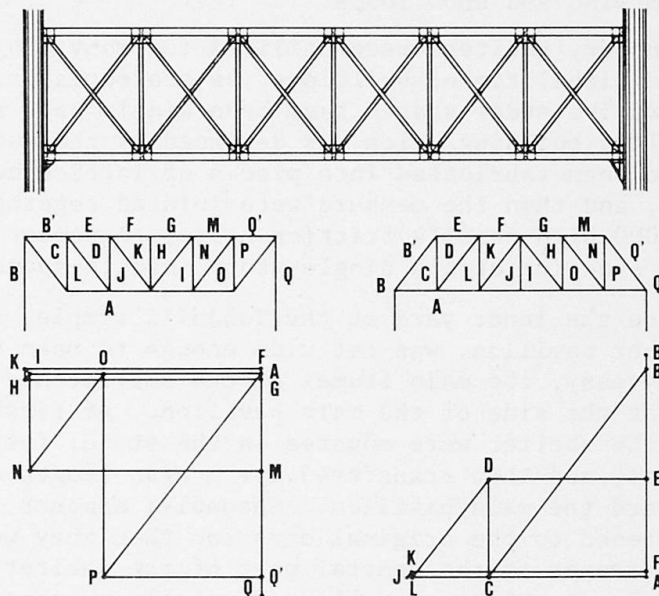
It may be interesting for structural engineers to see how the working stress on the members of the statically indeterminate trusses under the given vertical loads was obtained in that period of 75 years ago. As shown in Fig.6, there are the results obtained from graphical solutions of a Maxwell diagram for two trusses illustrated in the middle of the figure. It should be noticed that these two are the statically determinate trusses, and that each of them was looking like an elementary system of the double Warren trusses to be solved.

The result of the graphical solutions shows us that the Japanese engineer must have applied design vertical loads on both the elementary systems. After comparing the axial forces calculated for the members of the two statically determinate trusses with each other, he has adopted the larger value in either one of them as the stress for choosing cross-sections of the truss members.

Fig.6 The truss and the results of solution

Thus, we can say now that the engineer has tried his own approach of obtaining the approximate values of the working stress on his statically indeterminate structure, without consulting the theories of structures being developed in the European countries at that time. Nevertheless, the author has proved a number of years ago that his results were not inadequate but his values were different from the exact values by only 10.7 % toward the safe side.

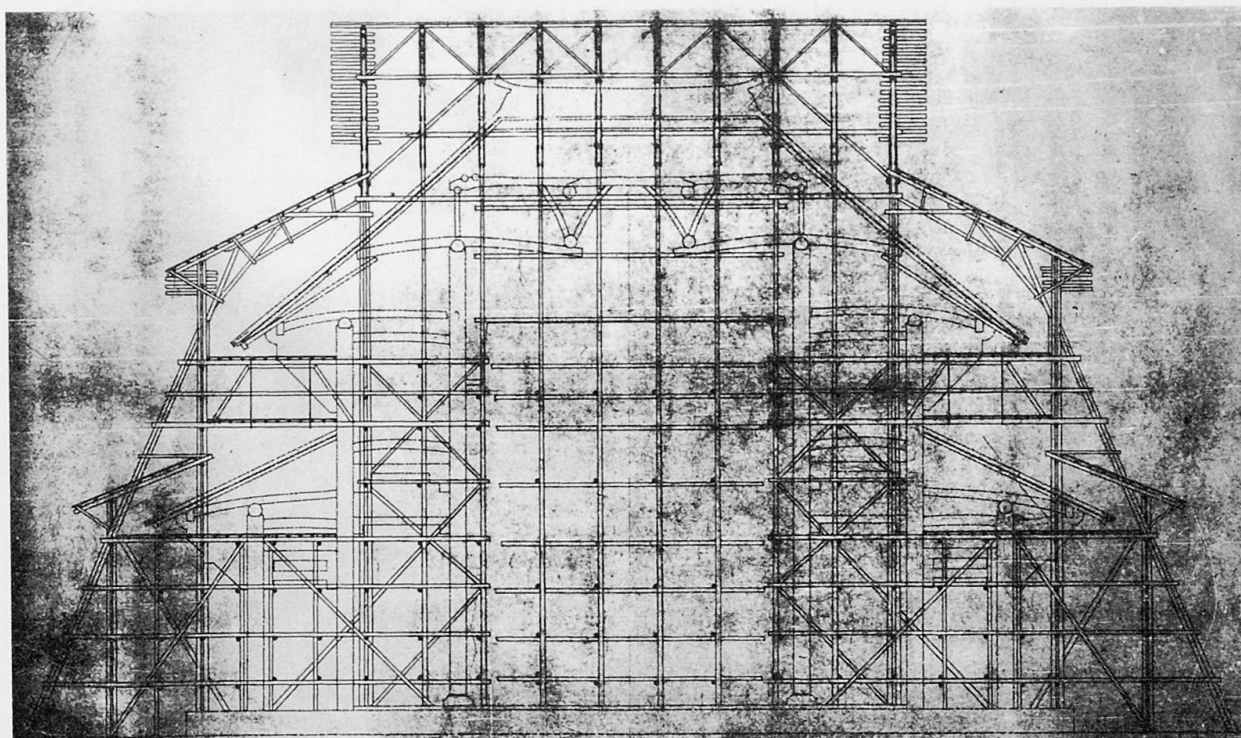
shelter built up for the large-scale repair work on the main pavilion of the Tohdaiji temple carried out in the period of 1905-15, showing us that the logs were used as the principal material and that how the shelter was assembled.

Fig.8 Section of the temporary shelter used for the project in 1905-15
