Collapse of the Bridge at Pulle

Daniël VANDEPITTE

The bridge at Pulle and its sudden failure after 8 years of service are described. The mechanism of the collapse is explained. As the investigation showed, the failure was due to the organizational set-up. The lessons that can be learnt from the collapse of the bridge at Pulle are not strikingly novel.

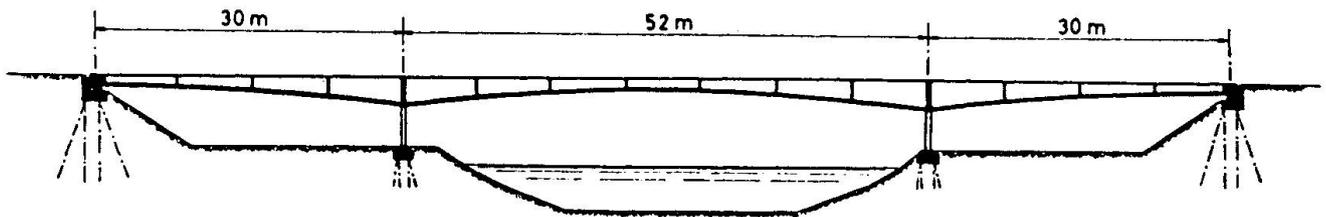
Fig. 1

The bridge at Pulle carried the Antwerp-Liège motorway across the Nete canal. Its spans were 30 m, 52 m and 30 m long (fig. 1). The concrete superstructure had 11 continuous prestressed longitudinal girders. The abutments and the piers were small concrete bodies supported by concrete piles. An unusual feature was the shortness of the piles under the piers: those under the east pier were only about 2.5 m long. This was due to the fact that a layer of sand was come upon which was so dense that the contractor was unable to drive the piles through it. The bridge at Pulle and 19 other bridges had been designed and built simultaneously under pressure of time in order to enable a section of the Antwerp-Liège motorway to be opened for traffic before a certain date. If the geotechnical report had reached the designers in good time they would probably have designed the piers with spread footings resting directly on the soil.

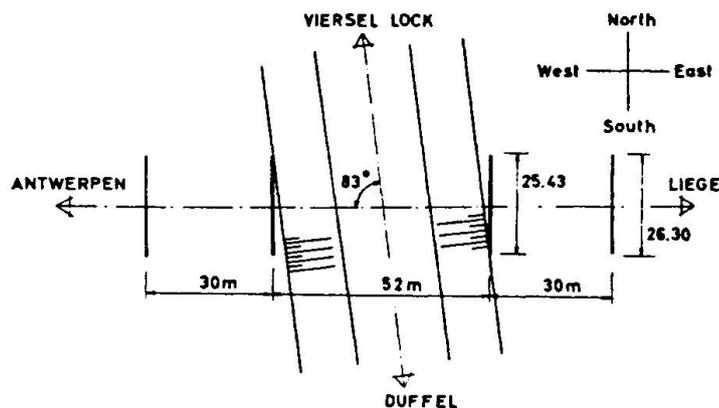
Fig. 2

The angle between the centre-line of the bridge and that of the canal was 83° (fig. 2). The centre of the east pier coincided at its southern end with the crest of the theoretical talus profile. Figure 3 is a vertical cross-section showing the relative position of the southern end of the east pier and the bank of the canal, drawn with its theoretical shape. The side slopes of the cutting were not protected by a lining of any kind. The newly completed bridge at Pulle was subjected to loading tests in September 1958. Its behaviour under a live load almost equivalent to the full (unfactored) design live load was entirely satisfactory.

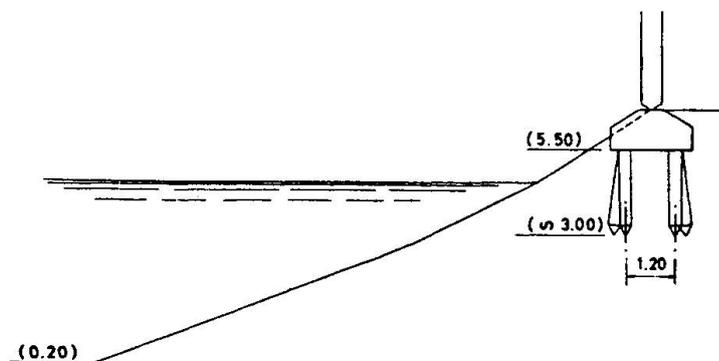
Fig. 3

The scour gradually removed the soil near the points of the left hand piles in figure 3. As a consequence the carrying capacity of those piles decreased. Figure 5b shows the configuration of the piles, the east pier and the concrete rocker bearing corresponding with an assumed 12 cm settlement of the piles on the canal side. The resulting inclination of the rocker increases the load acting on the left hand piles, thus accelerating the subsidence and the whole displacement of the body of the pier. Hence, once the settlement of the piles and the movement of the pier had begun, its horizontal displacement increased so rapidly that the foot of the rockers soon slid off the pier and that the main girders came crashing down.

- 1) Piles long enough to extend a few metres below the theoretical level of the bottom of the canal.
- 2) Canal banks efficiently protected against scour under the bridge and on either side of the bridge.

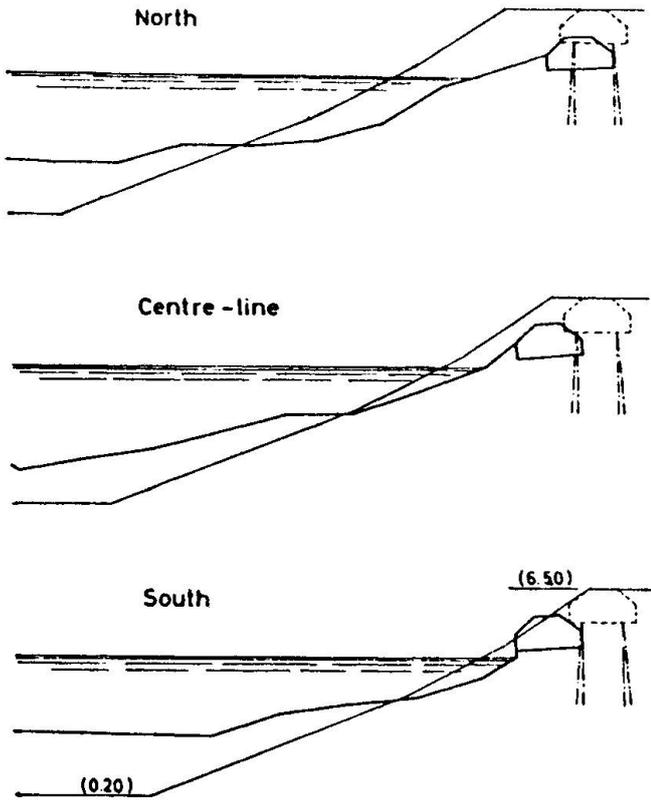
Fig. 4

possessed the necessary strength and that it had not been weakened by corrosion. Measurements revealed that the east pier had moved considerably towards the canal, settled and tilted. This is visible in figure 4, which consists of 3 cross-

sections and which shows the theoretical and the actual profiles of the canal, and the initial and the actual positions of the east pier. The amplitude of the displacement of the east pier was the greatest at its southern end.

The east talus of the canal was in very bad shape over the width of the bridge and also immediately to the south of it. The severe local scour which the east bank had undergone was mainly due to the proximity, just to the north of the bridge, of the Viersel navigation lock in the Nete canal. Barges awaiting their turn to lock through halted under the bridge or just to the south of the bridge, alongside of the east bank. When their turn came they started off and it is easy to imagine that the stir caused by their propellers a few metres from the bank slowly eroded the unprotected talus.

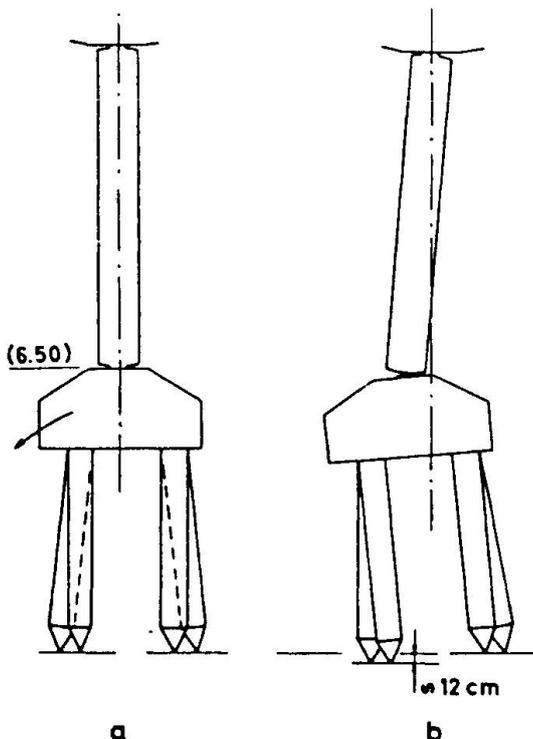
Fig. 5

So the cause of the collapse was erosion of the east bank of the canal in the immediate vicinity of the points of the canalside piles under the east pier. The bridge would not have failed if *either one* of the following situations had obtained :
