Collapse of the Bridge at Pulle

Daniël VANDEPITTE

The bridge at Pulle and its sudden failure after 8 years of service are described. The mechanism of the collapse is explained. As the investigation showed, the failure was due to the organizational set-up. The lessons that can be learnt from the collapse of the bridge at Pulle are not strikingly novel.

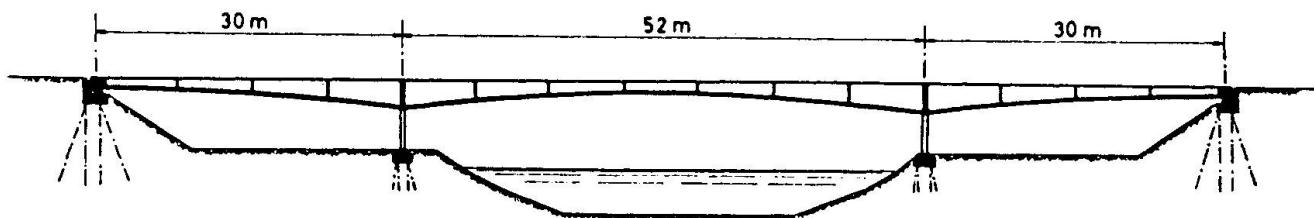
Fig. 1

The bridge at Pulle carried the Antwerp-Liège motorway across the Nete canal. Its spans were 30 m, 52 m and 30 m long (fig. 1). The concrete superstructure had 11 continuous prestressed longitudinal girders. The abutments and the piers were small concrete bodies supported by concrete piles. An unusual feature was the shortness of the piles under the piers : those under the east pier were only about 2.5 m long. This was due to the fact that a layer of sand was come upon which was so dense that the contractor was unable to drive the piles through it. The bridge at Pulle and 19 other bridges had been designed and built simultaneously under pressure of time in order to enable a section of the Antwerp-Liège motorway to be opened for traffic before a certain date. If the geotechnical report had reached the designers in good time they would probably have designed the piers with spread footings resting directly on the soil.

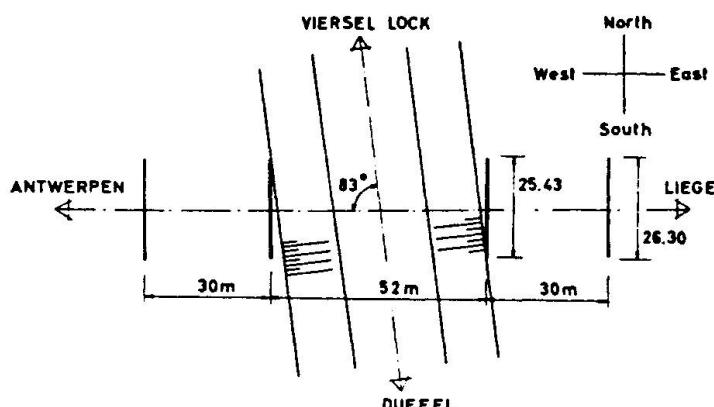
Fig. 2

The angle between the centre-line of the bridge and that of the canal was 83° (fig. 2). The centre of the east pier coincided at its southern end with the crest of the theoretical talus profile. Figure 3 is a vertical cross-section showing the relative position of the southern end of the east pier and the bank of the canal, drawn with its theoretical shape. The side slopes of the cutting were not protected by a lining of any kind. The newly completed bridge at Pulle was subjected to loading tests in September 1958. Its behaviour under a live load almost equivalent to the full (unfactored) design live load was entirely satisfactory.

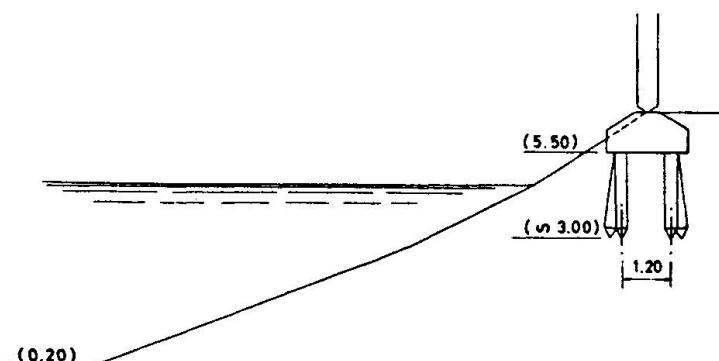
Fig. 3

The scour gradually removed the soil near the points of the left hand piles in figure 3. As a consequence the carrying capacity of those piles decreased. Figure 5b shows the configuration of the piles, the east pier and the concrete rocker bearing corresponding with an assumed 12 cm settlement of the piles on the canal side. The resulting inclination of the rocker increases the load acting on the left hand piles, thus accelerating the subsidence and the whole displacement of the body of the pier. Hence, once the settlement of the piles and the movement of the pier had begun, its horizontal displacement increased so rapidly that the foot of the rockers soon slid off the pier and that the main girders came crashing down.

So the cause of the collapse was erosion of the east bank of the canal in the immediate vicinity of the points of the canalside piles under the east pier. The bridge would not have failed if *either one* of the following situations had obtained :

- 1) Piles long enough to extend a few metres below the theoretical level of the bottom of the canal.
- 2) Canal banks efficiently protected against scour under the bridge and on either side of the bridge.

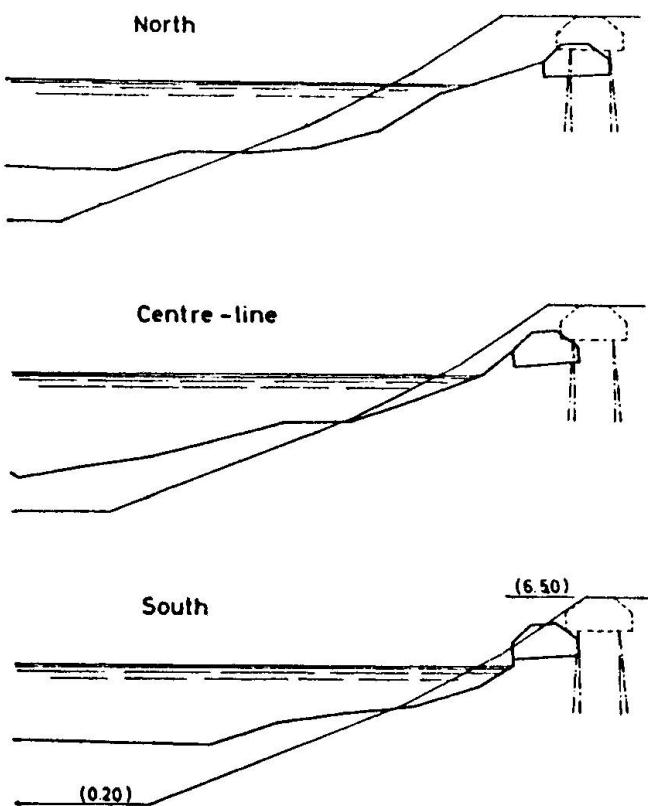
Fig. 4

possessed the necessary strength and that it had not been weakened by corrosion. Measurements revealed that the east pier had moved considerably towards the canal, settled and tilted. This is visible in figure 4, which consists of 3 cross-

sections and which shows the theoretical and the actual profiles of the canal, and the initial and the actual positions of the east pier. The amplitude of the displacement of the east pier was the greatest at its southern end.

The east talus of the canal was in very bad shape over the width of the bridge and also immediately to the south of it. The severe local scour which the east bank had undergone was mainly due to the proximity, just to the north of the bridge, of the Viersel navigation lock in the Nete canal. Barges awaiting their turn to lock through halted under the bridge or just to the south of the bridge, alongside of the east bank. When their turn came they started off and it is easy to imagine that the stir caused by their propellers a few metres from the bank slowly eroded the unprotected talus.
