Artikel: Collapse of the bridge at Pulle

Collapse of the Bridge at Pulle

Daniël VANDEPITTE Professor Ghent University Ghent, Belgium

SUMMARY

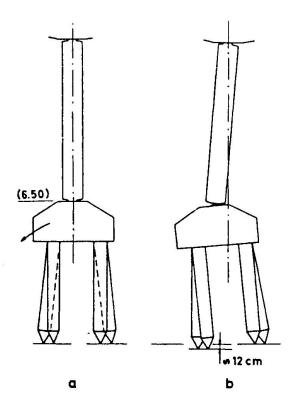
Fig. 4

possessed the necessary strength and that it had not been weakened by corrosion. Measurements revealed that the east pier had moved considerably towards the canal, settled and tilted. This is visible in figure 4, which consists of 3 cross-

sections and which shows the theoretical and the actual profiles of the canal, and the initial and the actual positions of the east pier. The amplitude of the displacement of the east pier was the greatest at its southern end.

The east talus of the canal was in very bad shape over the width of the bridge and also immediately to the south of it. The severe local scour which the east bank had undergone was mainly due to the proximity, just to the north of the bridge, of the Viersel navigation lock in the Nete canal. Barges awaiting their turn to lock through halted under the bridge or just to the south of the bridge, alongside of the east bank. When their turn came they started off and it is easy to imagine that the stir caused by their propellers a few metres from the bank slowly eroded the unprotected talus.

- Piles long enough to extend a few metres below the theoretical level of the bottom of the canal.
- Canal banks efficiently protected against scour under the bridge and on either side of the bridge.
