**Artikel:** Additional insulation of flat roofs with thin-walled metal structures

Autor: Höglund, Ingemar / Andersson, Patrick

# Additional Insulation of Flat Roofs with Thin-Walled Metal Structures

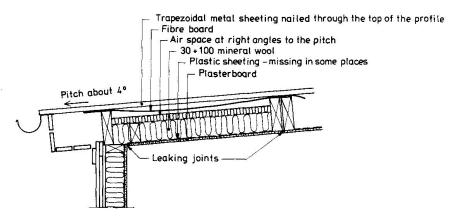
Fig. 3 The roof construction consists of prefabricated elements. Owing to leaks at the joints the inside air was able to leak into the construction, where it condensed against the metal sheeting. Outside moisture was also able to penetrate the roof. Owing to swelling from damp the fibre boarding hung down blocking the vented air space.

Fig. 4 Rebuilt roof. The ventilation was closed off. As the joints in the metal sheeting were not tight, a sheet of roofing felt was laid on the metal as a vapour barrier. The additional insulation was nailed on.

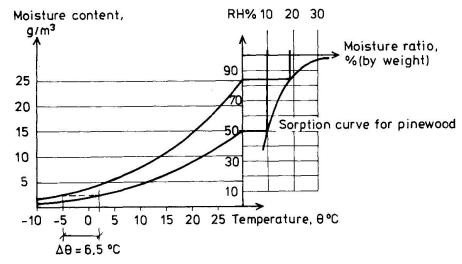
Fig. 5b The measurements in February -84 for the roof without additional insulation showed a moisture ratio of c. 18%, which corresponds to a relative humidity of 85% in the ventilation channel. The temperature in the air space was  $-5^{\circ}$ C. In the additionally insulated roofs the additional insulation resulted in the temperature rising to +1.5°C. With the same vapour content as for the roof without additional insulation this gives a relative humidity of 50% in the air space. This corresponds to a moisture ratio of c. 10%, which agrees with the value obtained (see Fig. 5a). Theory and practice agree nicely.

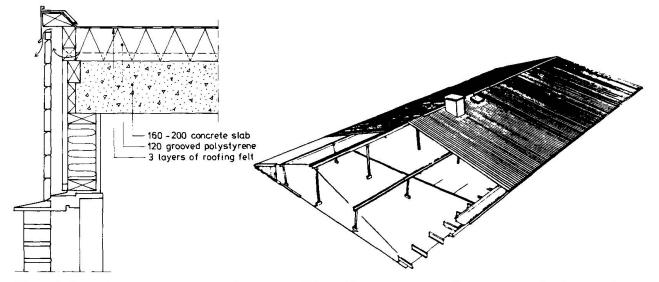
After a time moisture patches appeared on the ceilings and inner walls. The damage was caused by moisture penetrating from outside. Owing to initial shrinking and temperature movement in the polystyrene slabs gaps appeared between these slabs. The roofing felt then split above the gaps and water was able to penetrate the roof.

Fig. 9 Attachment to eaves of original roof.

Fig. 10 New strutted outer roof of metal sheeting with a 14° pitch. The roof was additionally insulated with 120 mm of mineral wool. The original internal drainage was closed off. The new roof was provided at the eaves with guttering connected to the storm-water drainage system.
