Additional Insulation of Flat Roofs with Thin-Walled Metal Structures

Ingemar HÖGLUND

Patrick ANDERSSON

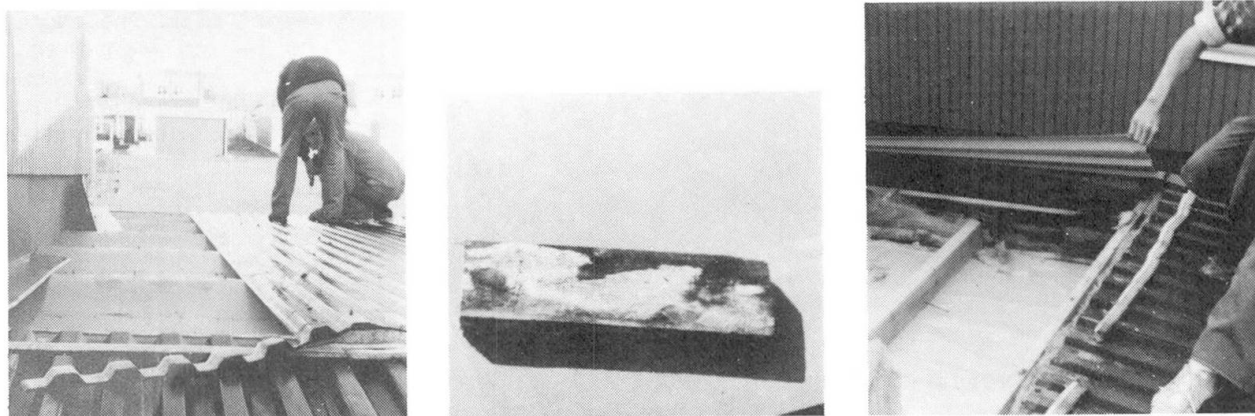
Fig. 1 Moisture damaged flat roof with metal sheeting. Moisture penetration from both the inside and the outside. The fibre board hung down, thus blocking the vented air space. The moisture content in the construction increased and caused mould and rot damage. (Example 1.)

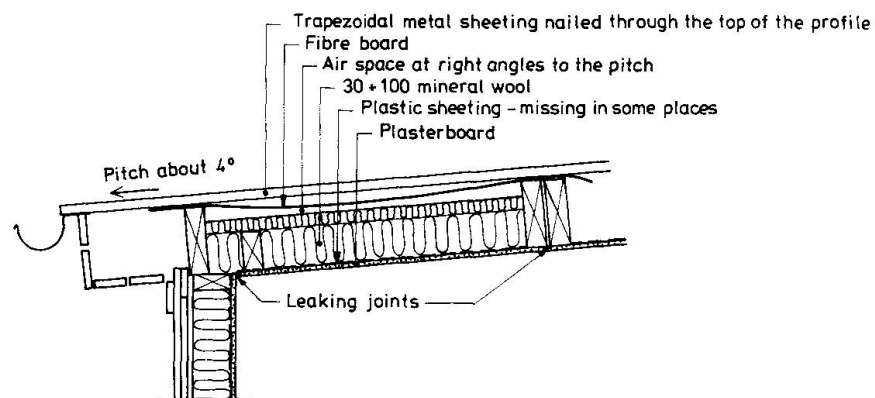
The investigation covered an estate of terraced houses in central Sweden built in 1973-74, comprising about 100 houses. The roof covering is metal sheeting and the pitch is only about 4° . The roof is ventilated and the ventilation is at right angles to the pitch. For the original roof construction and rebuilt roof see Figs 3 and 4. During the very first winter moisture patches appeared in the roof and walls. We established that the damage was due to moisture penetrating from both within and without.

Fig. 3 The roof construction consists of prefabricated elements. Owing to leaks at the joints the inside air was able to leak into the construction, where it condensed against the metal sheeting. Outside moisture was also able to penetrate the roof. Owing to swelling from damp the fibre boarding hung down blocking the vented air space.

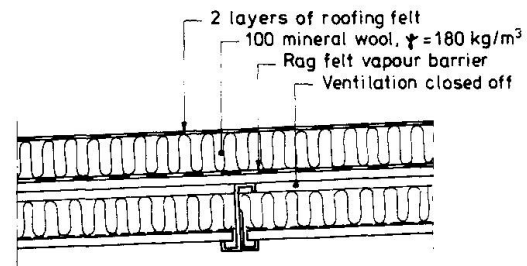
During the winter months dripping from the ceiling caused a problem. This was due to moisture transport by air convection caused by leaks between the vapour barrier in the ceiling and the structural beams. Since the construction does not contain organic material, damage to the ceiling was restricted to impaired heat

Fig. 7 Roof construction after rebuilding. A vapour barrier of rag felt was glued to the roof to prevent air convection. Dripping from the ceiling has stopped.

After additional insulation of the roof in spring 1983 dripping from the ceiling stopped and the roof now functions perfectly. Moisture and temperature are measured in the roof to check the moisture content there. See Fig. 8.

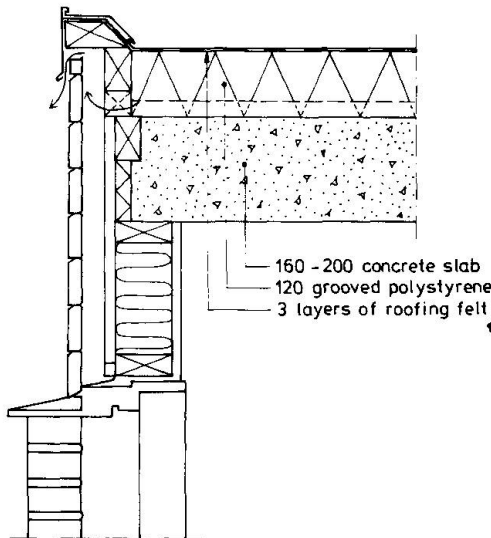
Fig. 9 Attachment to eaves of original roof.

After a time moisture patches appeared on the ceilings and inner walls. The damage was caused by moisture penetrating from outside. Owing to initial shrinking and temperature movement in the polystyrene slabs gaps appeared between these slabs. The roofing felt then split above the gaps and water was able to penetrate the roof.

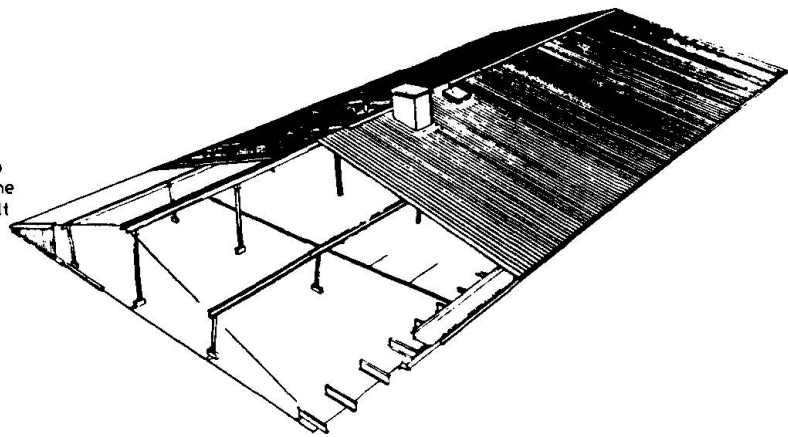
In order to fasten the steel construction to the concrete slab holes were cut in the weatherproofing and insulation. After raising the construction these holes were made watertight. In one row of houses the work was done unsatisfactorily, since rainwater penetrated the roof before the metal sheeting was placed in position. Thus, it is of the greatest importance that the holes are made watertight with great care, as even the smallest holes can lead to serious water leaks.

In summer 1984 the roofs were rebuilt as strutted roofs covered with metal sheeting. The sheeting was fastened to a steel construction which was in turn fastened to the concrete frame with expander bolts. See Fig. 10.

Fig. 10 New strutted outer roof of metal sheeting with a 14° pitch. The roof was additionally insulated with 120 mm of mineral wool. The original internal drainage was closed off. The new roof was provided at the eaves with guttering connected to the storm-water drainage system.

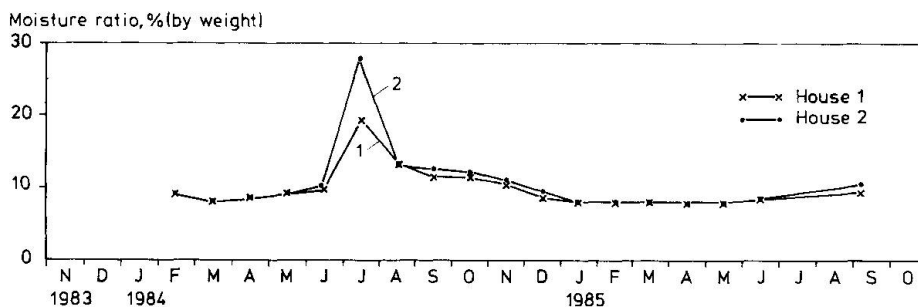
Fig. 11 Example of results. Moisture is measured by means of built-in wooden rounds placed between the concrete slab and the cellular plastic insulation. The large increase in the moisture ratio in June-July was caused by the leaks in connection with raising the steel construction. Apart from this incident the moisture ratio has remained during the whole period at an even and low level (8-10%). The moisture ratio values refer to the moisture ratio in the moisture-measuring gauges.
