Additional Insulation of Flat Roofs with Thin-Walled Metal Structures

Ingemar HÖGLUND

Patrick ANDERSSON

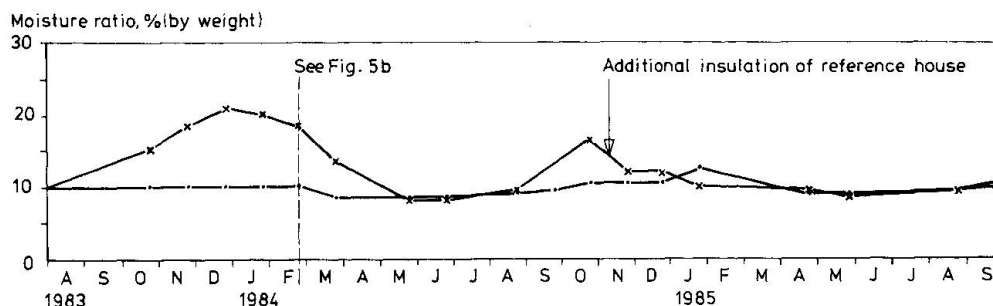
Fig. 5a Example of results. Moisture and temperature measured in three houses at the fibre board. Two houses additionally insulated and instrumented in summer 1983; the third house acted as a reference house and was not insulated until November 1984. During the winter of 1983-84 the effect of these measures could clearly be observed. In the additionally insulated roofs the moisture ratio remained at a low level, c. 10% during the whole period. In the house without additional insulation, however, the moisture ratio rose during the autumn and winter and reached its highest level c. 20% in Dec.-Jan. During the warm spring of -84 the roof dried out and the moisture ratio dropped to about 8%. During the autumn of -84 the moisture ratio rose again, only to drop immediately after the roof was additionally insulated in November -84. Since additional insulation all the roofs have had a low moisture ratio.

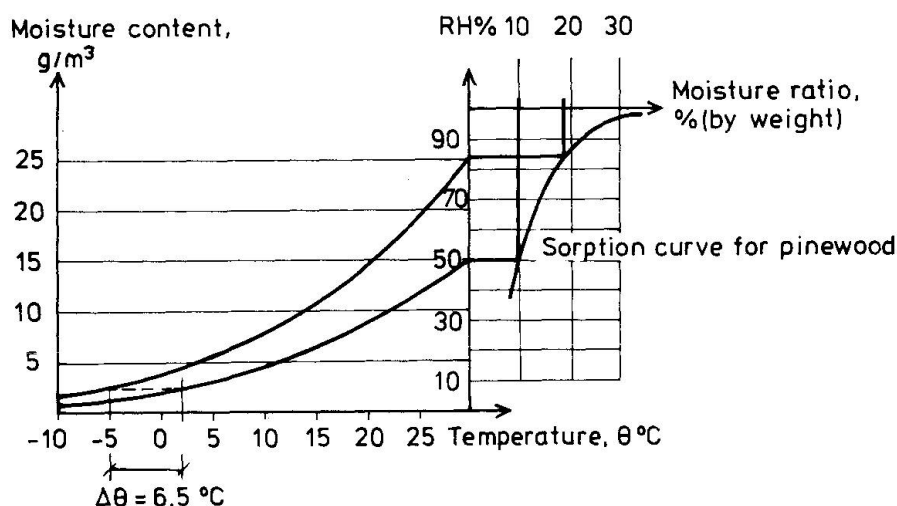
Fig. 5b The measurements in February -84 for the roof without additional insulation showed a moisture ratio of c. 18%, which corresponds to a relative humidity of 85% in the ventilation channel. The temperature in the air space was -5°C. In the additionally insulated roofs the additional insulation resulted in the temperature rising to +1.5°C. With the same vapour content as for the roof without additional insulation this gives a relative humidity of 50% in the air space. This corresponds to a moisture ratio of c. 10%, which agrees with the value obtained (see Fig. 5a). Theory and practice agree nicely.

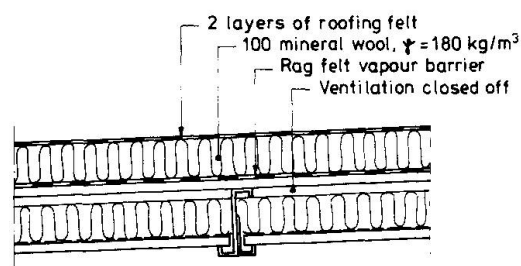
During the winter months dripping from the ceiling caused a problem. This was due to moisture transport by air convection caused by leaks between the vapour barrier in the ceiling and the structural beams. Since the construction does not contain organic material, damage to the ceiling was restricted to impaired heat

Fig. 7 Roof construction after rebuilding. A vapour barrier of rag felt was glued to the roof to prevent air convection. Dripping from the ceiling has stopped.

After additional insulation of the roof in spring 1983 dripping from the ceiling stopped and the roof now functions perfectly. Moisture and temperature are measured in the roof to check the moisture content there. See Fig. 8.

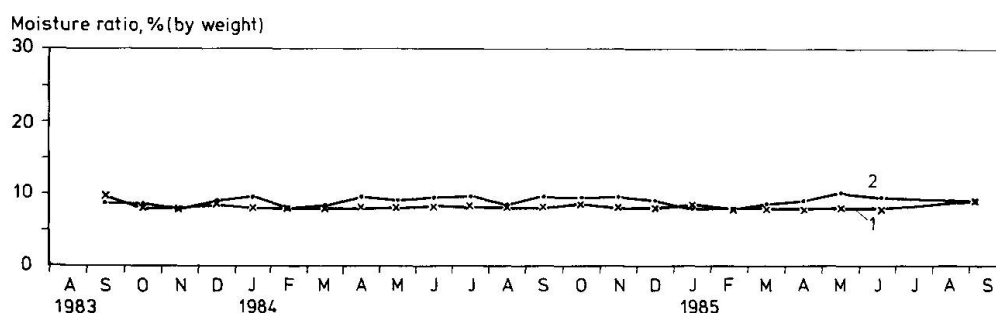
Fig. 8 Example of results. Moisture and temperature are measured both in the air space, line 1 and immediately below the new weatherproof layer, line 2. Since additionally insulating the roof the moisture ratio in the roof has remained for the whole period at a low level, c. 8% in the air space and c. 10% under the new weatherproofing. However, the moisture ratio at one of the measurement points immediately below the new weatherproofing was c. 20%, which indicates that moisture has been enclosed. Moisture is measured by means of built-in moisture-measure gauges; figures refer to the moisture ratio in these rounds.

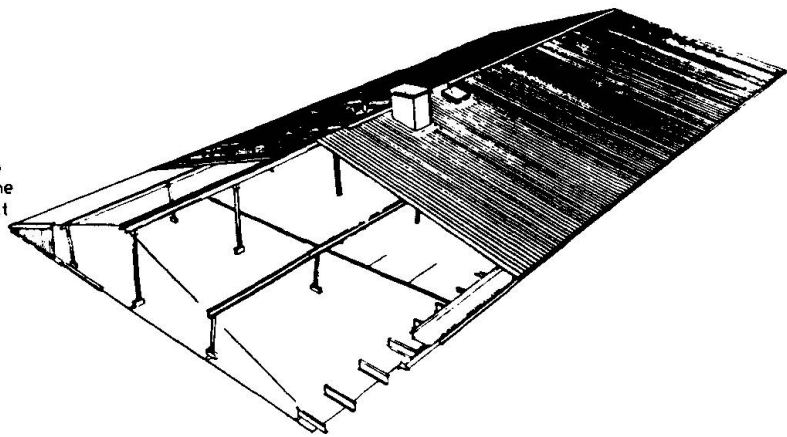
In order to fasten the steel construction to the concrete slab holes were cut in the weatherproofing and insulation. After raising the construction these holes were made watertight. In one row of houses the work was done unsatisfactorily, since rainwater penetrated the roof before the metal sheeting was placed in position. Thus, it is of the greatest importance that the holes are made watertight with great care, as even the smallest holes can lead to serious water leaks.

In summer 1984 the roofs were rebuilt as strutted roofs covered with metal sheeting. The sheeting was fastened to a steel construction which was in turn fastened to the concrete frame with expander bolts. See Fig. 10.

Fig. 10 New strutted outer roof of metal sheeting with a 14° pitch. The roof was additionally insulated with 120 mm of mineral wool. The original internal drainage was closed off. The new roof was provided at the eaves with guttering connected to the storm-water drainage system.
