Additional insulation of flat roofs with thin-walled metal structures

Autor(en): **Höglund, Ingemar / Andersson, Patrick**

Zeitschrift: **IABSE reports = Rapports AIPC = IVBH Berichte**

Band (Jahr): **49 (1986)**

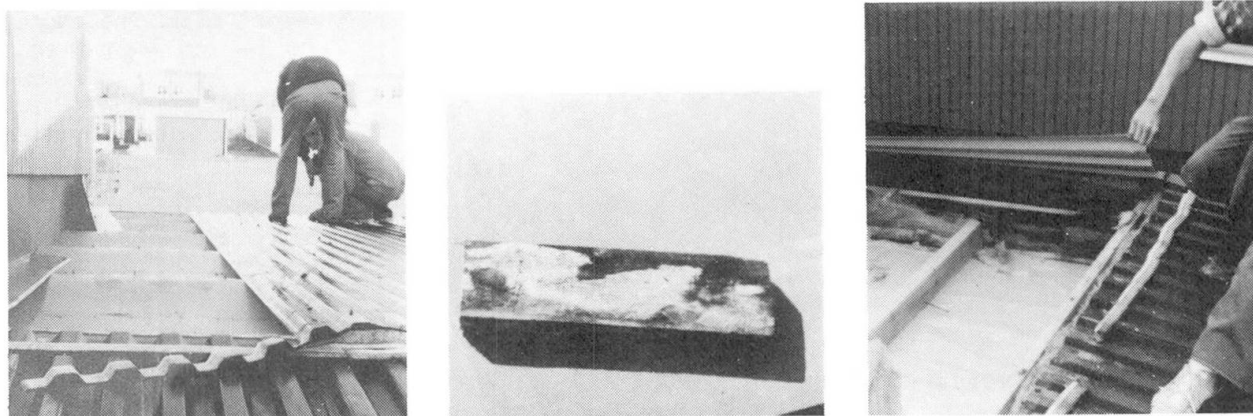
Fig. 1 Moisture damaged flat roof with metal sheeting. Moisture penetration from both the inside and the outside. The fibre board hung down, thus blocking the vented air space. The moisture content in the construction increased and caused mould and rot damage. (Example 1.)

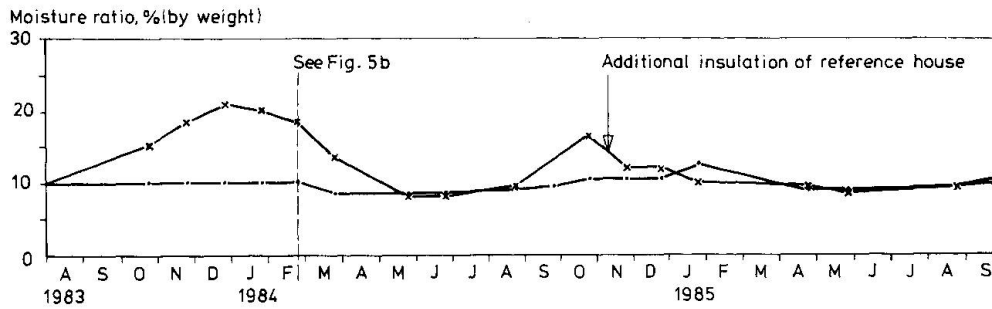
Fig. 5a Example of results. Moisture and temperature measured in three houses at the fibre board. Two houses additionally insulated and instrumented in summer 1983; the third house acted as a reference house and was not insulated until November 1984. During the winter of 1983-84 the effect of these measures could clearly be observed. In the additionally insulated roofs the moisture ratio remained at a low level, c. 10% during the whole period. In the house without additional insulation, however, the moisture ratio rose during the autumn and winter and reached its highest level c. 20% in Dec.-Jan. During the warm spring of -84 the roof dried out and the moisture ratio dropped to about 8%. During the autumn of -84 the moisture ratio rose again, only to drop immediately after the roof was additionally insulated in November -84. Since additional insulation all the roofs have had a low moisture ratio.

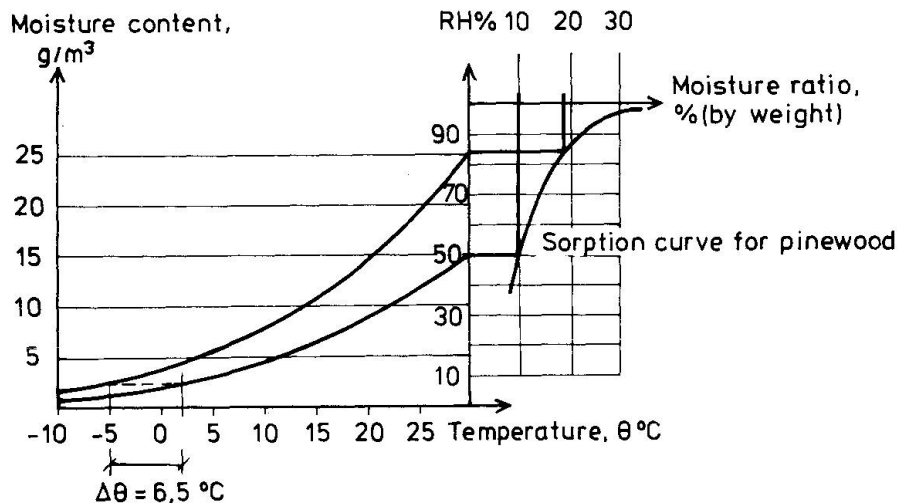
Fig. 5b The measurements in February -84 for the roof without additional insulation showed a moisture ratio of c. 18%, which corresponds to a relative humidity of 85% in the ventilation channel. The temperature in the air space was -5°C . In the additionally insulated roofs the additional insulation resulted in the temperature rising to $+1.5^{\circ}\text{C}$. With the same vapour content as for the roof without additional insulation this gives a relative humidity of 50% in the air space. This corresponds to a moisture ratio of c. 10%, which agrees with the value obtained (see Fig. 5a). Theory and practice agree nicely.

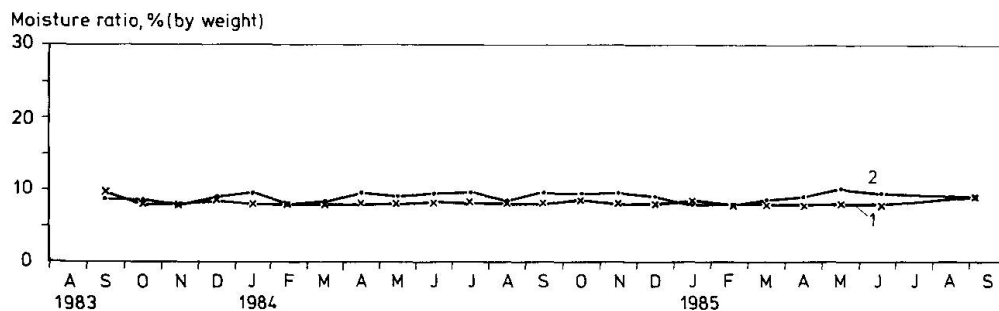
Fig. 8 Example of results. Moisture and temperature are measured both in the air space, line 1 and immediately below the new weatherproof layer, line 2. Since additionally insulating the roof the moisture ratio in the roof has remained for the whole period at a low level, c. 8% in the air space and c. 10% under the new weatherproofing. However, the moisture ratio at one of the measurement points immediately below the new weatherproofing was c. 20%, which indicates that moisture has been enclosed. Moisture is measured by means of built-in moisture-measure gauges; figures refer to the moisture ratio in these rounds.
