**Zeitschrift:** IABSE reports = Rapports AIPC = IVBH Berichte  
**Band:** 49 (1986)

**Artikel:** Additional insulation of flat roofs with thin-walled metal structures  
**Autor:** Höglund, Ingemar / Andersson, Patrick  
**DOI:** <https://doi.org/10.5169/seals-38324>

## **Additional Insulation of Flat Roofs with Thin-Walled Metal Structures**

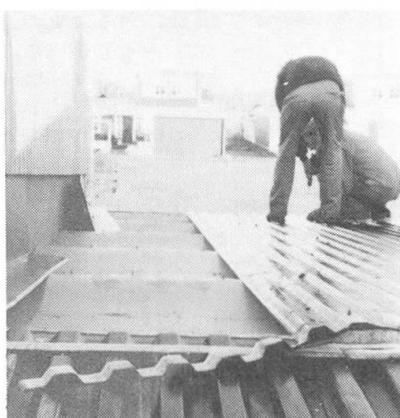
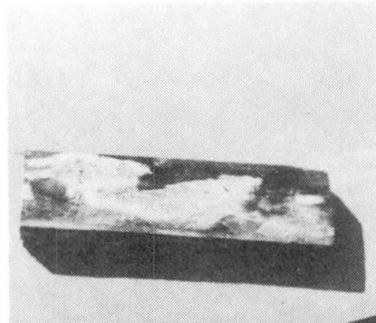
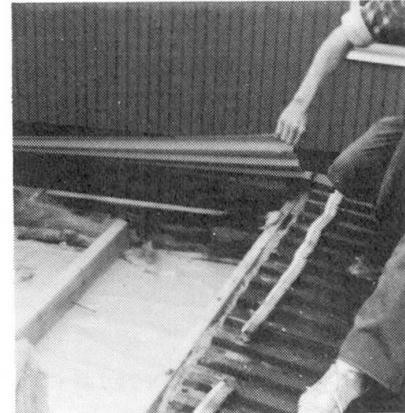
**Fig. 1** Moisture damaged flat roof with metal sheeting. Moisture penetration from both the inside and the outside. The fibre board hung down, thus blocking the vented air space. The moisture content in the construction increased and caused mould and rot damage. (Example 1.)

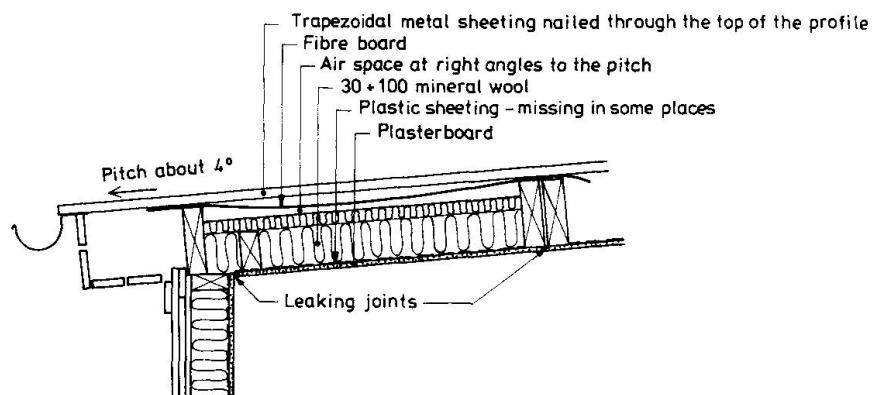
The investigation covered an estate of terraced houses in central Sweden built in 1973-74, comprising about 100 houses. The roof covering is metal sheeting and the pitch is only about  $4^\circ$ . The roof is ventilated and the ventilation is at right angles to the pitch. For the original roof construction and rebuilt roof see Figs 3 and 4. During the very first winter moisture patches appeared in the roof and walls. We established that the damage was due to moisture penetrating from both within and without.

Fig. 3 The roof construction consists of prefabricated elements. Owing to leaks at the joints the inside air was able to leak into the construction, where it condensed against the metal sheeting. Outside moisture was also able to penetrate the roof. Owing to swelling from damp the fibre boarding hung down blocking the vented air space.

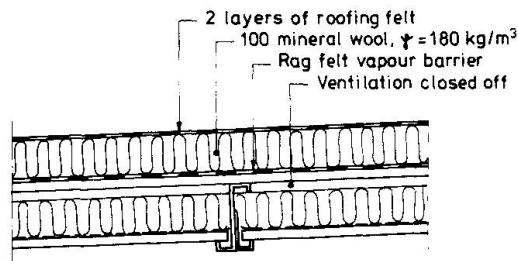
During the winter months dripping from the ceiling caused a problem. This was due to moisture transport by air convection caused by leaks between the vapour barrier in the ceiling and the structural beams. Since the construction does not contain organic material, damage to the ceiling was restricted to impaired heat

**Fig. 7** Roof construction after rebuilding. A vapour barrier of rag felt was glued to the roof to prevent air convection. Dripping from the ceiling has stopped.

After additional insulation of the roof in spring 1983 dripping from the ceiling stopped and the roof now functions perfectly. Moisture and temperature are measured in the roof to check the moisture content there. See Fig. 8.

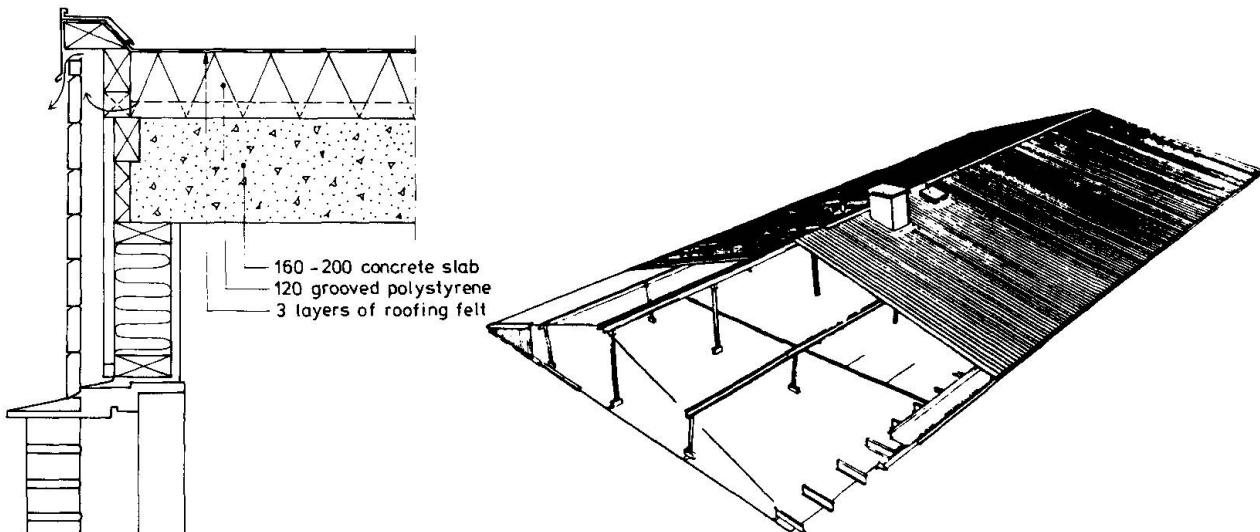
After a time moisture patches appeared on the ceilings and inner walls. The damage was caused by moisture penetrating from outside. Owing to initial shrinking and temperature movement in the polystyrene slabs gaps appeared between these slabs. The roofing felt then split above the gaps and water was able to penetrate the roof.

Fig. 9 Attachment to eaves of original roof.

In summer 1984 the roofs were rebuilt as strutteted roofs covered with metal sheeting. The sheeting was fastened to a steel construction which was in turn fastened to the concrete frame with expander bolts. See Fig. 10.

In order to fasten the steel construction to the concrete slab holes were cut in the weatherproofing and insulation. After raising the construction these holes were made watertight. In one row of houses the work was done unsatisfactorily, since rainwater penetrated the roof before the metal sheeting was placed in position. Thus, it is of the greatest importance that the holes are made watertight with great care, as even the smallest holes can lead to serious water leaks.

Fig. 10 New strutteted outer roof of metal sheeting with a  $14^\circ$  pitch. The roof was additionally insulated with 120 mm of mineral wool. The original internal drainage was closed off. The new roof was provided at the eaves with guttering connected to the storm-water drainage system.

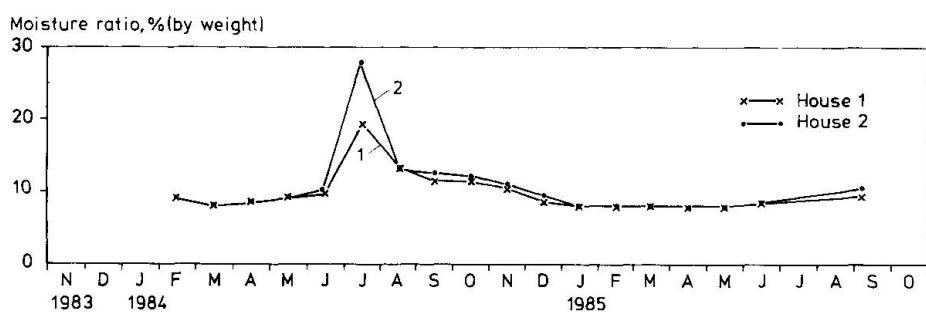
Fig. 11 Example of results. Moisture is measured by means of built-in wooden rounds placed between the concrete slab and the cellular plastic insulation. The large increase in the moisture ratio in June-July was caused by the leaks in connection with raising the steel construction. Apart from this incident the moisture ratio has remained during the whole period at an even and low level (8-10%). The moisture ratio values refer to the moisture ratio in the moisture-measuring gauges.
