TSING YI SOUTH BRIDGE  
ASSESSMENT AND REHABILITATION

### A.S. BEARD

### H.S.S. TUNG

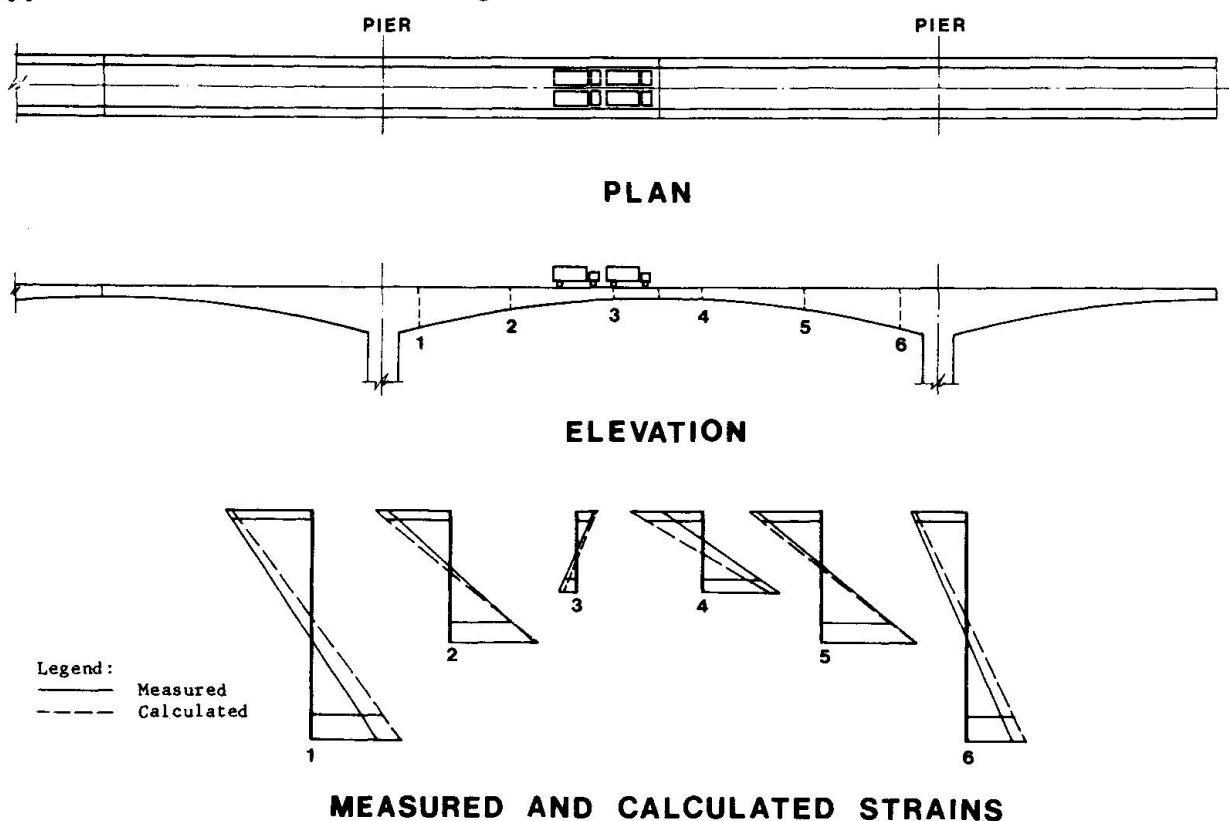
Figure 2

Next, vibrating wire strain gauges were attached to the concrete surface at three cross-sections on each of the two cantilevers and a series of load tests were carried out. In these tests four fully laden bulk cement carriers were parked on the deck in various patterns and readings of the strain gauges were taken. The deck was also levelled. Upon removal of each test loading the superstructure quickly rebounded to its original level. The results of analyses of the bridge under the various loading patterns agreed well with the test readings, and it was concluded that the bridge was behaving elastically. Typical results are shown in Figure 2.

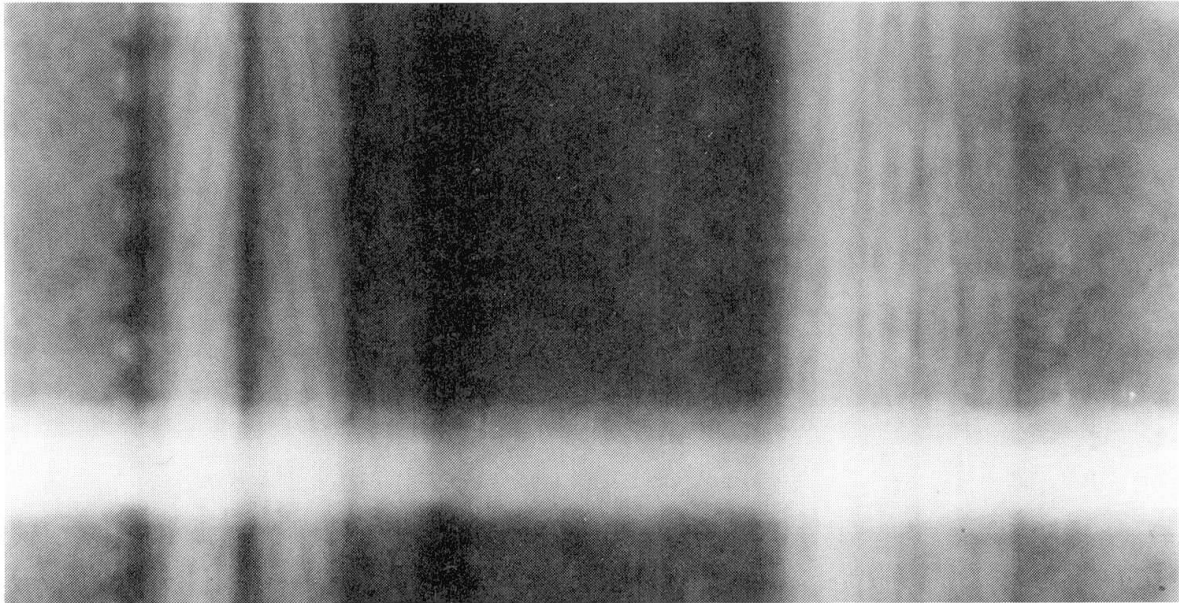
**Figure 3**

In order to establish that all the design prestressing tendons were present, and also to check on their condition a radiographic inspection was carried out using a Cobalt 60, 30 currie source. Radiographic plates were taken at sections across the top flange at five metre centres. However, where necessary additional plates were taken at intermediate locations. From this inspection it was concluded that all the design prestressing tendons were present but that approximately ten per cent were either partially or completely ungrouted. No signs of deterioration of either tendons or ducts were detected. A section of a typical plate showing grouted and ungrouted ducts is shown in Figure 3.
