Zeitschrift: IABSE reports = Rapports AIPC = IVBH Berichte
Band: 52 (1986)

Artikel: Fatigue damage and repair of steel railway bridges in Japan
Autor: Abe, Hidehiko / Sakamoto, Kenji / Abe, Makoto
DOI: <https://doi.org/10.5169/seals-40343>

FATIGUE DAMAGE AND REPAIR OF STEEL RAILWAY BRIDGES IN JAPAN

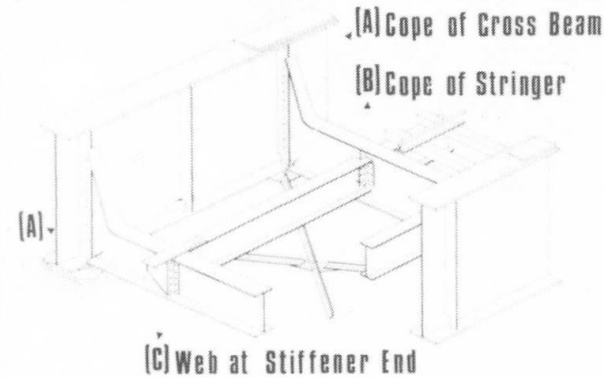
Fatigue damages have been occasionally experienced in structural details of railway bridges, because relatively large train loading is repeated in many cycles. Fig. 1 shows a schematic of the through type steel railway bridge and locations of fatigue cracks, as an example.

THROUGH TYPE GIRDER AND CRACK LOCATIONS

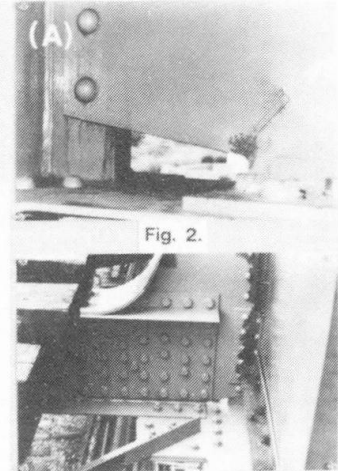
Failure Mode: A crack is originated at the cope corner or the toe of fillet weld at the cope formed for connection with the main girder. It develops diagonally in the web plate, as shown in Fig. 2. It occurs even in case the lower flange of the main girder and that of the cross beam are connected with each other.

Cause: Both insufficiency of resisting moment of the beam due to the coping and local stress concentration are the causes of crack.

As seen in Fig. 2 in Poster, a crack initiated from the cope at the lower corner of floor beam of a through girder bridge. Such cracks have occurred in a few end floor beams and one intermediate floor beam. Their lower flanges were connected by gusset plates with those of the main girders. Fig. I shows an example of the stress variation during passage of a train in the vicinity of the cope. Then, half-scale models, in which the horizontal lengths

Repair: The web plate of the cross beam is locally reinforced by bolting additional plates, as shown in Fig. 3.

In the damaged floor beams holes were drilled at the tips of fatigue cracks in order to relieve the stress and steel plates were attached by high-strength-bolts, as shown in Fig. 3 in Poster. The details of currently designed bridges have been improved as illustrated in Fig. III. The whole width of at least a half width of the lower flange of floor beam is extended to its end.

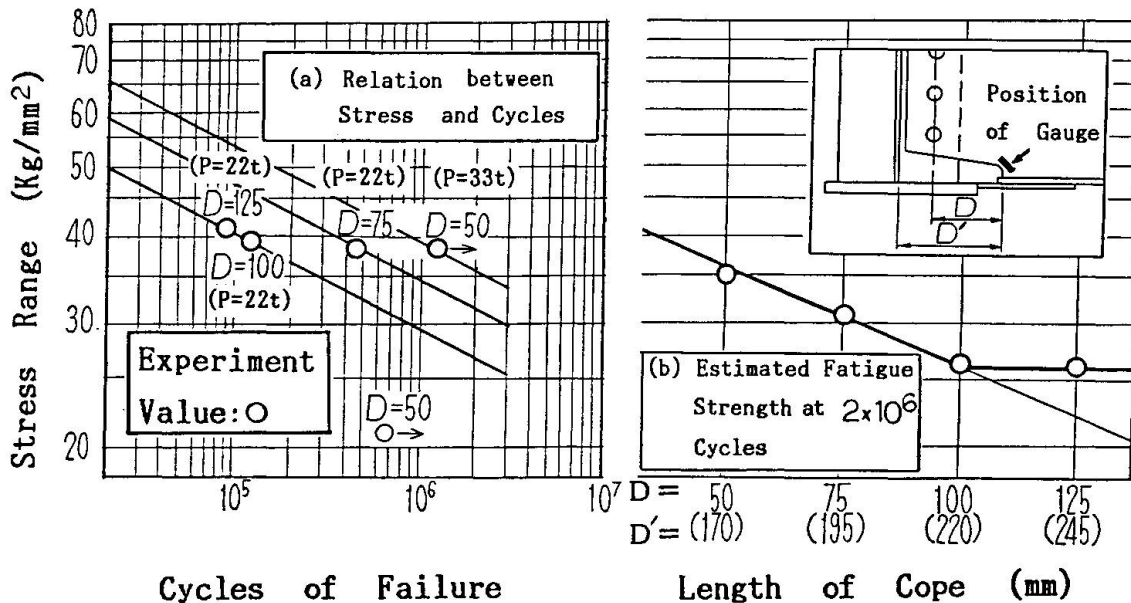
Fig. II Fatigue Strength of Coped Portion of Floor Beam

of the copes were varied, were tested under repeated loading and developed the same kind of crack as seen in the actual bridges. Both the FEM analysis and the model test revealed that the local tensile stress along the periphery of the cope became greater and consequently the fatigue strength decreased, as the cope length increased, as shown in Fig. II.

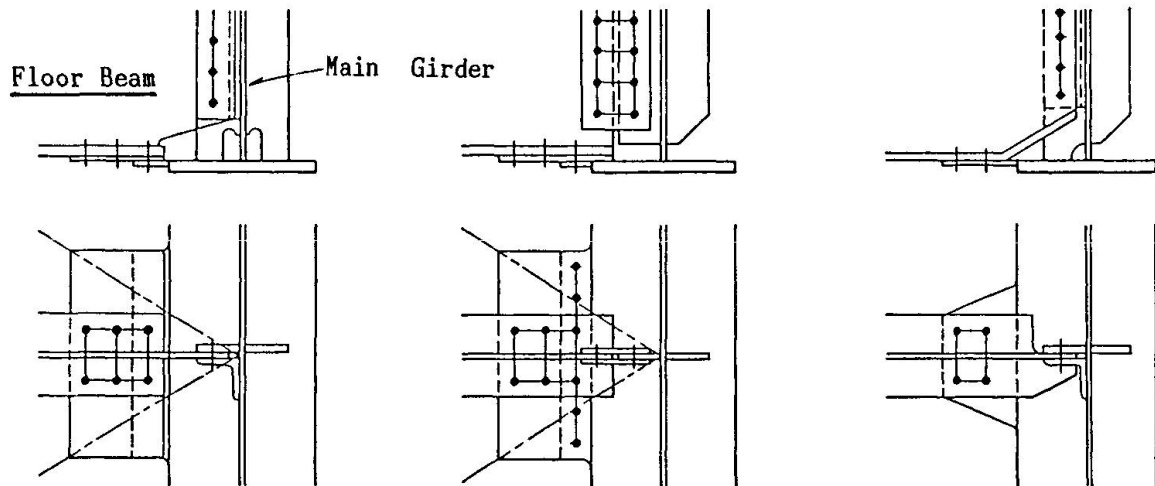
Fig. III Details of Floor Beam

(a) Defective Details

(b) Examples of Improved Details

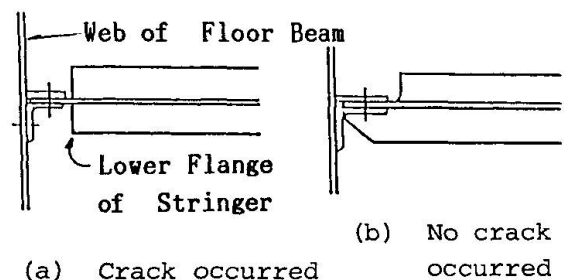
Fig. IV Details of Stringer

In a stringer where the lower flange was cut short as shown in Fig. IV (a), and only the web plate was connected with the web of floor beam, a crack started from the cope, as shown in Fig. 4 in Poster. According to the observation of an actual bridge, the copped part was subjected to a high local tensile stress, because of the loss of flanges and, moreover, the lower flange moved sideways by a small amount. It is supposed, then, that the combined effect developed a crack from the cope.

(a) Crack occurred

In case the damage was significant, a small hole was drilled at the tip of the crack and the lower flange was fixed to the web of floor beam, as shown in Fig. 5 in Poster and, if necessary, additional plates were attached to the end portion of the web. In case the lower flanges of adjacent stringers are connected with each other, or a half width of the lower flange is extended to the end of the web, as shown in Fig. IV (b), there has been no instance of this kind of crack.

(b) No crack occurred

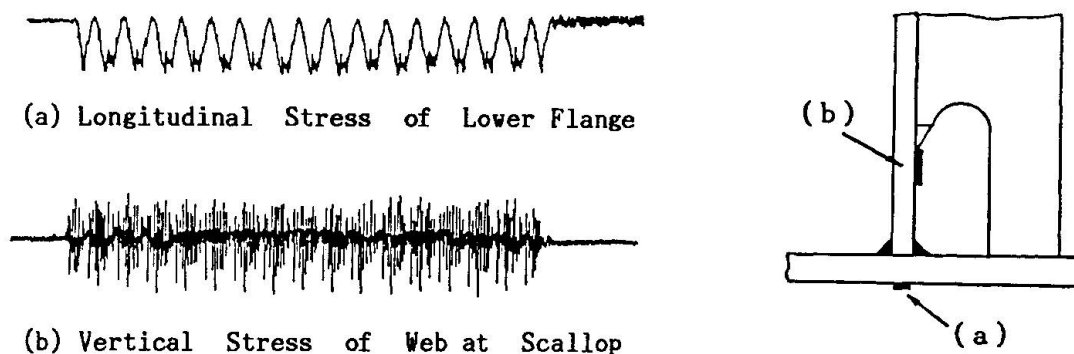
Fig. V Stress Variations of Lower Flange and Web at Scallop

often provided at the lower end of stiffener. A crack developed in the plate from the web-side toe of the fillet weld deposited between the stiffener and the web around the scallop at the lower end, as shown in Fig. 6 in Poster. After it grew in the web along the toe of corner fillet weld to some extent, it turned to the horizontal direction, extending as far as 10 cm at most, penetrating the web plate. The observation of actual bridges revealed a relative transverse displacement between the web and the lower flange due to various causes. The web plate may be forcibly subjected to repetition of out-of-plane bending of less than 10 Hz. in frequency due to the train axle loading on the girder, and also the web plate vibrates in its natural frequency of 20 to 50 Hz. as seen in Fig.V.

Based on an analysis it was found that the latter relatively more contributed to the fatigue effect on the critical part than the former. Because this kind of crack grows very slowly, not exceeding 10 cm or so in length, and the direction of the crack is parallel to the primary stress of the girder, it seems practically harmless.

For the repair work, usually, a holes were drilled at the tips of cracks and plates or angle steels were attached to that part by high-strength bolts, as shown in Fig. 7 in Poster. It will be effective that the lower end of the vertical stiffener is fixed by some means such as high-strength bolts, which will not so much reduce the fatigue strength of the tension flange.
