Zeitschrift: IABSE reports = Rapports AIPC = IVBH Berichte
Band: 52 (1986)

Artikel: Fatigue damage and repair of steel railway bridges in Japan
Autor: Abe, Hidehiko / Sakamoto, Kenji / Abe, Makoto
DOI: <https://doi.org/10.5169/seals-40343>

FATIGUE DAMAGE AND REPAIR OF STEEL RAILWAY BRIDGES IN JAPAN

Fatigue Damage and Repair of Steel Railway Bridges in Japan

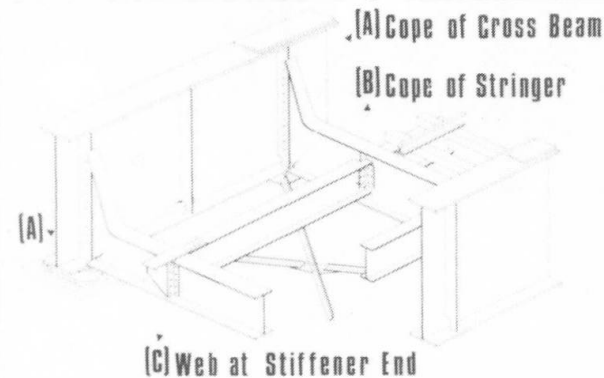
Fatigue damages have been occasionally experienced in structural details of railway bridges, because relatively large train loading is repeated in many cycles. Fig. 1 shows a schematic of the through type steel railway bridge and locations of fatigue cracks, as an example.

THROUGH TYPE GIRDER AND CRACK LOCATIONS

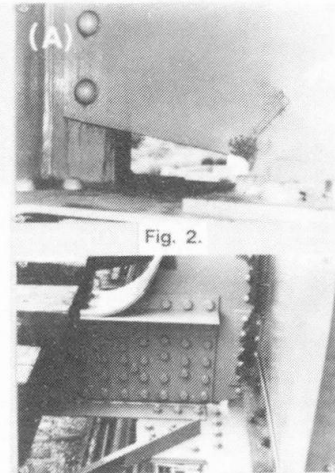
Failure Mode: A crack is originated at the cope corner or the toe of fillet weld at the cope formed for connection with the main girder. It develops diagonally in the web plate, as shown in Fig. 2. It occurs even in case the lower flange of the main girder and that of the cross beam are connected with each other.

Cause: Both insufficiency of resisting moment of the beam due to the coping and local stress concentration are the causes of crack.

As seen in Fig. 2 in Poster, a crack initiated from the cope at the lower corner of floor beam of a through girder bridge. Such cracks have occurred in a few end floor beams and one intermediate floor beam. Their lower flanges were connected by gusset plates with those of the main girders. Fig. I shows an example of the stress variation during passage of a train in the vicinity of the cope. Then, half-scale models, in which the horizontal lengths

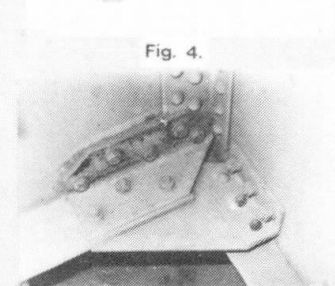
Failure Mode: A crack develops at the cope corner of stringer web, where the lower flange is cut short for connection with the cross beam, as shown in Fig. 4.

Cause: The lower flange of a stringer tends to be displaced sideways during train passage and a stress concentration takes place at the cope corner.

In a stringer where the lower flange was cut short as shown in Fig. IV (a), and only the web plate was connected with the web of floor beam, a crack started from the cope, as shown in Fig. 4 in Poster. According to the observation of an actual bridge, the coped part was subjected to a high local tensile stress, because of the loss of flanges and, moreover, the lower flange moved sideways by a small amount. It is supposed, then, that the combined effect developed a crack from the cope.

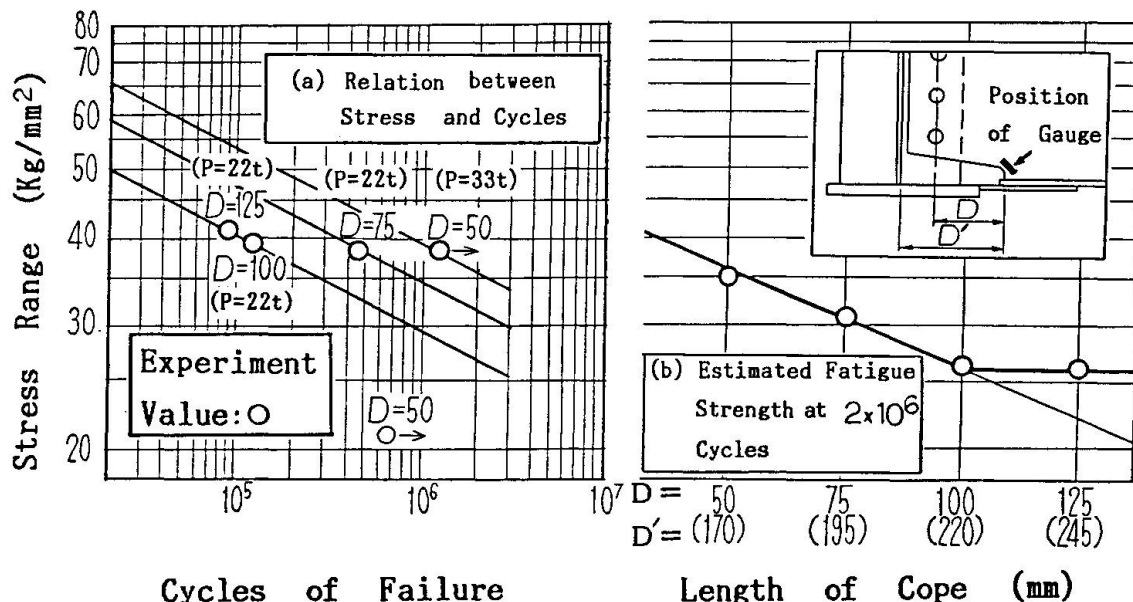
Fig. II Fatigue Strength of Coped Portion of Floor Beam

of the copes were varied, were tested under repeated loading and developed the same kind of crack as seen in the actual bridges. Both the FEM analysis and the model test revealed that the local tensile stress along the periphery of the cope became greater and consequently the fatigue strength decreased, as the cope length increased, as shown in Fig. II.

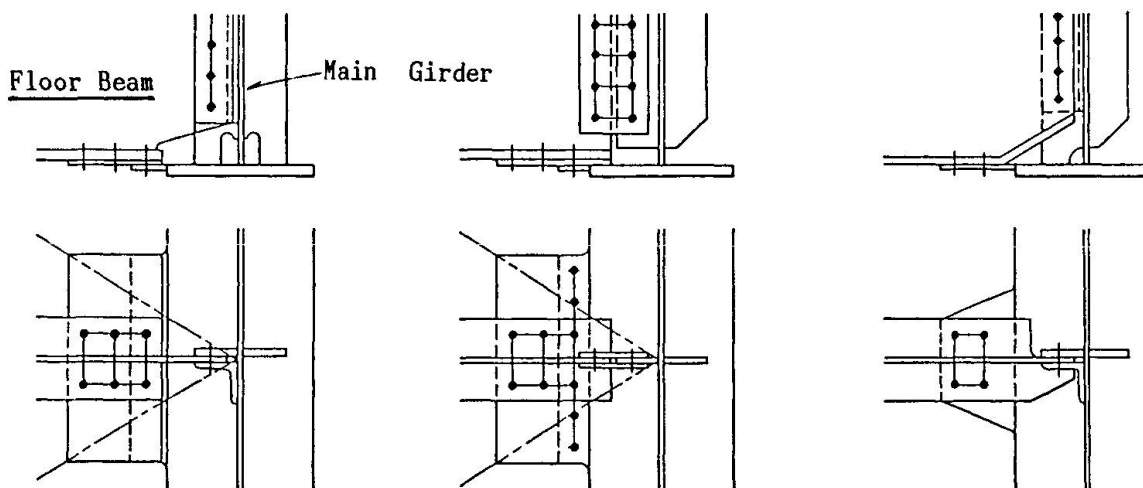
Fig. III Details of Floor Beam

(a) Defective Details

In the damaged floor beams holes were drilled at the tips of fatigue cracks in order to relieve the stress and steel plates were attached by high-strength-bolts, as shown in Fig. 3 in Poster. The details of currently designed bridges have been improved as illustrated in Fig. III. The whole width of at least a half width of the lower flange of floor beam is extended to its end.

(b) Examples of Improved Details

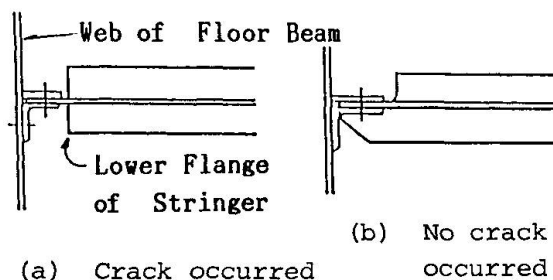
Fig. IV Details of Stringer

(a) Crack occurred

(b) No crack occurred

In case the damage was significant, a small hole was drilled at the tip of the crack and the lower flange was fixed to the web of floor beam, as shown in Fig. 5 in Poster and, if necessary, additional plates were attached to the end portion of the web. In case the lower flanges of adjacent stringers are connected with each other, or a half width of the lower flange is extended to the end of the web, as shown in Fig. IV (b), there has been no instance of this kind of crack.

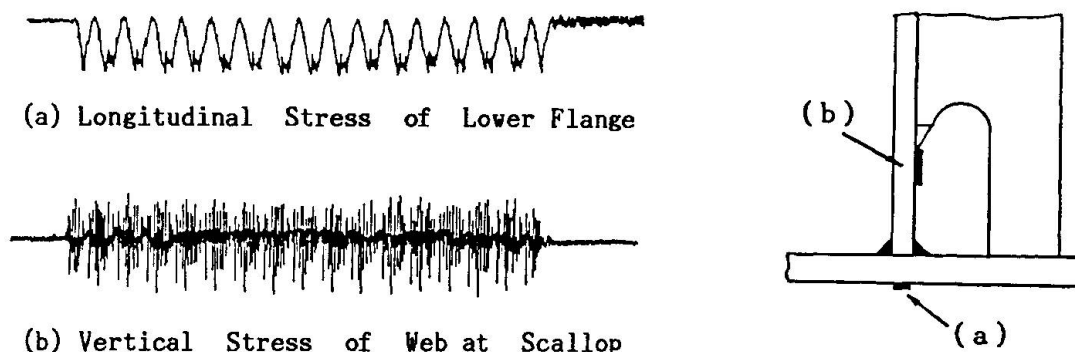
Fig. V Stress Variations of Lower Flange and Web at Scallop

often provided at the lower end of stiffener. A crack developed in the plate from the web-side toe of the fillet weld deposited between the stiffener and the web around the scallop at the lower end, as shown in Fig. 6 in Poster. After it grew in the web along the toe of corner fillet weld to some extent, it turned to the horizontal direction, extending as far as 10 cm at most, penetrating the web plate. The observation of actual bridges revealed a relative transverse displacement between the web and the lower flange due to various causes. The web plate may be forcibly subjected to repetition of out-of-plane bending of less than 10 Hz. in frequency due to the train axle loading on the girder, and also the web plate vibrates in its natural frequency of 20 to 50 Hz. as seen in Fig.V.

Based on an analysis it was found that the latter relatively more contributed to the fatigue effect on the critical part than the former. Because this kind of crack grows very slowly, not exceeding 10 cm or so in length, and the direction of the crack is parallel to the primary stress of the girder, it seems practically harmless.
