Artikel: Fatigue damage and repair of steel railway bridges in Japan

Autor: Abe, Hidehiko / Sakamoto, Kenji / Abe, Makoto

FATIGUE DAMAGE AND REPAIR OF STEEL RAILWAY BRIDGES IN JAPAN

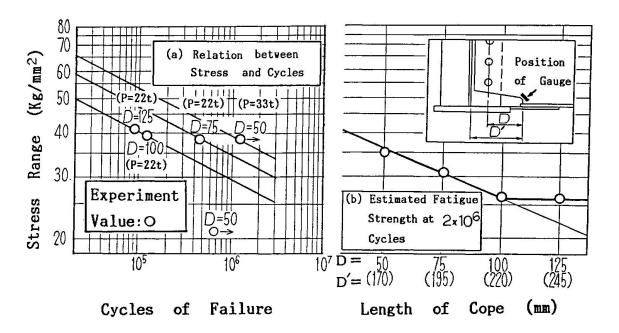
Fig. II Fatigue Strength of Coped Portion of Floor Beam

of the copes were varied, were tested under repeated loading and developed the same kind of crack as seen in the actual bridges. Both the FEM analysis and the model test revealed that the local tensile stress along the periphery of the cope became greater and consequently the fatigue strength decreased, as the cope length increased, as shown in Fig. $\rm I\!I$.

In the damaged floor beams holes were drilled at the tips of fatigue cracks in order to releave the stress and steel plates were attached by high-strength-bolts, as shown in Fig. 3 in Poster. The details of currently designed bridges have been improved as illustrated in Fig. III. The whole width of at least a half width of the lower flange of floor beam is extended to its end.

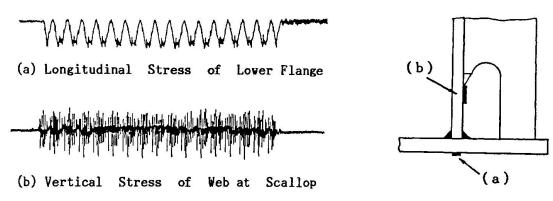
Fig. V Stress Variations of Lower Flange and Web at Scallop

often provided at the lower end of stiffener. A crack developed in the plate from the web-side toe of the fillet weld deposited between the stiffener and the web around the scallop at the lower end, as shown in Fig. 6 in Poster. After it grew in the web along the toe of corner fillet weld to some extent, it turned to the horizontal direction, extending as far as 10 cm at most, penetrating the web plate. The observation of actual bridges revealed a relative transverse displacement between the web and the lower flange due to various causes. The web plate may be forcibly subjected to repetition of out-of-plane bending of less than 10 Hz. in frequency due to the train axle loading on the girder, and also the web plate vibrates in its natural frequency of 20 to 50 Hz. as seen in Fig.V.

Based on an analysis it was found that the latter relatively more contributed to the fatigue effect on the critical part than the former. Because this kind of crack grows very slowly, not exceeding 10 cm or so in length, and the direction of the crack is parallel to the primary stress of the girder, it seems practically harmless.

For the repair work, usually, a holes were drilled at the tips of cracks and plates or angle steels were attached to that part by high-strength bolts, as shown in Fig. 7 in Poster. It will be effective that the lower end of the vertical stiffener is fixed by some means such as high-strength bolts, which will not so much reduce the fatigue strength of the tension flange.
