Artikel: Fatigue damage and repair of steel railway bridges in Japan

FATIGUE DAMAGE AND REPAIR OF STEEL RAILWAY BRIDGES IN JAPAN

Fatigue Damage and Repair of Steel Railway Bridges in Japan

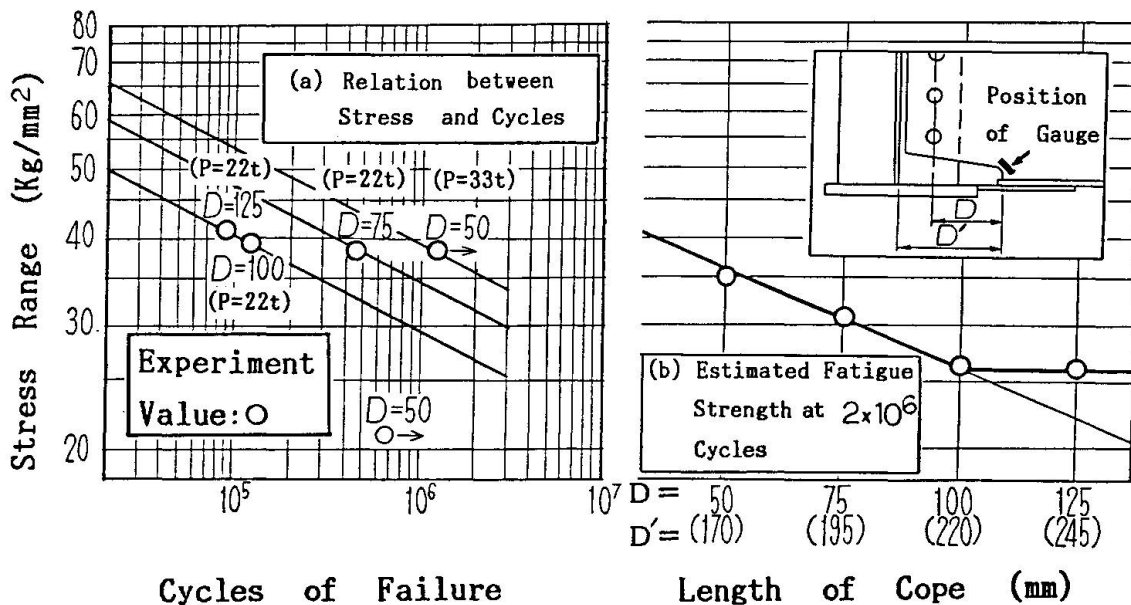
Fig. II Fatigue Strength of Coped Portion of Floor Beam

of the copes were varied, were tested under repeated loading and developed the same kind of crack as seen in the actual bridges. Both the FEM analysis and the model test revealed that the local tensile stress along the periphery of the cope became greater and consequently the fatigue strength decreased, as the cope length increased, as shown in Fig. II.

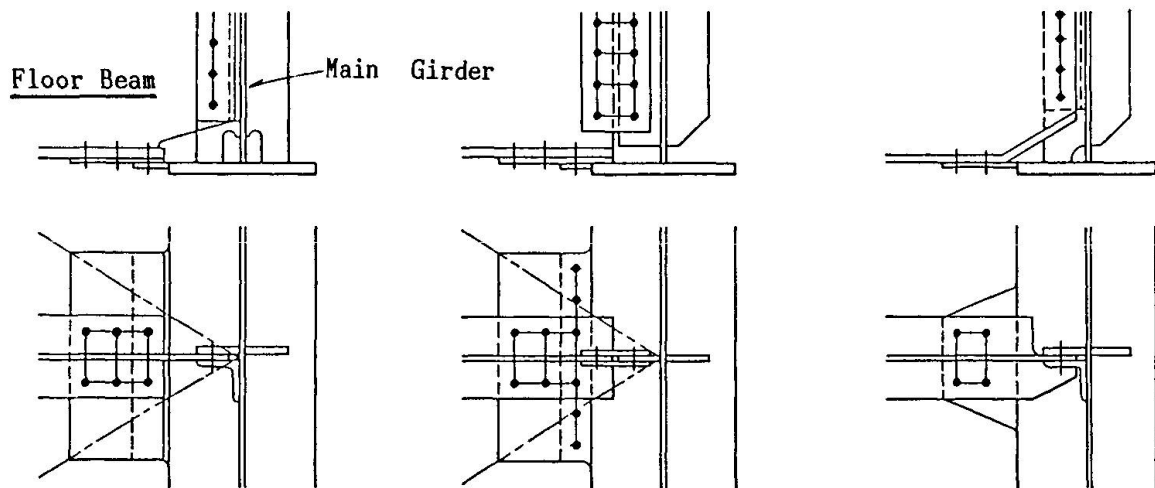
Fig. III Details of Floor Beam

(a) Defective Details

In the damaged floor beams holes were drilled at the tips of fatigue cracks in order to relieve the stress and steel plates were attached by high-strength-bolts, as shown in Fig. 3 in Poster. The details of currently designed bridges have been improved as illustrated in Fig. III. The whole width of at least a half width of the lower flange of floor beam is extended to its end.

(b) Examples of Improved Details

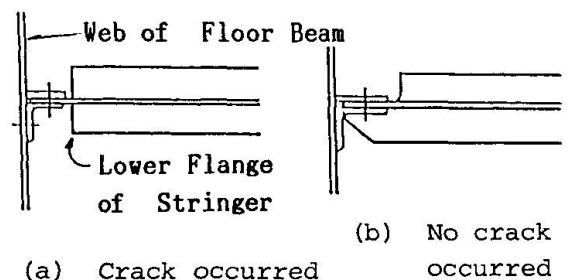
Fig. IV Details of Stringer

In a stringer where the lower flange was cut short as shown in Fig. IV (a), and only the web plate was connected with the web of floor beam, a crack started from the cope, as shown in Fig. 4 in Poster. According to the observation of an actual bridge, the copped part was subjected to a high local tensile stress, because of the loss of flanges and, moreover, the lower flange moved sideways by a small amount. It is supposed, then, that the combined effect developed a crack from the cope.

(a) Crack occurred

In case the damage was significant, a small hole was drilled at the tip of the crack and the lower flange was fixed to the web of floor beam, as shown in Fig. 5 in Poster and, if necessary, additional plates were attached to the end portion of the web. In case the lower flanges of adjacent stringers are connected with each other, or a half width of the lower flange is extended to the end of the web, as shown in Fig. IV (b), there has been no instance of this kind of crack.

(b) No crack occurred

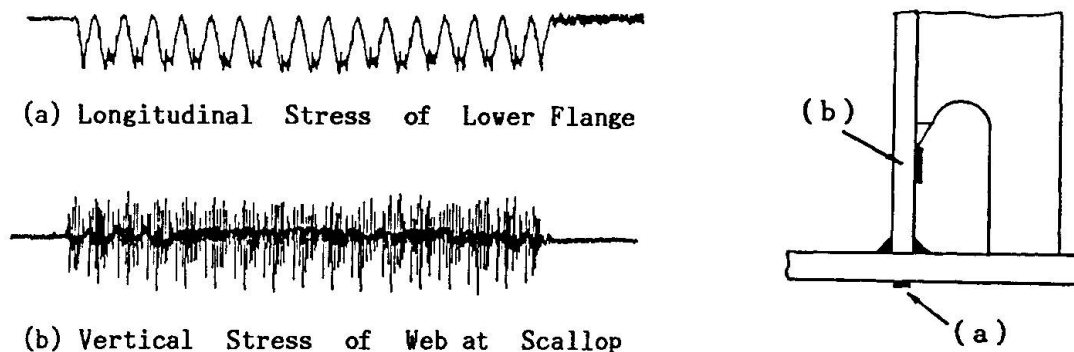
Fig. V Stress Variations of Lower Flange and Web at Scallop

often provided at the lower end of stiffener. A crack developed in the plate from the web-side toe of the fillet weld deposited between the stiffener and the web around the scallop at the lower end, as shown in Fig. 6 in Poster. After it grew in the web along the toe of corner fillet weld to some extent, it turned to the horizontal direction, extending as far as 10 cm at most, penetrating the web plate. The observation of actual bridges revealed a relative transverse displacement between the web and the lower flange due to various causes. The web plate may be forcibly subjected to repetition of out-of-plane bending of less than 10 Hz. in frequency due to the train axle loading on the girder, and also the web plate vibrates in its natural frequency of 20 to 50 Hz. as seen in Fig.V.

Based on an analysis it was found that the latter relatively more contributed to the fatigue effect on the critical part than the former. Because this kind of crack grows very slowly, not exceeding 10 cm or so in length, and the direction of the crack is parallel to the primary stress of the girder, it seems practically harmless.

For the repair work, usually, a holes were drilled at the tips of cracks and plates or angle steels were attached to that part by high-strength bolts, as shown in Fig. 7 in Poster. It will be effective that the lower end of the vertical stiffener is fixed by some means such as high-strength bolts, which will not so much reduce the fatigue strength of the tension flange.
