Zeitschrift: IABSE reports = Rapports AIPC = IVBH Berichte
Band: 52 (1986)

Artikel: Fatigue damage and repair of steel railway bridges in Japan
Autor: Abe, Hidehiko / Sakamoto, Kenji / Abe, Makoto
DOI: <https://doi.org/10.5169/seals-40343>

FATIGUE DAMAGE AND REPAIR OF STEEL RAILWAY BRIDGES IN JAPAN

Fatigue Damage and Repair of Steel Railway Bridges in Japan

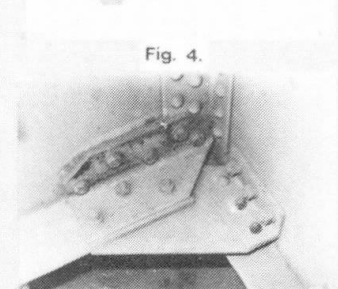
Failure Mode: A crack develops at the cope corner of stringer web, where the lower flange is cut short for connection with the cross beam, as shown in Fig. 4.

Cause: The lower flange of a stringer tends to be displaced sideways during train passage and a stress concentration takes place at the cope corner.

In a stringer where the lower flange was cut short as shown in Fig. IV (a), and only the web plate was connected with the web of floor beam, a crack started from the cope, as shown in Fig. 4 in Poster. According to the observation of an actual bridge, the coped part was subjected to a high local tensile stress, because of the loss of flanges and, moreover, the lower flange moved sideways by a small amount. It is supposed, then, that the combined effect developed a crack from the cope.

Repair: In case the crack is small, the lower flange is connected with the web, as shown in Fig. 5. But in case the damage is significant, the whole stringer is replaced by a new one.

In case the damage was significant, a small hole was drilled at the tip of the crack and the lower flange was fixed to the web of floor beam, as shown in Fig. 5 in Poster and, if necessary, additional plates were attached to the end portion of the web. In case the lower flanges of adjacent stringers are connected with each other, or a half width of the lower flange is extended to the end of the web, as shown in Fig. IV (b), there has been no instance of this kind of crack.

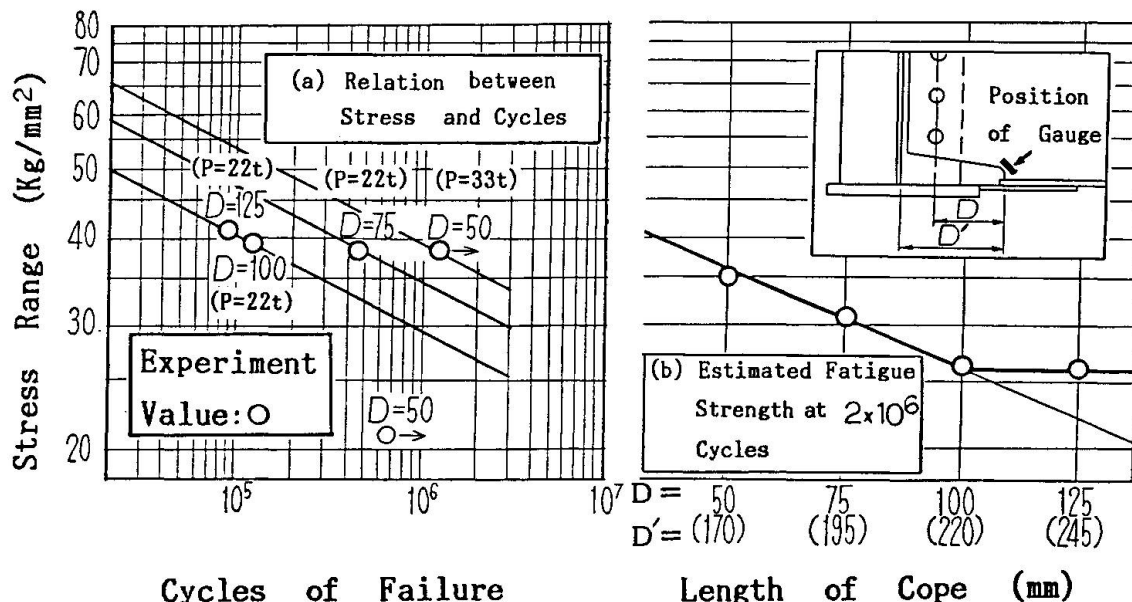
Fig. II Fatigue Strength of Coped Portion of Floor Beam

of the copes were varied, were tested under repeated loading and developed the same kind of crack as seen in the actual bridges. Both the FEM analysis and the model test revealed that the local tensile stress along the periphery of the cope became greater and consequently the fatigue strength decreased, as the cope length increased, as shown in Fig. II.
