Artikel: Fatigue damage and repair of steel railway bridges in Japan

Autor: Abe, Hidehiko / Sakamoto, Kenji / Abe, Makoto

FATIGUE DAMAGE AND REPAIR OF STEEL RAILWAY BRIDGES IN JAPAN

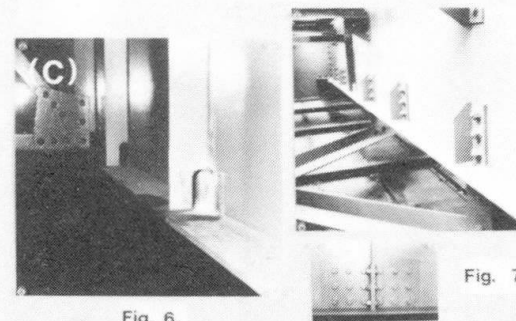
Failure Mode: A crack develops in the web plate at the toe of fillet weld around the lower scalloped end of an intermediate stiffener, as shown in Fig. 6.

Cause: In addition to the in-plane-deformation due to the bending moment, the out-of-plane deformation due to vibration of the web plate or due to relative lateral displacement between the web and the lower flange causes this kind of crack.

often provided at the lower end of stiffener. A crack developed in the plate from the web-side toe of the fillet weld deposited between the stiffener and the web around the scallop at the lower end, as shown in Fig. 6 in Poster. After it grew in the web along the toe of corner fillet weld to some extent, it turned to the horizontal direction, extending as far as 10 cm at most, penetrating the web plate. The observation of actual bridges revealed a relative transverse displacement between the web and the lower flange due to various causes. The web plate may be forcibly subjected to repetition of out-of-plane bending of less than 10 Hz. in frequency due to the train axle loading on the girder, and also the web plate vibrates in its natural frequency of 20 to 50 Hz. as seen in Fig.V.

Based on an analysis it was found that the latter relatively more contributed to the fatigue effect on the critical part than the former. Because this kind of crack grows very slowly, not exceeding 10 cm or so in length, and the direction of the crack is parallel to the primary stress of the girder, it seems practically harmless.

Repair: Local reinforcing plates are bolted, as shown in Fig. 7.

For the repair work, usually, a holes were drilled at the tips of cracks and plates or angle steels were attached to that part by high-strength bolts, as shown in Fig. 7 in Poster. It will be effective that the lower end of the vertical stiffener is fixed by some means such as high-strength bolts, which will not so much reduce the fatigue strength of the tension flange.

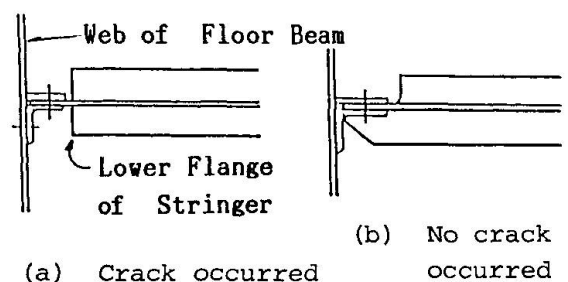
Fig. IV Details of Stringer

In a stringer where the lower flange was cut short as shown in Fig. IV (a), and only the web plate was connected with the web of floor beam, a crack started from the cope, as shown in Fig. 4 in Poster. According to the observation of an actual bridge, the copped part was subjected to a high local tensile stress, because of the loss of flanges and, moreover, the lower flange moved sideways by a small amount. It is supposed, then, that the combined effect developed a crack from the cope.

(a) Crack occurred

In case the damage was significant, a small hole was drilled at the tip of the crack and the lower flange was fixed to the web of floor beam, as shown in Fig. 5 in Poster and, if necessary, additional plates were attached to the end portion of the web. In case the lower flanges of adjacent stringers are connected with each other, or a half width of the lower flange is extended to the end of the web, as shown in Fig. IV (b), there has been no instance of this kind of crack.
