**Zeitschrift:** IABSE reports = Rapports AIPC = IVBH Berichte  
**Band:** 57/1/57/2 (1989)

**Artikel:** Rehabilitation and maintenance design for durability  
**Autor:** Searls, Carolyn L. / Zook, Barbara  
**DOI:** <https://doi.org/10.5169/seals-44306>

## Rehabilitation and Maintenance Design for Durability

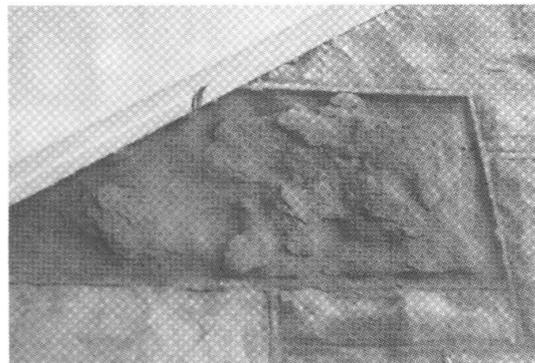
Use of a modern, high strength "durable" material for repointing mortar joints often results in lessened durability for the building as a whole. In general, repointing should be done with a "soft" mortar, lower in strength than the adjacent masonry so that stresses from expansion, moisture migration or settlement can be accommodated within the joints rather than the stones. Use of a hard portland cement mortar can result in accelerated deterioration of the stone, while the mortar joints remain intact, as shown in Fig. 1.

Fig. 1 Stone deterioration at repointed joint

Periodic maintenance of mortar joints will greatly increase the durability of the building by reducing water infiltration into the stone.

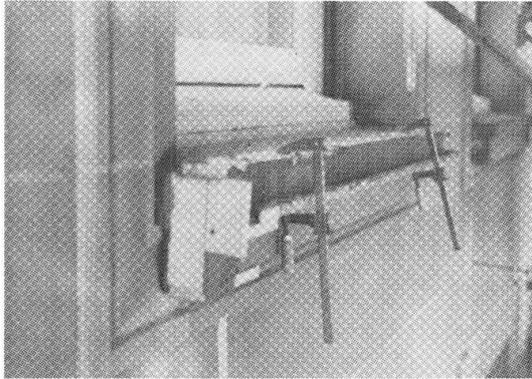
Mortar material is used to rebuild deteriorated sections of stone. The mortar is placed by hand or cast into forms to reproduce original details, as shown in Fig. 2. The durability of the patch improves when the patching material is similar to the stone in strength, porosity, and thermal expansion characteristics. The surface preparation, application method, reinforcement, and curing

Fig. 2 Stone window sill rebuilt with mortar

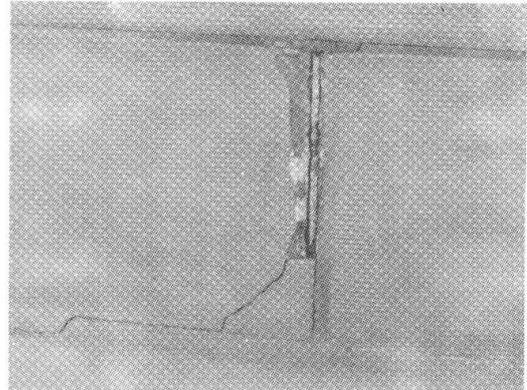
also control the success of the patch. Failure of the repair shown in Fig. 3 occurred because the patch was placed across a mortar joint with no provision for movement of the stones on either side of the joint.

Fig. 3 Failure of patch installed across mortar joint

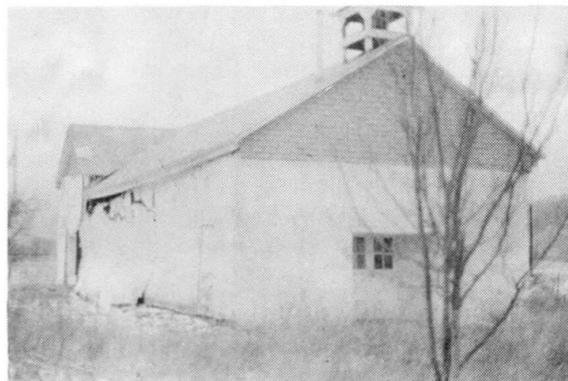
Basal erosion caused by the presence of moisture and freeze thaw action, requires immediate repair because it reduces the load bearing capacity of the wall. The west wall of the San Jose Church in Upper Rociada, New Mexico, shown in Fig. 4, slumped recently after the removal of interior wood furring and removal of adjacent exterior grade. The base of the wall had a moisture content of 17 to 24 percent and the imposition of additional loads on the moist mudbrick base caused the wall failure. Basal erosion is repaired by removing loose material and adding new mudbrick, using

Fig. 4 Wall failure resulting from high moisture content

matching mud mortar. Specifying a good particle size distribution, a nonexpansive clay, and using correct manufacturing procedures for the replacement mudbrick will increase the durability of the repair. [5]

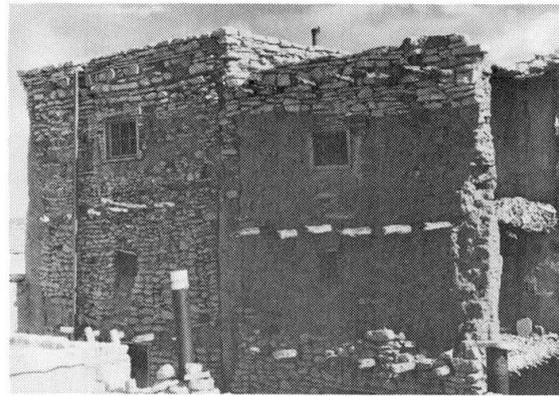
The Pueblo of Acoma in central New Mexico consists of three-story contiguous southfacing mudbrick structures on a high sandstone mesa built by Indians in the eighteenth century. Moisture deterioration has not been a problem in these structures but construction with unkeyed corners and narrow widths of three-story high mudbrick walls caused collapse of a section of an Acoma structure, as shown in Fig. 5. The collapsed wall was rebuilt with additional thickness of adobe and with keyed in corners.

Fig. 5 Mudbrick wall collapse
