**Artikel:** Rehabilitation and maintenance design for durability  
**Autor:** Searls, Carolyn L. / Zook, Barbara  
**DOI:** <https://doi.org/10.5169/seals-44306>

## Rehabilitation and Maintenance Design for Durability

### Carolyn L. SEARLS

### Barbara ZOOK

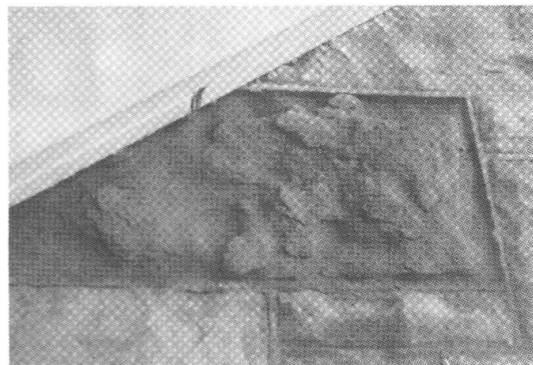
Use of a modern, high strength "durable" material for repointing mortar joints often results in lessened durability for the building as a whole. In general, repointing should be done with a "soft" mortar, lower in strength than the adjacent masonry so that stresses from expansion, moisture migration or settlement can be accommodated within the joints rather than the stones. Use of a hard portland cement mortar can result in accelerated deterioration of the stone, while the mortar joints remain intact, as shown in Fig. 1.

Fig. 1 Stone deterioration at repointed joint

Periodic maintenance of mortar joints will greatly increase the durability of the building by reducing water infiltration into the stone.

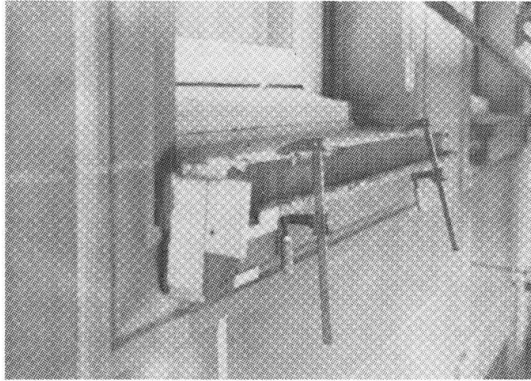
Mortar material is used to rebuild deteriorated sections of stone. The mortar is placed by hand or cast into forms to reproduce original details, as shown in Fig. 2. The durability of the patch improves when the patching material is similar to the stone in strength, porosity, and thermal expansion characteristics. The surface preparation, application method, reinforcement, and curing

Fig. 2 Stone window sill rebuilt with mortar

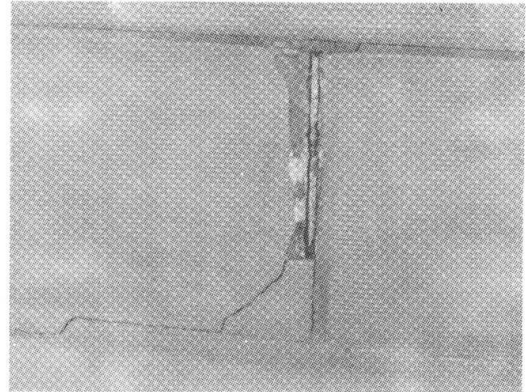
also control the success of the patch. Failure of the repair shown in Fig. 3 occurred because the patch was placed across a mortar joint with no provision for movement of the stones on either side of the joint.

Fig. 3 Failure of patch installed across mortar joint

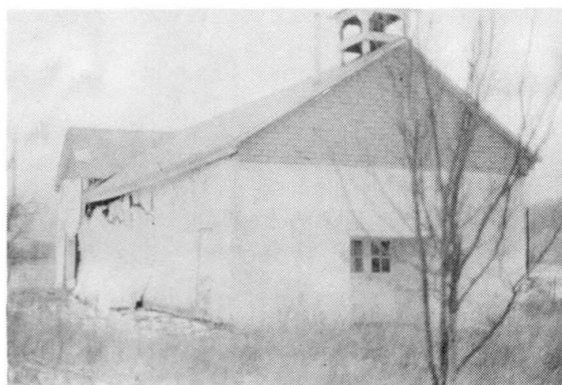
Basal erosion caused by the presence of moisture and freeze thaw action, requires immediate repair because it reduces the load bearing capacity of the wall. The west wall of the San Jose Church in Upper Rociada, New Mexico, shown in Fig. 4, slumped recently after the removal of interior wood furring and removal of adjacent exterior grade. The base of the wall had a moisture content of 17 to 24 percent and the imposition of additional loads on the moist mudbrick base caused the wall failure. Basal erosion is repaired by removing loose material and adding new mudbrick, using

Fig. 4 Wall failure resulting from high moisture content

matching mud mortar. Specifying a good particle size distribution, a nonexpansive clay, and using correct manufacturing procedures for the replacement mudbrick will increase the durability of the repair. [5]

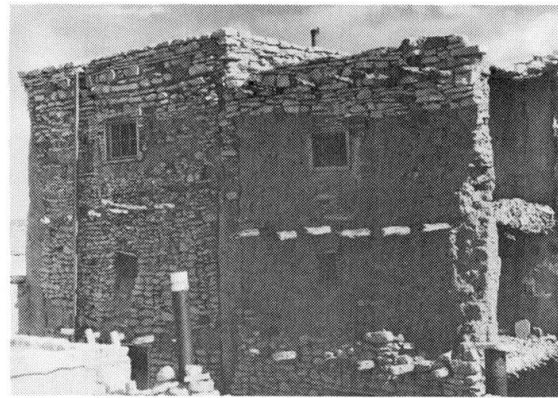
The Pueblo of Acoma in central New Mexico consists of three-story contiguous southfacing mudbrick structures on a high sandstone mesa built by Indians in the eighteenth century. Moisture deterioration has not been a problem in these structures but construction with unkeyed corners and narrow widths of three-story high mudbrick walls caused collapse of a section of an Acoma structure, as shown in Fig. 5. The collapsed wall was rebuilt with additional thickness of adobe and with keyed in corners.

Fig. 5 Mudbrick wall collapse
