**Zeitschrift:** IABSE reports = Rapports AIPC = IVBH Berichte  
**Band:** 57/1/57/2 (1989)

## Rehabilitation and Maintenance Design for Durability

### Carolyn L. SEARLS

Wiss, Janney, Elstner Assoc. Inc.  
Emeryville, CA, USA

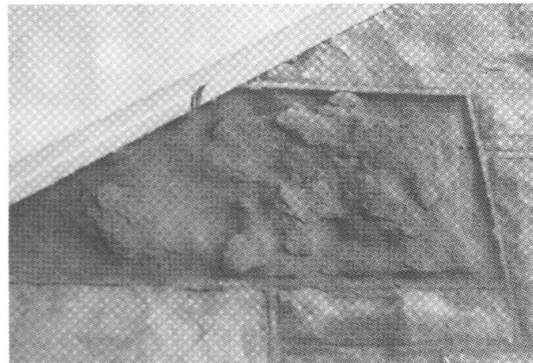
Use of a modern, high strength "durable" material for repointing mortar joints often results in lessened durability for the building as a whole. In general, repointing should be done with a "soft" mortar, lower in strength than the adjacent masonry so that stresses from expansion, moisture migration or settlement can be accommodated within the joints rather than the stones. Use of a hard portland cement mortar can result in accelerated deterioration of the stone, while the mortar joints remain intact, as shown in Fig. 1.

Fig. 1 Stone deterioration at repointed joint

Periodic maintenance of mortar joints will greatly increase the durability of the building by reducing water infiltration into the stone.

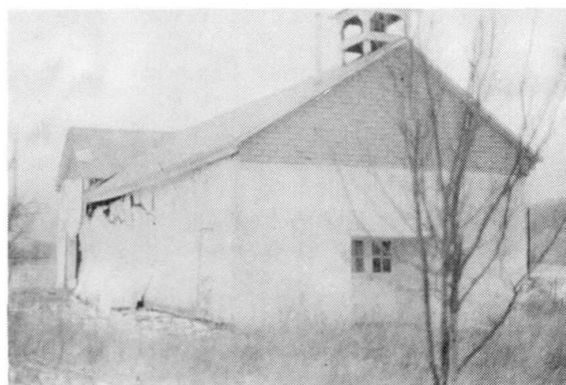
Basal erosion caused by the presence of moisture and freeze thaw action, requires immediate repair because it reduces the load bearing capacity of the wall. The west wall of the San Jose Church in Upper Rociada, New Mexico, shown in Fig. 4, slumped recently after the removal of interior wood furring and removal of adjacent exterior grade. The base of the wall had a moisture content of 17 to 24 percent and the imposition of additional loads on the moist mudbrick base caused the wall failure. Basal erosion is repaired by removing loose material and adding new mudbrick, using

Fig. 4 Wall failure resulting from high moisture content

matching mud mortar. Specifying a good particle size distribution, a nonexpansive clay, and using correct manufacturing procedures for the replacement mudbrick will increase the durability of the repair. [5]
