Artikel: Assessment of existing structures for their rehabilitation

Autor: Brito, Jorge de / Branco, Fernando / Batista, A.R.

Assessment of Existing Structures for their Rehabilitation
Evaluation de structures existantes en vue de leur assainissement
Beurteilung von Bauwerken und deren Instandsetzung

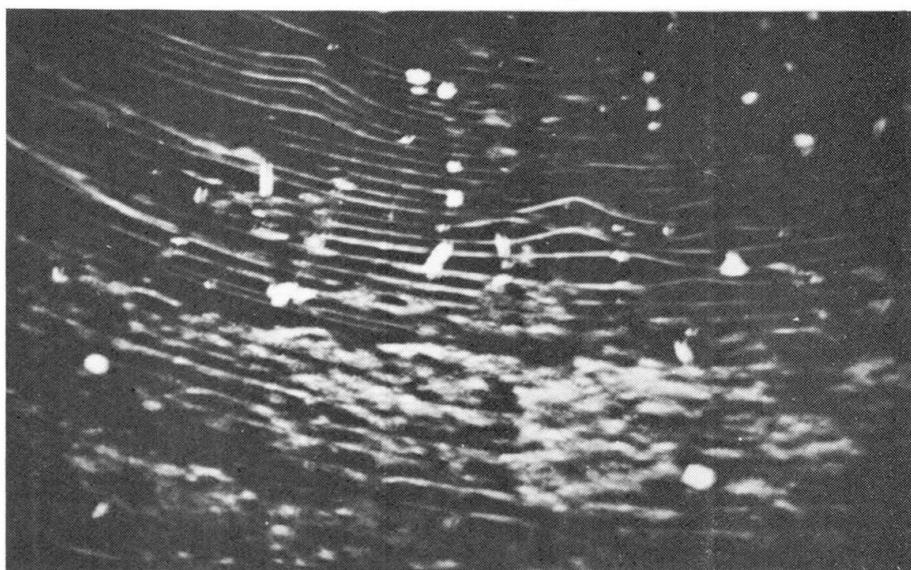
The tunnel inside which a fire broke consists of a reinforced concrete arch with a radius of 3 meters and a length of about 100 meters open at both ends. An accident next to one of the ends ignited the wooden formwork. Due to a chimney effect along the tunnel, the fire quickly propagated to all the wooden structure. The consequent high temperatures gave rise to significant deterioration of the gallery next to the formwork. The damage decreased in importance along the length of the tunnel.

Area D - very high degree of concrete degradation, loose and twisted reinforcement (Fig. 1).

Sclerometric tests were made along the total length of the gallery. They showed that superficial concrete in Area D (next to where the fire broke) had a lower residual resistance. To quantify more precisely the heat effect in depth, some cores were taken out and tested in compression (Fig. 2). The results varied between $\sigma_{ck} = 30,6 \text{ MPa}$ and $\sigma_{ck} = 22,8 \text{ MPa}$ in Area D for concrete not directly exposed to the fire. As all these values were superior to the one used in the initial design ($\sigma_{ck} = 22,1 \text{ MPa}$), it was considered that the existing concrete presented no safety problems for the structure.

Fig. 1 [2] Damage in the cross-section of the tunnel (Area D)

Area D - the reinforcement was replaced, about 3 cm of the surface concrete were removed and the cover was replaced by shotcreting. To efficiently verify the bond between old and new concrete, some cores were taken out and tested to quantify the bond strength of the joint. The ultimate shear stress was about 2,3 MPa, similar to that of 0,00 the concrete used in the tunnel construction.

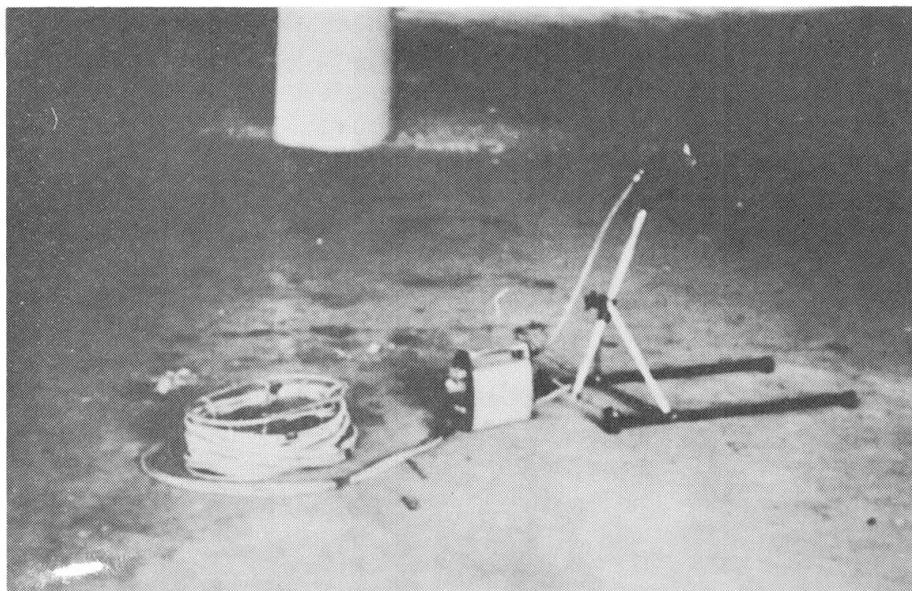
- groove making in concrete beams to determine the number and size of the reinforcement.
- non-destructive in-situ testing using X Rays to detect and identify the reinforcement in some slabs (Fig. 2). It proved to be efficient in the analysis of slabs up to 30 cm deep with the equipment used and the safety conditions imposed [3]. The radiographies showed the reinforcement layout and size.

According to the results obtained, it was not possible to guarantee analytically the safety factors in the dimensioning of the slabs with the new in-service loads. It was then decided to resort to a full scale load test of the slab with the least favourable conditions. The load consisted of water contained by a small wall specially built for the effect (Fig. 2).

The results showed a good behaviour of the slab with almost no visible cracking for the future in-service loads with a factor $\gamma_f = 1,25$. One of the main reasons for this was the good quality of the mortar layers used on top of the slabs that functioned monolithically with the concrete. There was then no need to strengthen the slab.

Fig. 2 X Ray equipment and full scale load test of slab
