Assessment of Existing Structures for their Rehabilitation

Jorge DE BRITO Research Assistant CMEST Lisbon, Portugal Fernando BRANCO Assoc. Professor CMEST Lisbon, Portugal

4. RE-EYALUATION AND REPAIR OF A TUNNEL DAMAGED BY A FIRE

5. EXTENSION AND STRENGTHENING OF A BUILDING

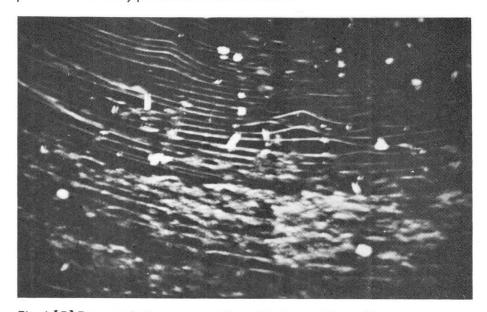
Area D - very high degree of concrete degradation, loose and twisted reinforcement (Fig. 1).

Sclerometric tests were made along the total length of the gallery. They showed that superficial concrete in Area D (next to where the fire broke) had a lower residual resistance. To quantify more precisely the heat effect in depth, some cores were taken out and tested in compression (Fig. 2). The results varied between $\sigma_{\rm CK}=30.6$ MPa and $\sigma_{\rm CK}=22.8$ MPa in Area D for concrete not directly exposed to the fire. As all these values were superior to the one used in the initial design ($\sigma_{\rm CK}=22.1$ MPa), it was considered that the existing concrete presented no safety problems for the structure.

Fig. 1 [2] Damage in the cross-section of the tunnel (Area D)

Some steel cores from the various areas were also taken out and tested. Only the reinforcement in Area D showed some decrease in its mechanical characteristics ($f_{\rm S0,2k}$ = 350 MPa < 400 MPa). As its residual extensions were substantial, the reinforcement was replaced. Adhesion tests were also performed before repair took place.

Area D - the reinforcement was replaced, about 3 cm of the surface concrete were removed and the cover was replaced by shotcreting. To efficiently verify the bond between old and new concrete, some cores were taken out and tested to quantify the bond strength of the joint. The ultimate shear stress was about 2,3 MPa, similar to that of 0,00the concrete used in the tunnel construction.

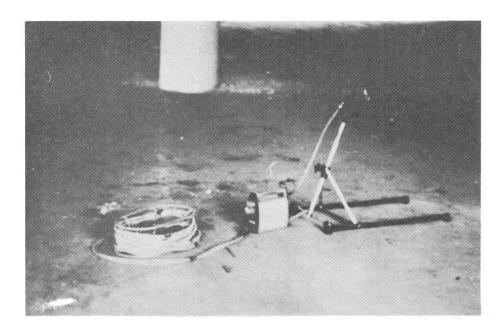
- groove making in concrete beams to determine the number and size of the reinforcement.
- non-destructive in-situ testing using X Flays to detect and identify the reinforcement in some stabs (Fig. 2). It proved to be efficient in the analysis of stabs up to 30 cm deep with the equipment used and the safety conditions imposed [3]. The radiographies showed the reinforcement layout and size.

According to the results obtained, it was not possible to guarantee analytically the safety factors in the dimensioning of the slabs with the new in-service loads. It was then decided to resort to a full scale load test of the slab with the least favourable conditions. The load consisted of water contained by a small wall specially built for the effect (Fig. 2).

The results showed a good behaviour of the slab with almost no visible cracking for the future in-service loads with a factor $\gamma_f = 1,25$. One of the main reasons for this was the good quality of the mortar layers used on top of the slabs that functioned monolitically with the concrete. There was then no need to strengthen the slab.

Fig. 2 X Ray equipment and full scale load test of slab
