**Artikel:** Load testing as an assessment method

# Load Testing as an Assessment Method

The load test of a motorway bridge at Skovdiget north of Copenhagen will be presented as an example of a load test of a deteriorated concrete structure. The twin motorway bridges (Eastern and Western respectively) were constructed in 1965-67 for the Copenhagen Highway Authorities. The bridges now belong under the Danish Road Directorate. The first load test was performed in 1984 and the second in 1988.

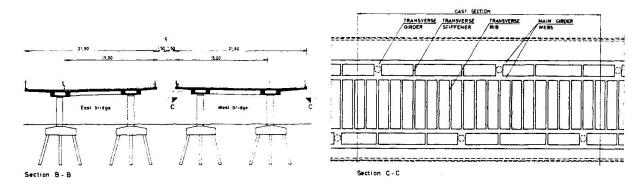
Fig. 2 Cross section

The main girders are constructed as box sections with a cross sectional height of approx. 1 m. Transverse stiffeners 1.4 m wide are cast in the main girders over the columns as transverse girders with short cables arranged as a reversed U. The structure of the bridges is shown in figures 1-3.
