Zeitschrift: IABSE reports = Rapports AIPC = IVBH Berichte
Band: 57/1/57/2 (1989)

Rubrik: Workshop 3: Durability of suspended structures

Inspection Evaluation, and Rehabilitation of Suspension Bridge Cables

Peter SLUSZKA
Vice President
Steinman
New York, NY, USA

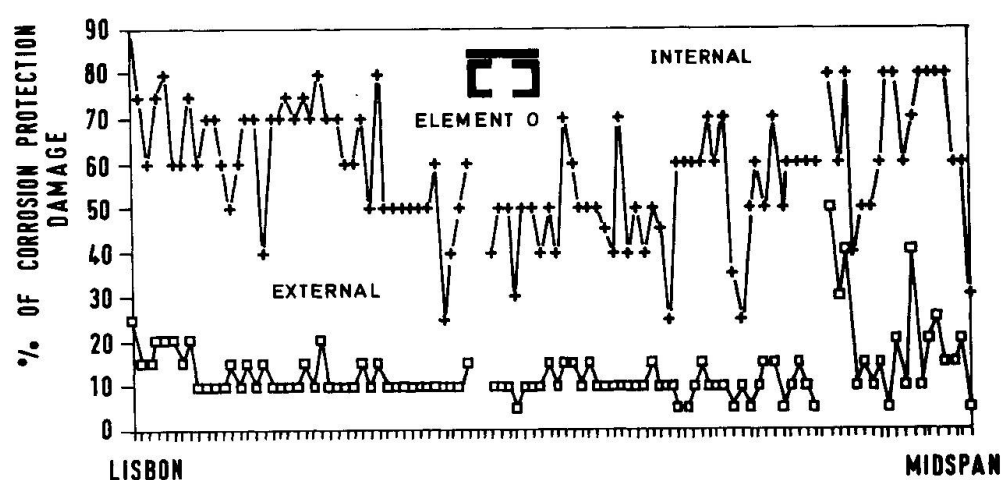
Fig. 3 - ANTICORROSION PROTECTION DAMAGE AT ELEMENT 0, ALONG THE SPAN.

At the first stage of the program, the corrosion inspection was implemented. At the columns only superficial corrosion was found, mostly at the interior of the base section. The concrete caissons were also observed and filmed under water to check for concrete degradation, but no relevant findings were obtained. At the cables hangers and cable bands, and with an external observation, only small spots of superficial corrosion were found. Due to the good external condition, an internal observation with electromagnetic techniques was not considered necessary at this stage. All the bars of the deck truss were also inspected and plots of the superficial corrosion along the bridge were drawn for each element (Fig. 3). Structural damage by corrosion was found only in a few nuts of the bolted connections which presented section reductions of more than 20%. It is estimated that about 2% of the deck bolts will need to be replaced shortly. During deck inspection some transversal bars located over the longitudinal girders (shown in Fig. 2 by A). It is estimated that 13% of the total number present this problems.

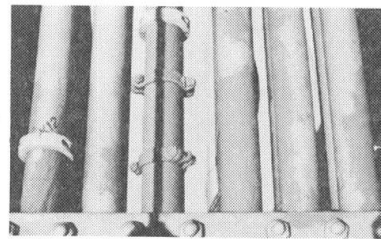
Treten die Drahtbrüche vereinzelt auf, so genügt eine Sanierung der klaffenden Bruchenden durch Plombieren mittels Kunstharz. Dadurch wird das Eindringen von Feuchtigkeit verhindert. Tritt Drahtbruchhäufung auf oder befinden sich die Bruchstellen in benachbarten Z-Drähten, besteht die Gefahr, daß Z-Drähte aus dem Seil treten und sich auf weite Strecken aus dem Verband schälen. Um dies zu verhindern, sind im Bereich der Schadensstelle Schraubklemmen zu montieren. (Fig. 2)

Fig.2 Drahtbruchhäufung in verschlossenen Tragseilen einer Hängebrücke im Bereich einer Hängerklemme

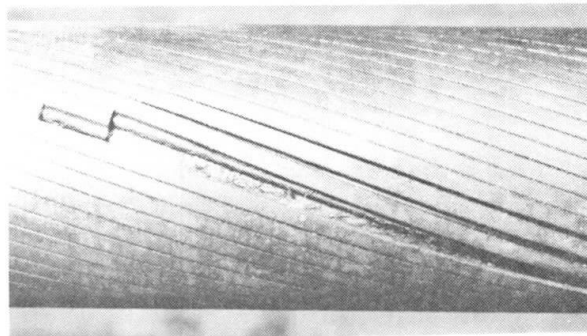
Um das zehn Meter lange verschlossene Tragseil, 63 mm Durchmesser, belasten zu können, wurde es an beiden Enden mit Vergußköpfen versehen. Die äußere Z-Drahtlage weist in Seilmitte zwei nebeneinander liegende Drahtbrüche auf. (Fig. 3)

Fig.3 Verschlossenes Tragseil, 63 mm Durchmesser, mit zwei nebeneinander liegenden gebrochenen Z-Drähten, Belastung des Seiles in der Seilreckanlage: 1430 kN

Im ersten Arbeitsgang wurde das Bruchende des Drahtes Nr.1 aus dem Seilverband gehoben und der Z-Draht in Richtung Kuppelwagen aus dem Seilverband geschält. In einer Entfernung von 560 mm, das entspricht einer Seilschlaglänge, wurde der Z-Draht durchtrennt, geschält und mit einem neuen, 2800 mm langen Z-Draht, hart verlötet.

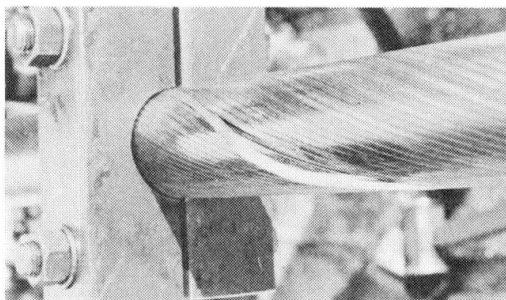
Fig. 6 Einpressen der Drahtüberlänge (Schleife) in den Seilverband mittels einer Schraubklemme

Im zweiten Arbeitsgang wurde der neue Z-Draht mittels einer gut passenden Schraubklemme in den Seilverband gepreßt und zwar vorerst bis zur ursprünglichen Schadensstelle. Im weiteren Verlauf der Sanierung wurde das zweite Bruchende des Z-Drahtes Nr.1 aus dem Seilverband gehoben und in Richtung Klemmenwagen, auf eine Länge von 2240 mm, aus dem Seilverband geschält. Anschließend wurde der neue Z-Draht von der ursprünglichen Schadensstelle mittels Schraubklemme in den Seilverband gepreßt. In einer Entfernung von 2800 mm von der ersten Lötung wurde die zweite Lötung mit kurzer Drahtüberlänge vorgenommen. (Fig.6) Nach Behandlung der Lötstelle mit Spezialwerkzeugen wurde im dritten Arbeitsgang die Drahtschleife mittels Schraubklemme bis zum Verschwinden in die Außenlage des verschlossenen Tragseiles gepreßt. (Fig.7) Hierzu war eine Wegstrecke von ein Meter Länge erforderlich. Die Gesamtlänge zur Sanierung eines gebrochenen Z-Drahtes beträgt in diesem Falle 3800 mm, das sind ca. sechs Seilschlaglängen. Mit der Sanierung des zweiten Drahtbruchs wurde in gleicher Weise wie beim Drahtbruch Nr.1 verfahren.

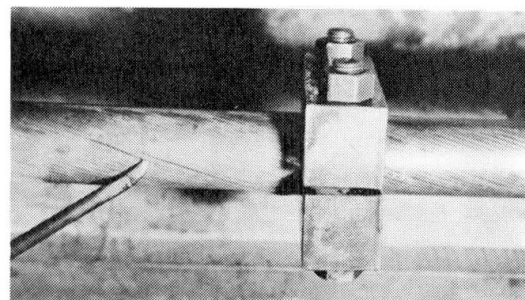
Fig. 7: Seilzustand nach dem Einpressen der Drahtüberlänge in den Seilverband, Entfernung von der sanierten Bruchstelle: 2800 mm

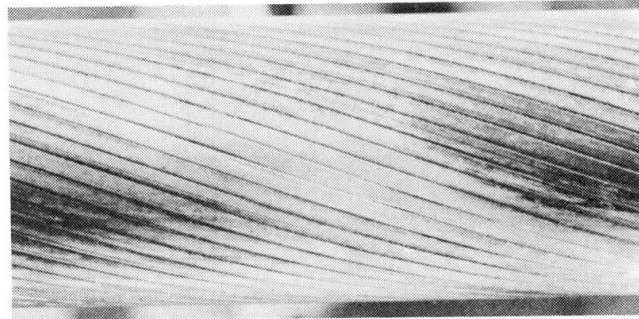
Aus Fig.8 ist der Seilverband im sanierten Bereich ersichtlich. 'Alle Z-Drähte der Außenanlage liegen fest im Seilverband. Unmittelbar nach der Sanierung tragen die eingepreßten und gelöteten Z-Drähte nicht voll mit. Ein weitgehender Spannungsausgleich zwischen den Z-Drähten tritt jedoch nach mehrmaliger Be- und Entlastung auf.

Fig.8 Verschlossenes Tragseil, 63 mm Durchmesser, Seilzustand im sanierten Bereich

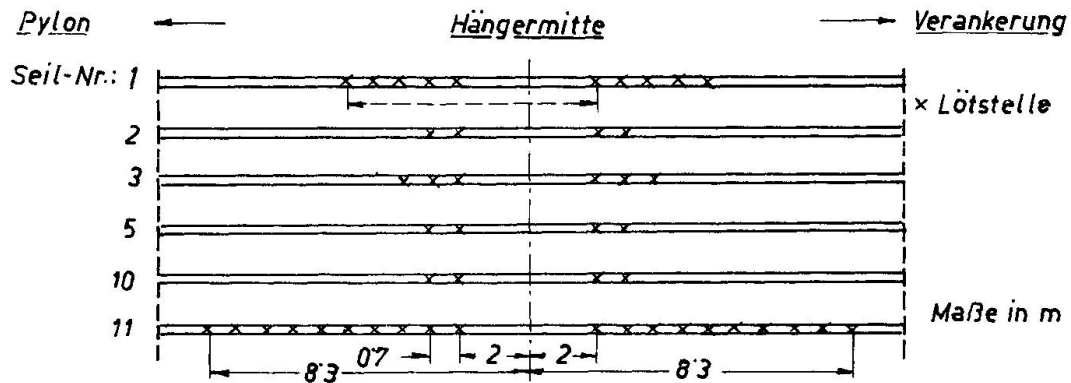
Im Bereich einer Hängerklemme wurden in 6 von 12 Tragseilen insgesamt 24 Drahtbrüche festgestellt. Die Lage der Drahtbrüche in den einzelnen Seilen ist aus dem Lötstellenplan ersichtlich. (Fig.9) Die Verteilung der Lötstellen wurde so festgelegt, daß der Abstand zwischen zwei benachbarten Lötstellen 700 mm beträgt. Im Bereich der Hängerklemme wurde eine lötstellenfreie Zone von 4 m geschaffen. Aufgrund der Drahtbruchverteilung ergaben sich im zu sanierenden Bereich folgende maximale Einziehlängen bzw. Sanierungslänge: Seil Nr. 11: Einziehlänge 10,3 m und Länge des sanierten Bereiches 16,6 m.

Fig.9 Lötstellenplan zur Sanierung der verschlossenen Tragseile im Bereich einer Hängerklemme
